Inspection Report

Property Address:
2711 Claypool-Alvaton Rd
Bowling Green KY 42103

Foremost RV Inspections

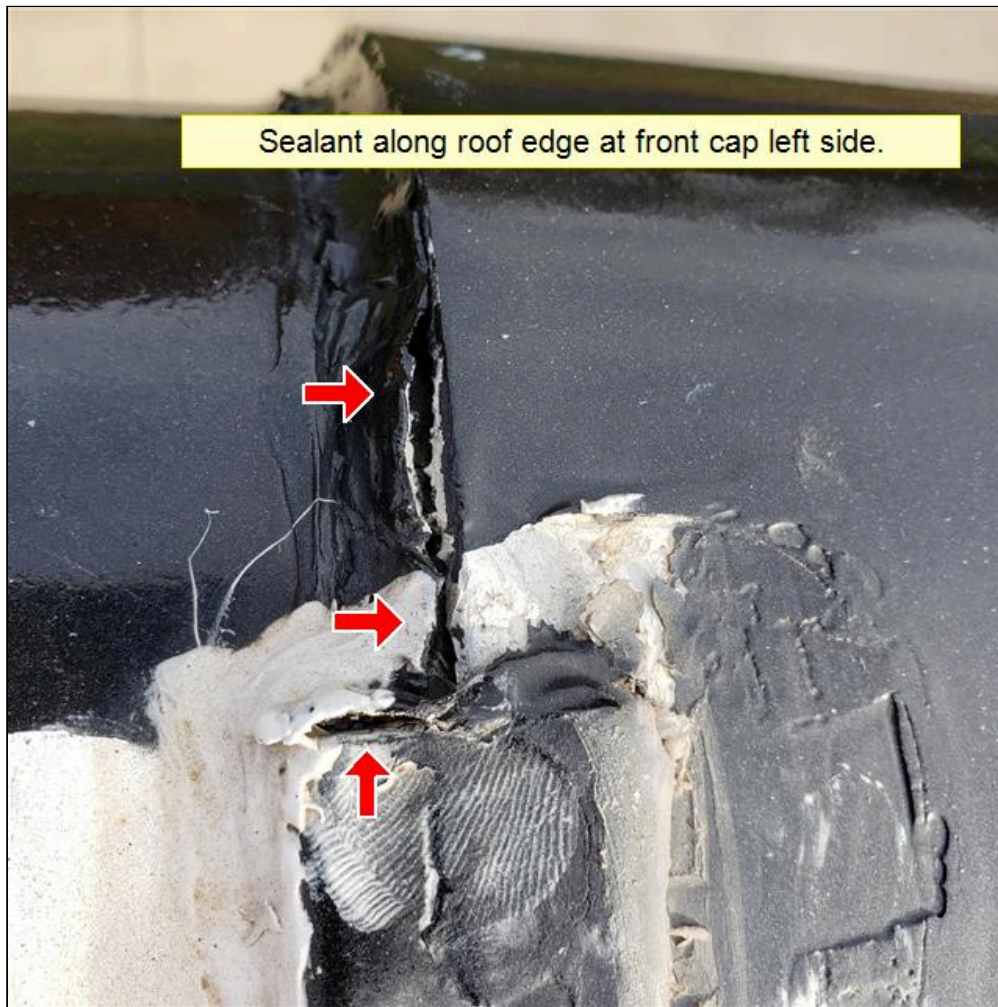
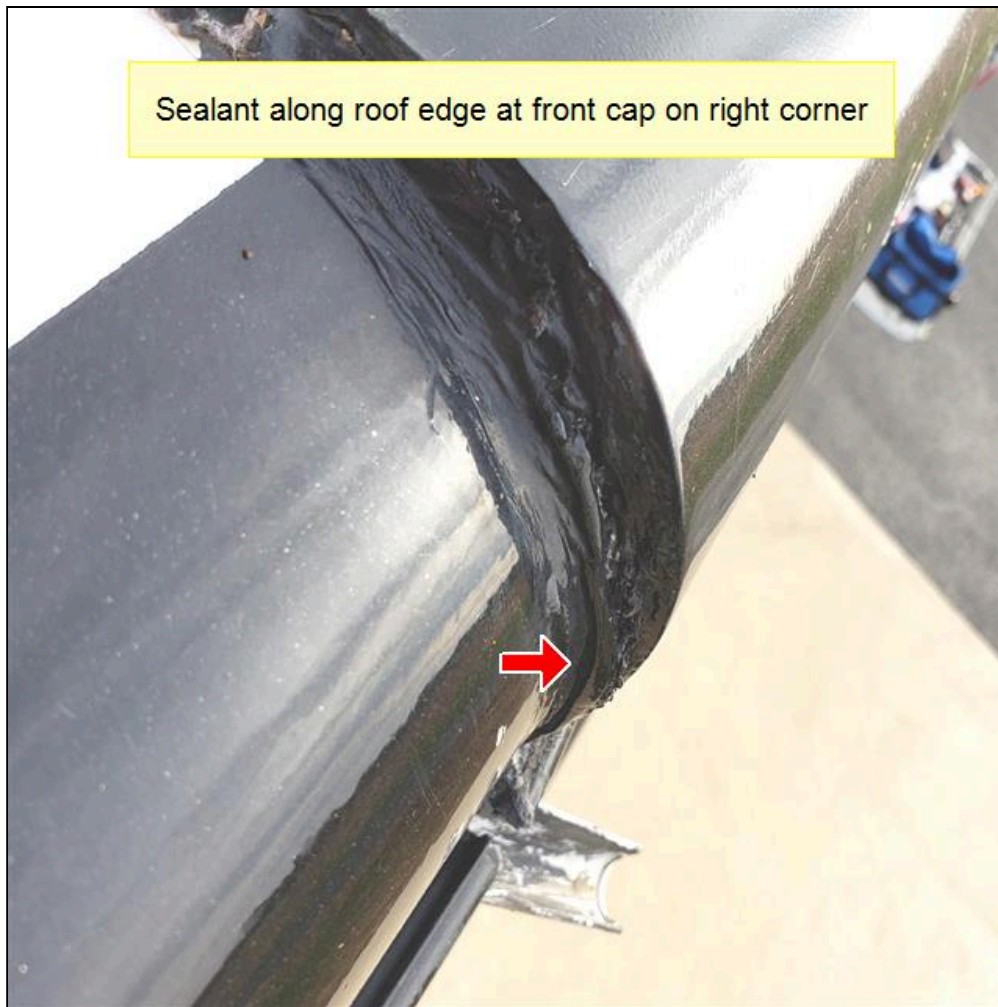
Sealant along left and right corners and joint molding screws is cracking. Reseal areas to prevent water intrusion.

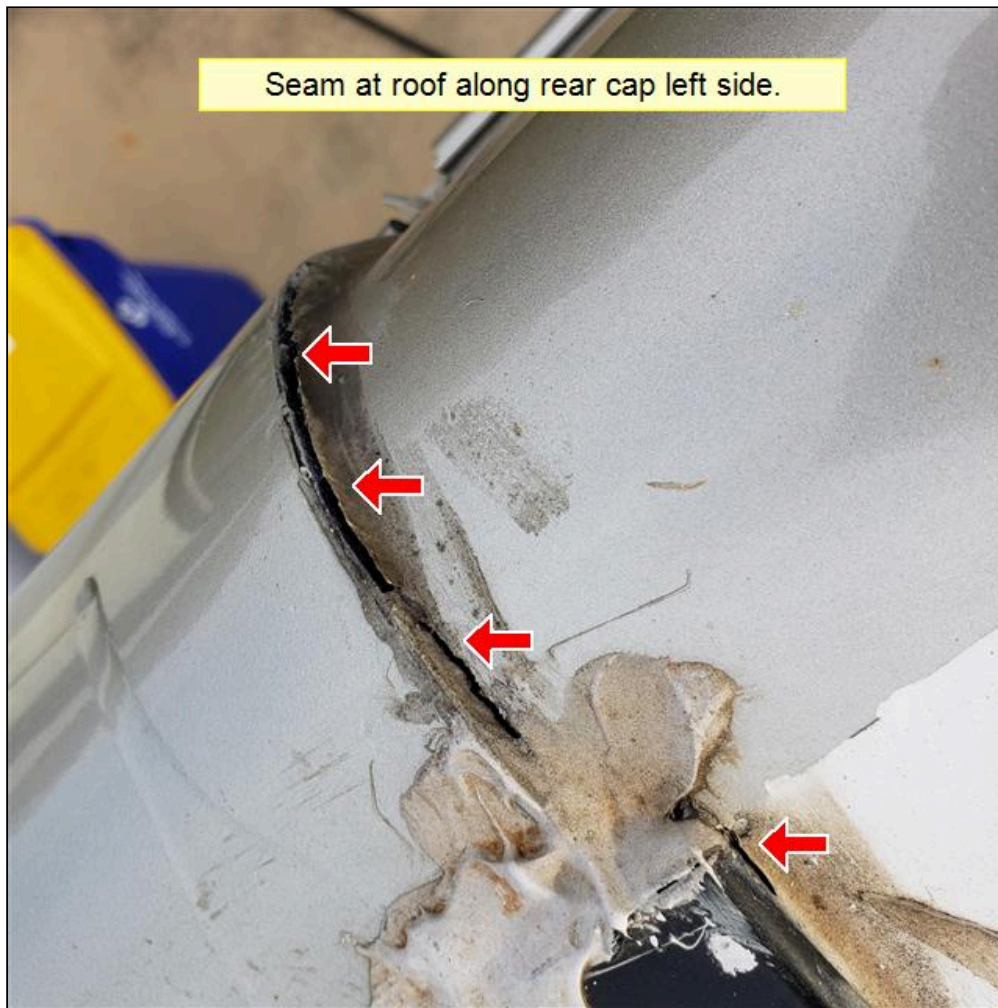
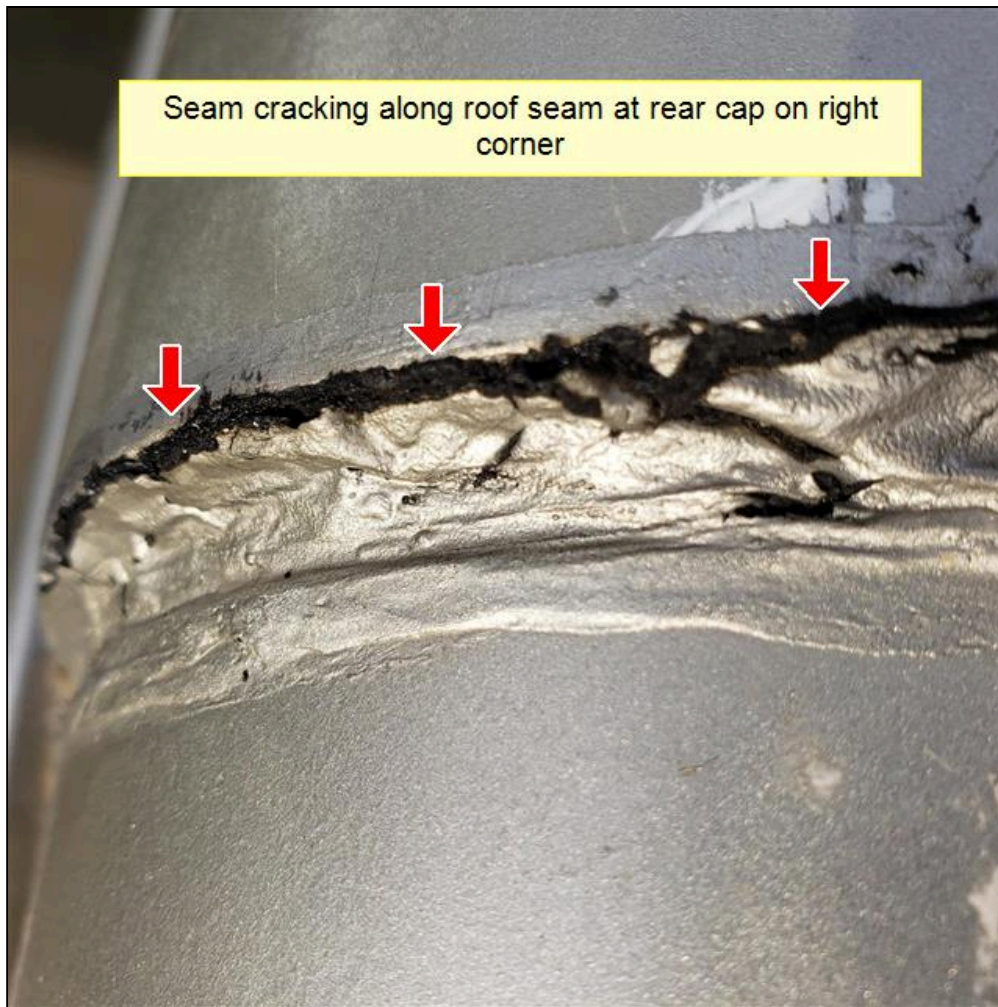
Sealant cracking at roof seam along rear cap at corners and along edge

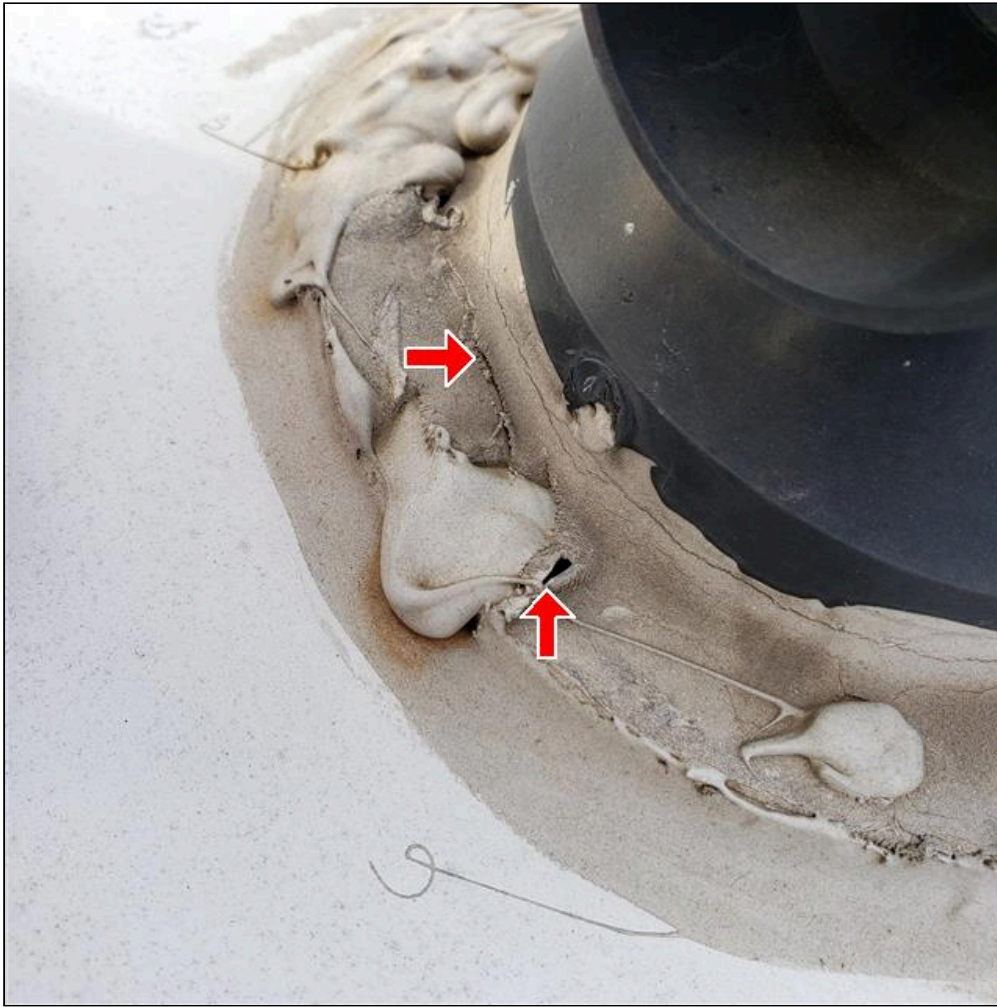
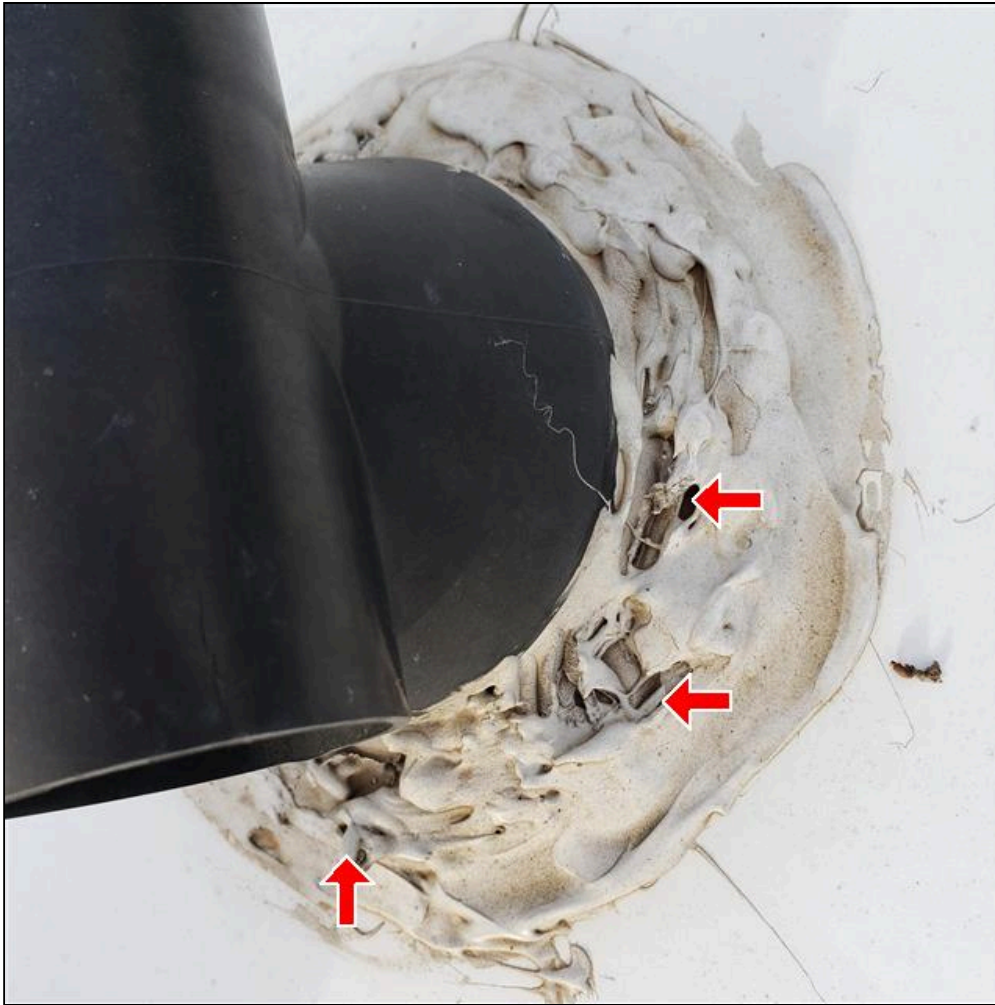
Minor cracking/gaps in sealant around plumbing vents

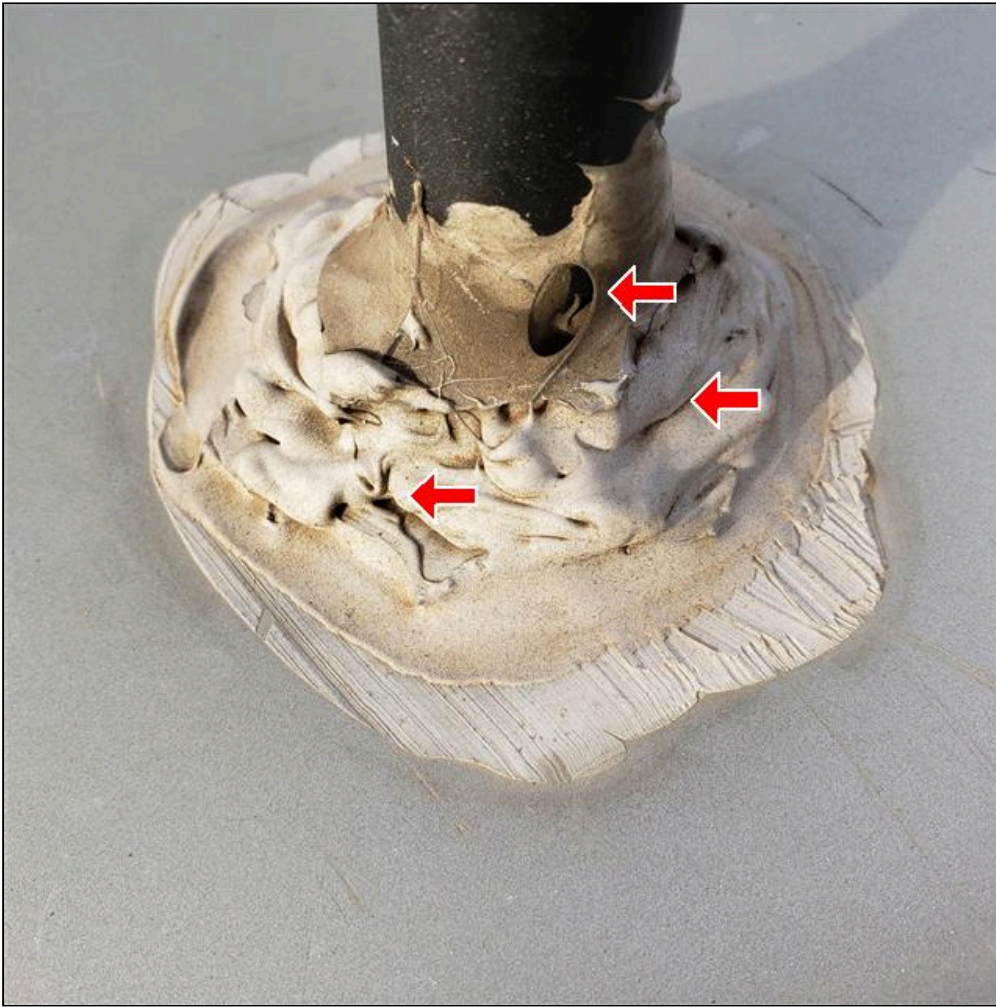
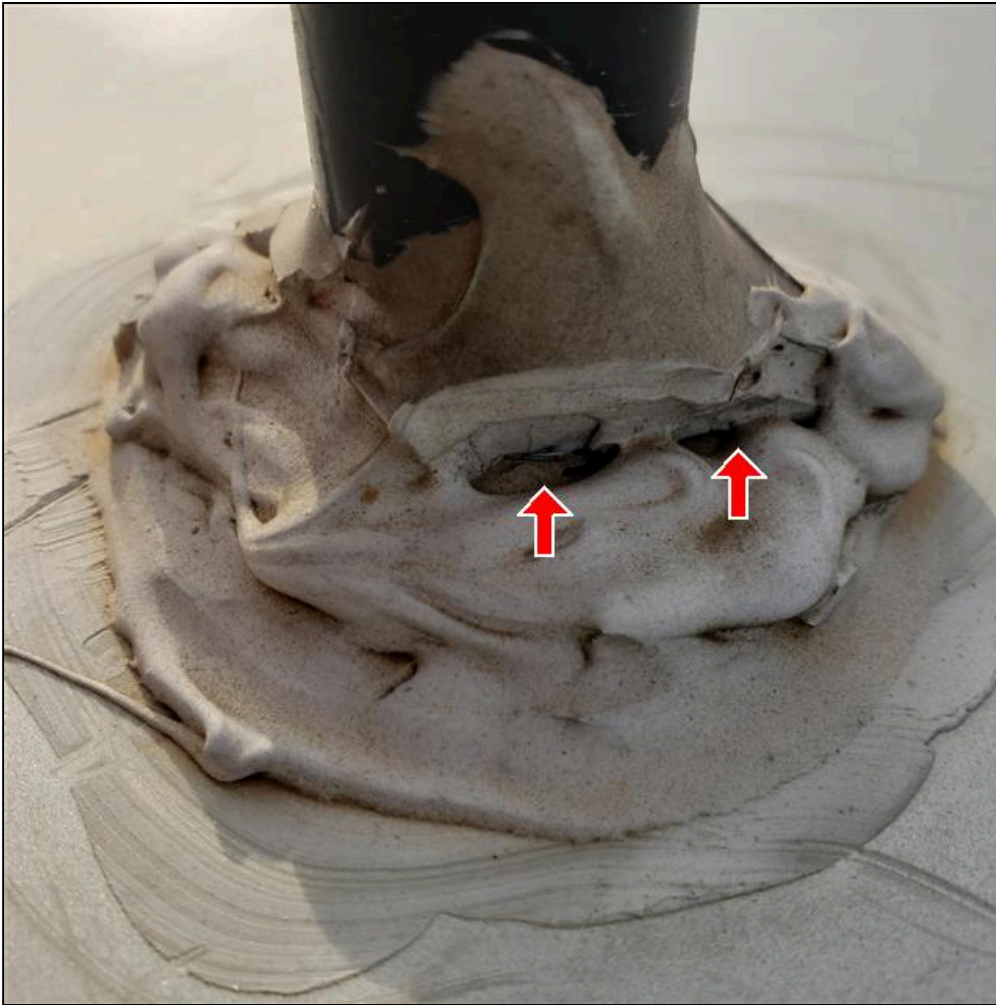
Cracking in sealant around ladder mounts on roof.

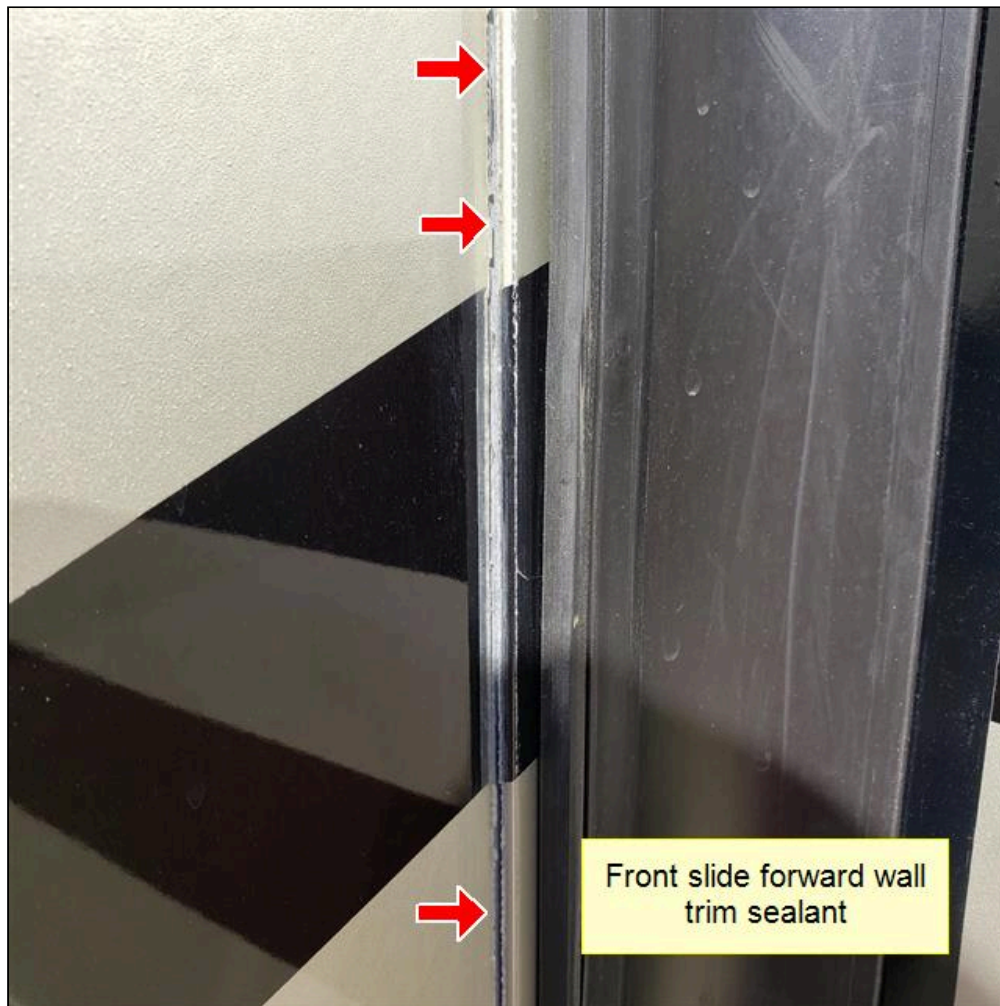
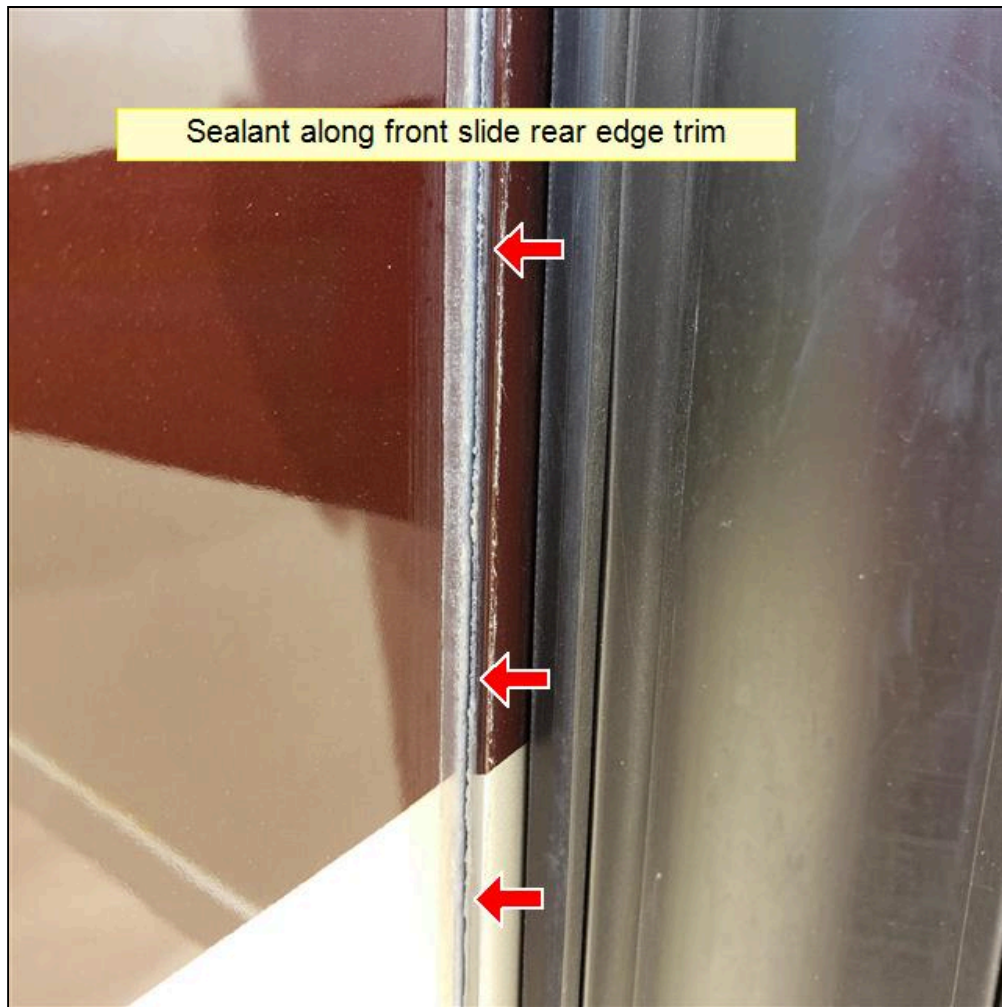
Sealant cracking along front and rear slide trim along sidewall. Reseal to prevent water intrusion

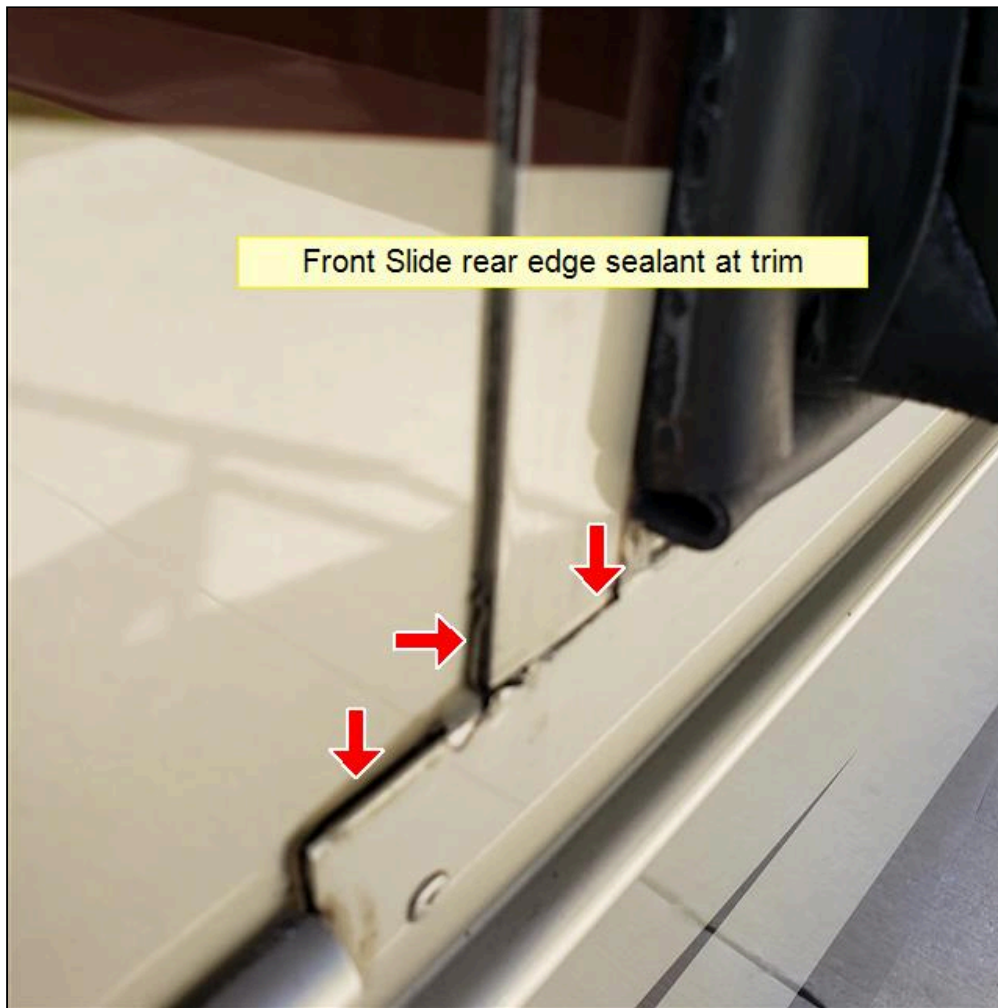
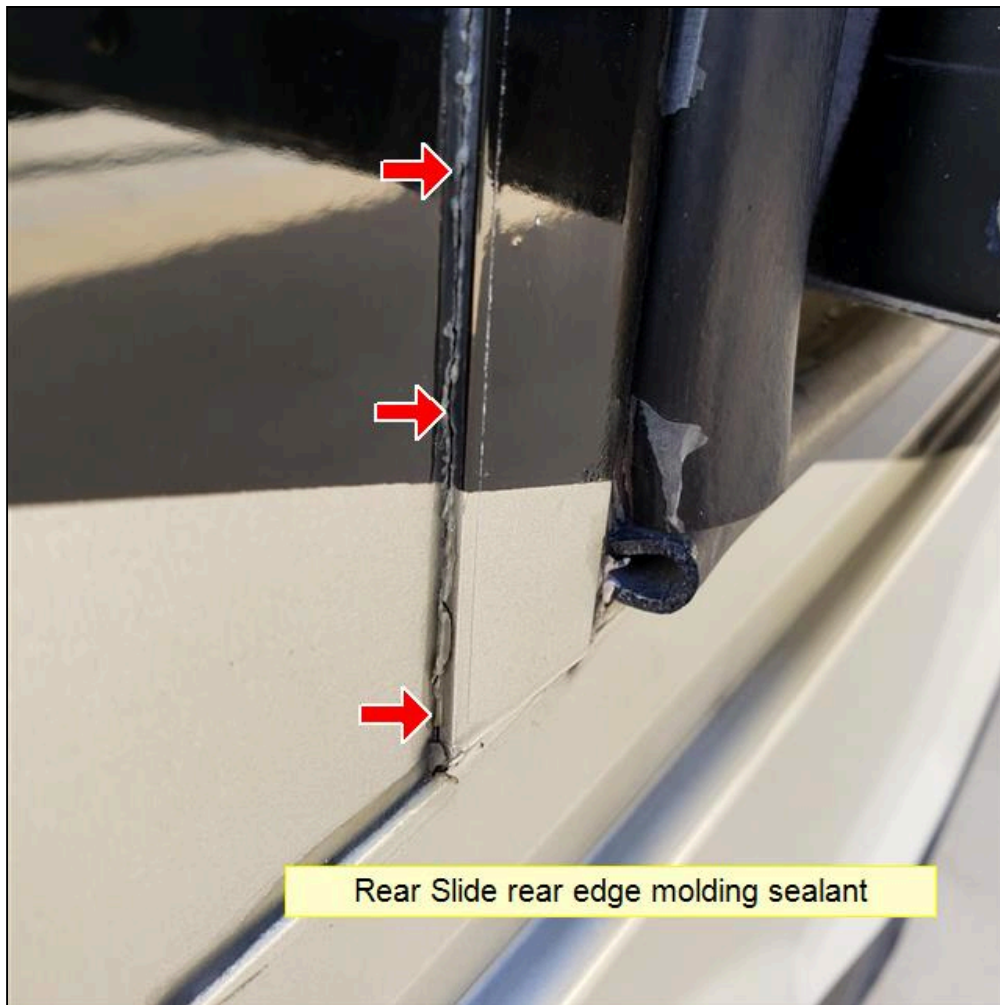
Sealant cracking along trim on slides. Misaligned bulb seal on forward slide at rear had rubbed paint off.

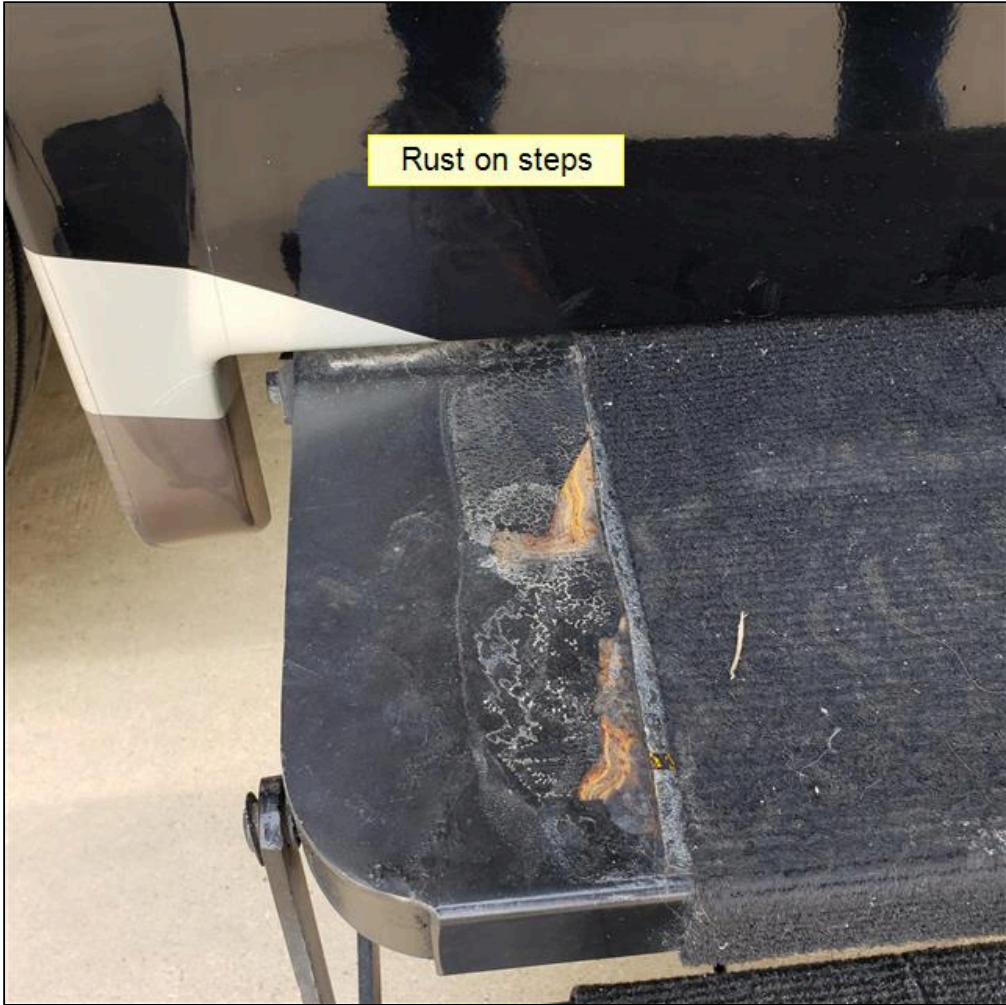
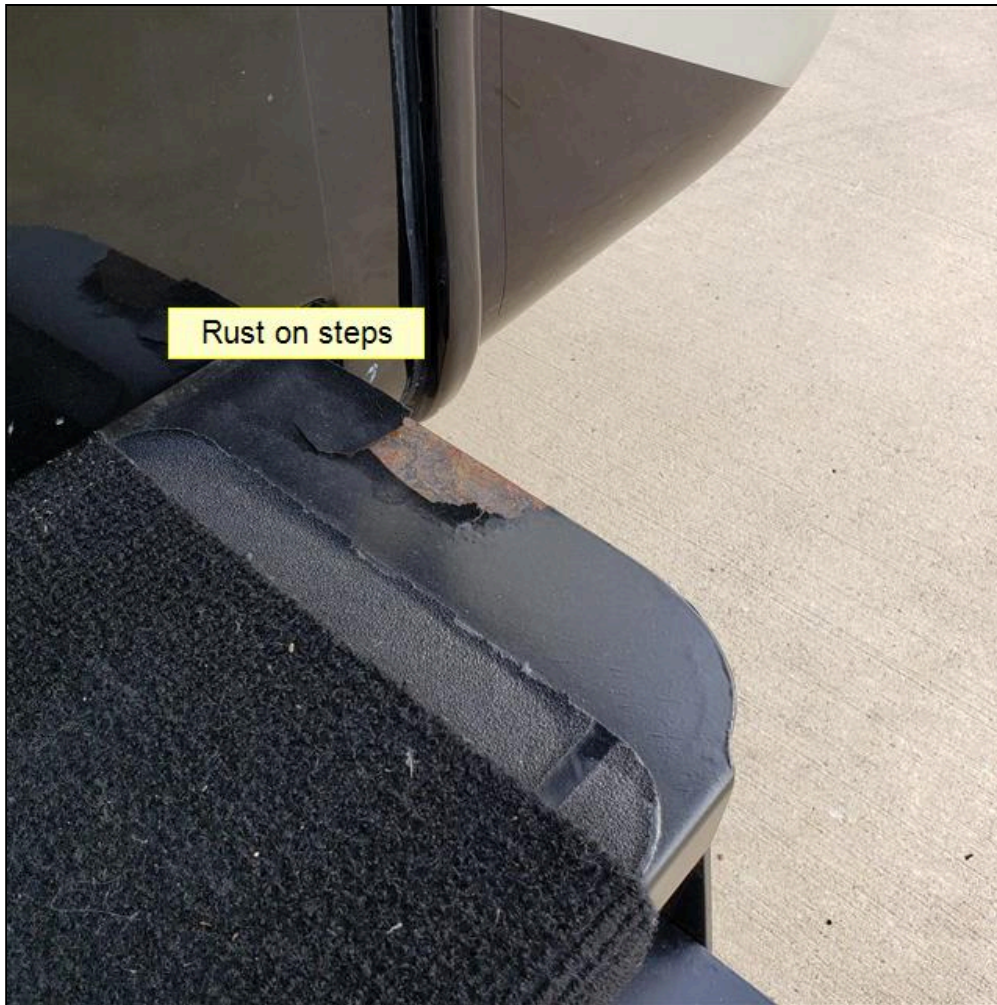
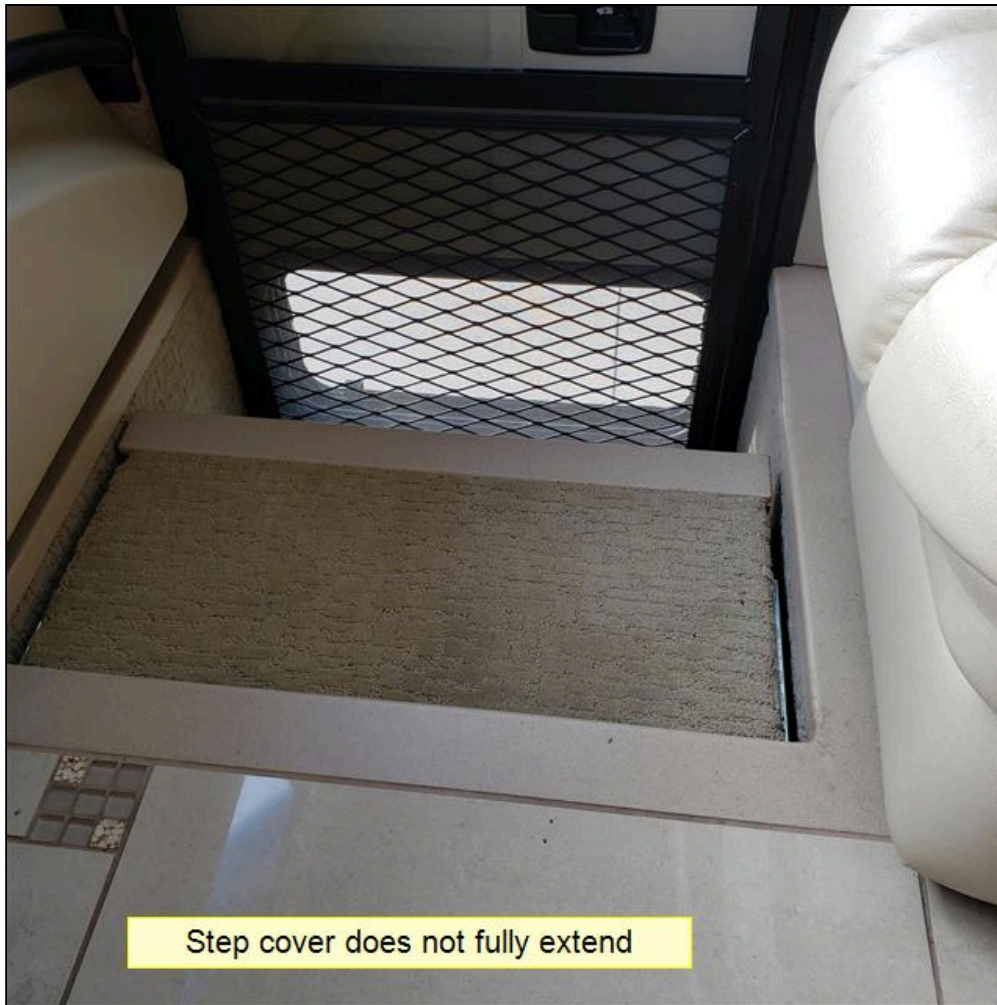
Acceptable
Keyless entry did not operate from key fob.

Interior step cover did not work appropriately, only partially closed. Had to manually close. Exterior steps showing some surface rust.

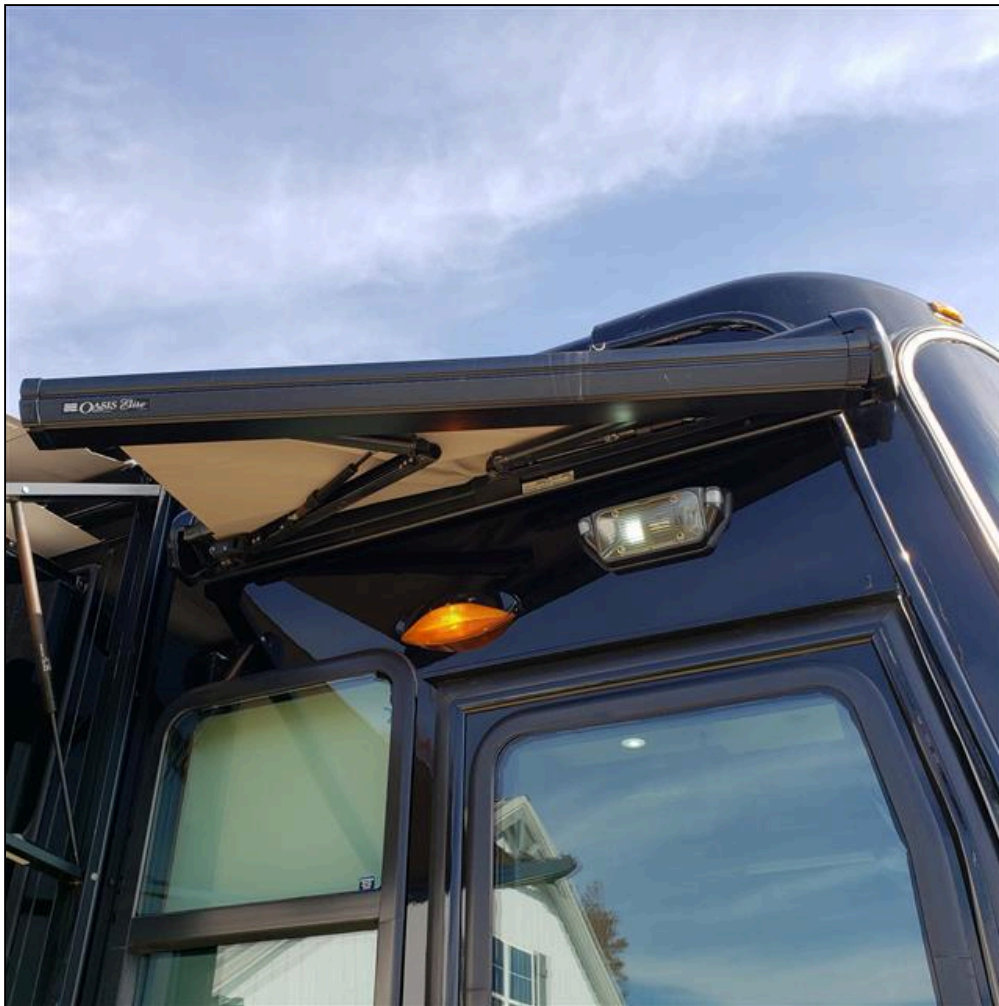
Door awning does not extend properly.

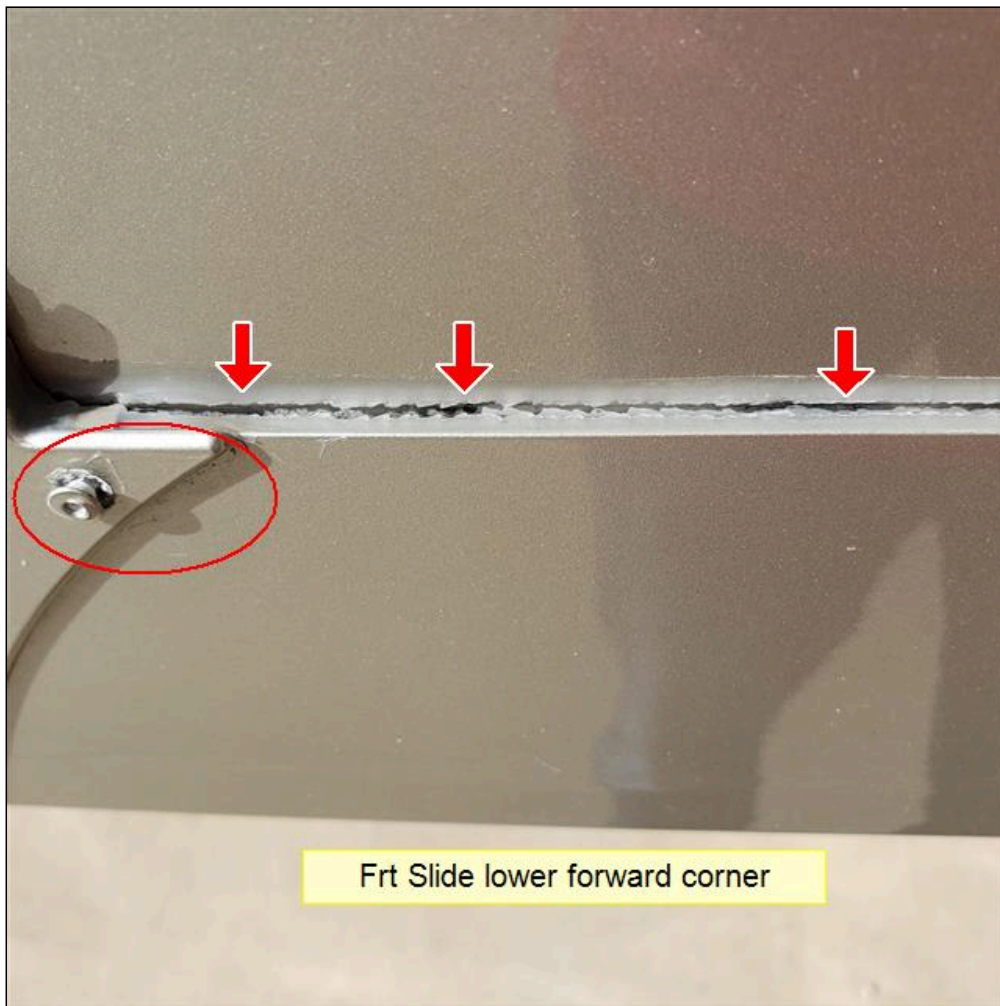
7.1.A Slideout T-Molding Trim
Fair

Molding at lower forward corner cracked and sealant pulled loose.

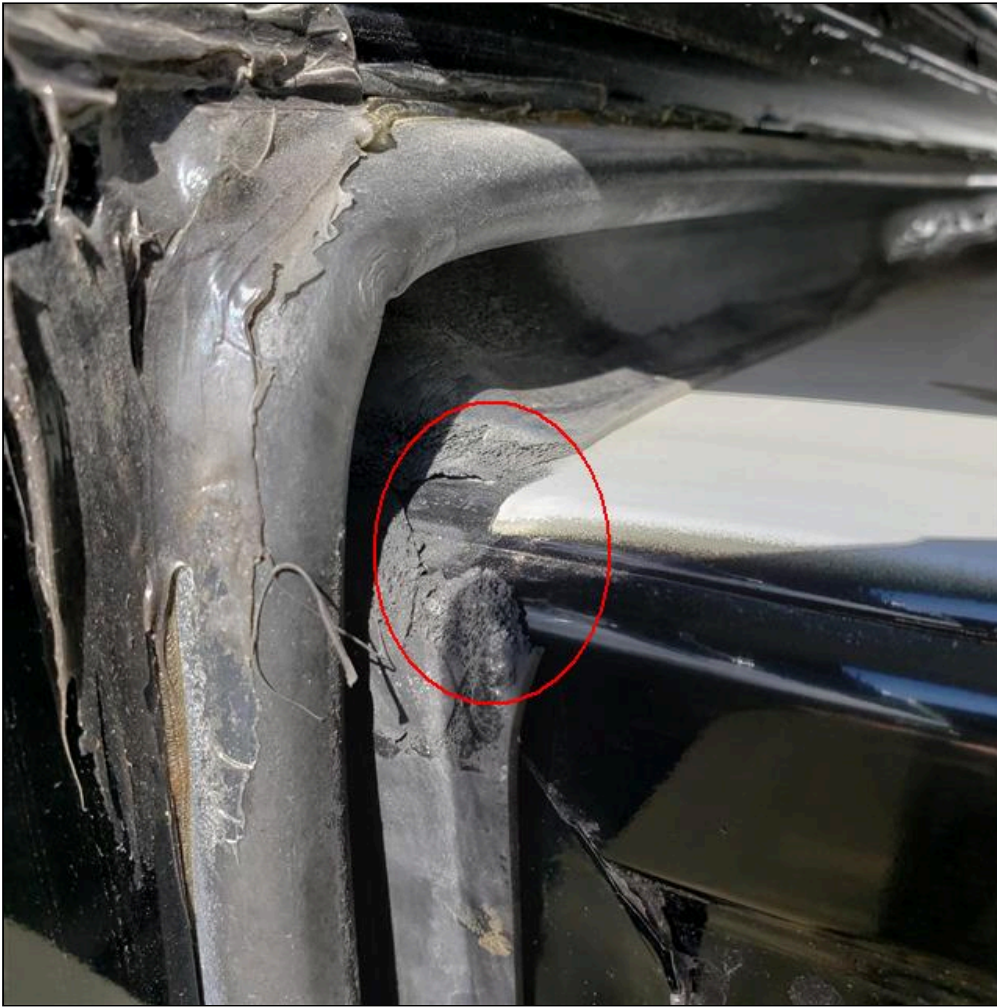
Worn/tear top forward corner

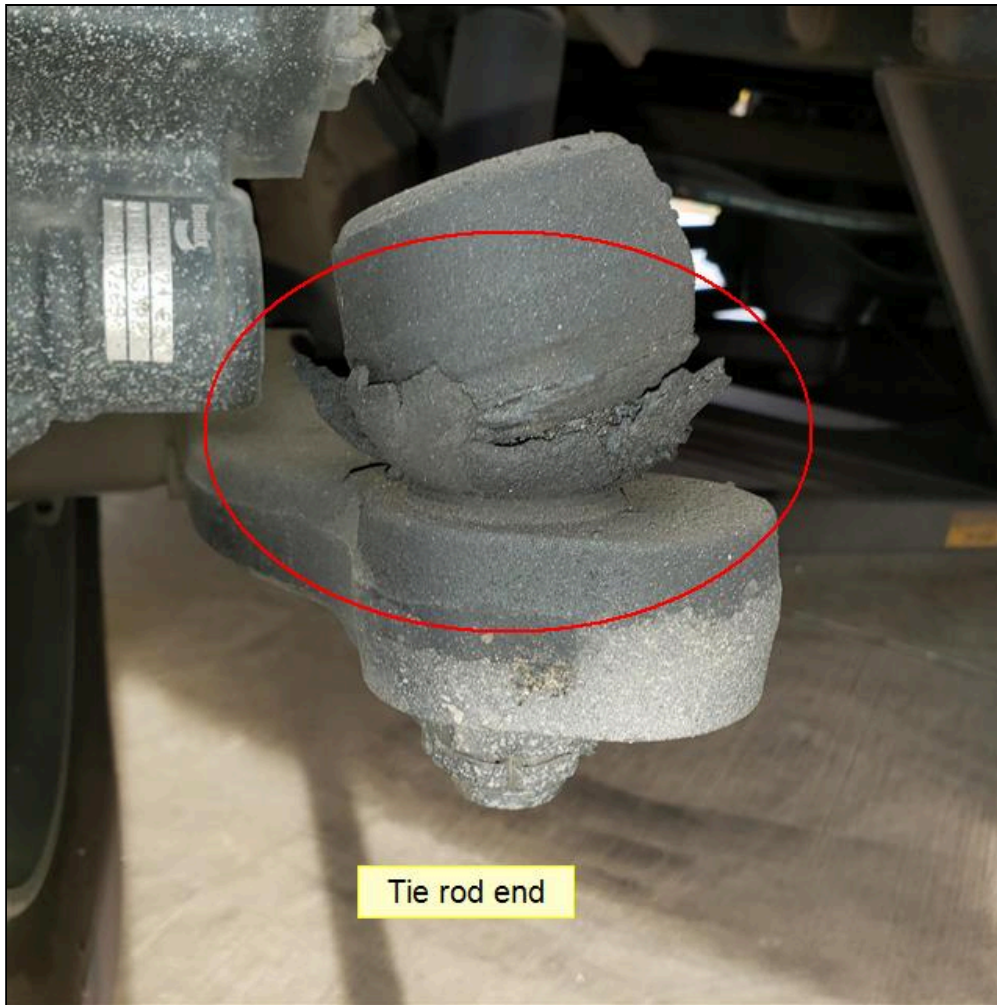
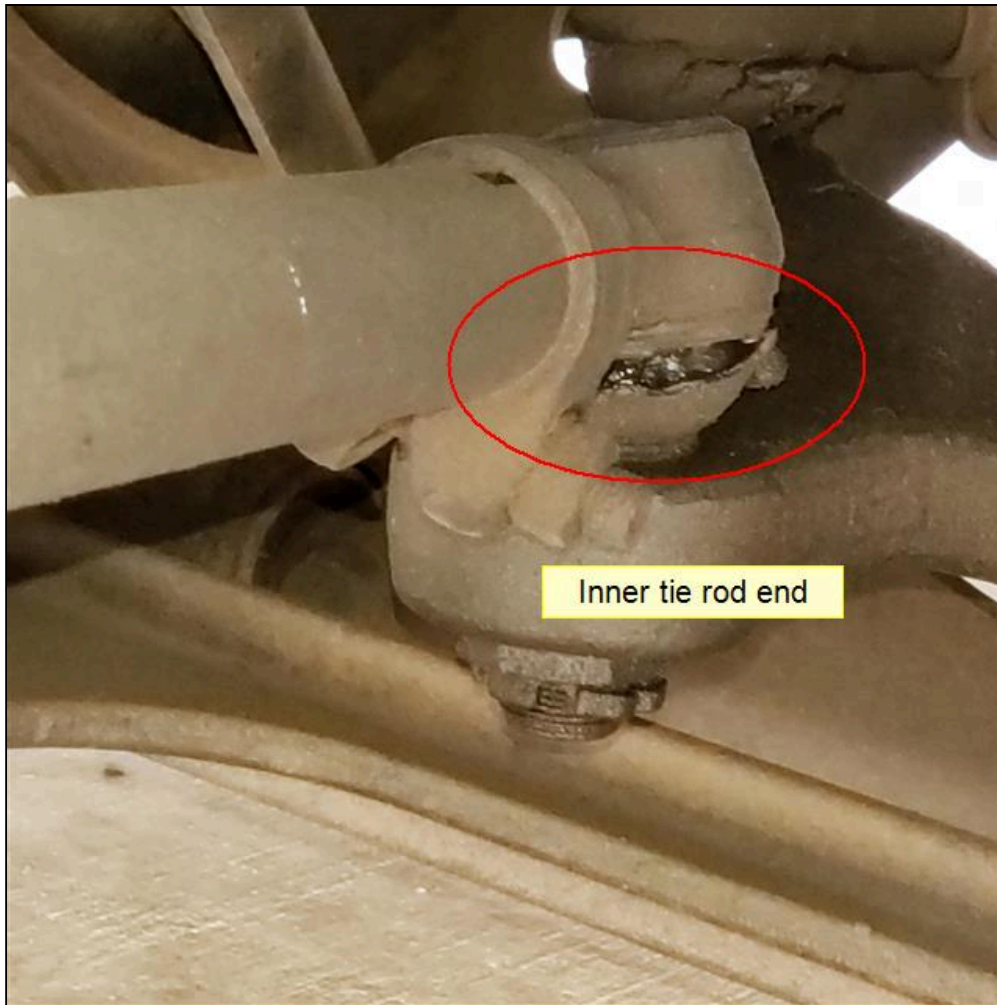
Front inner and outer tie-rod end boots dry rotted and broken require replacement

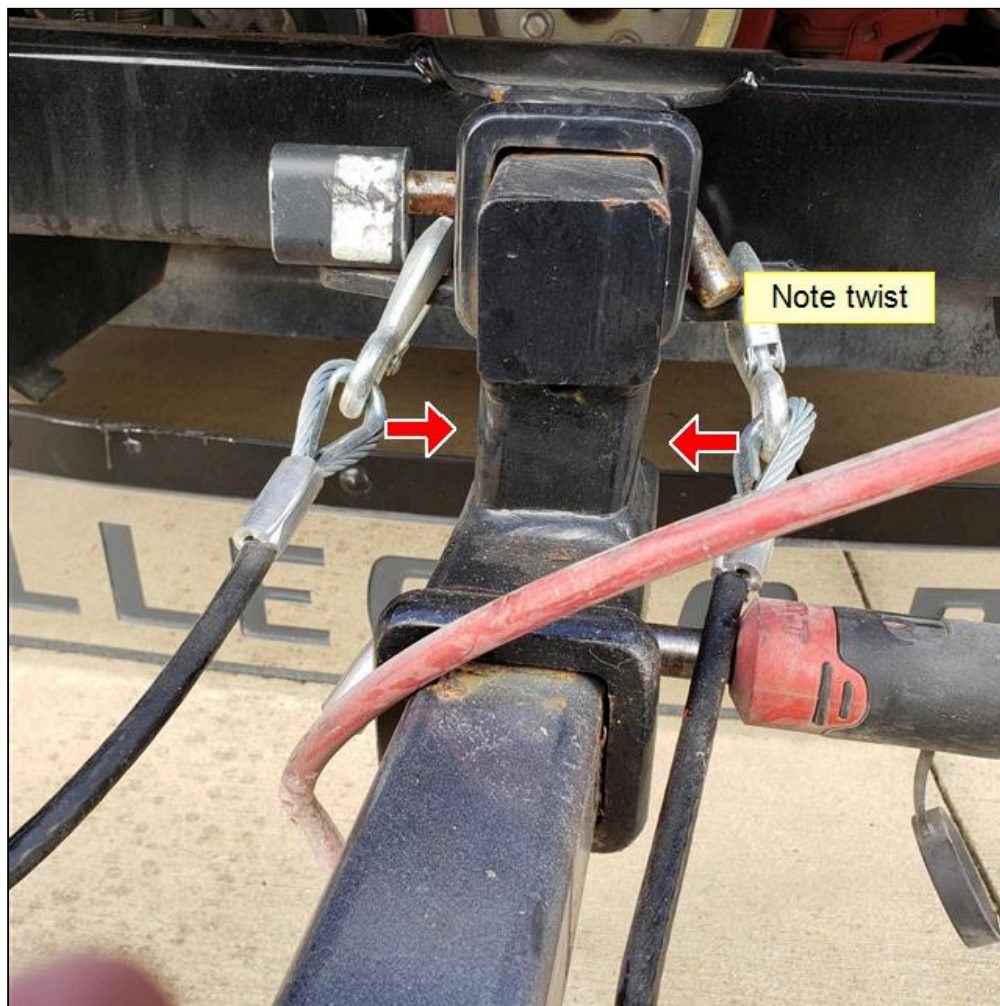
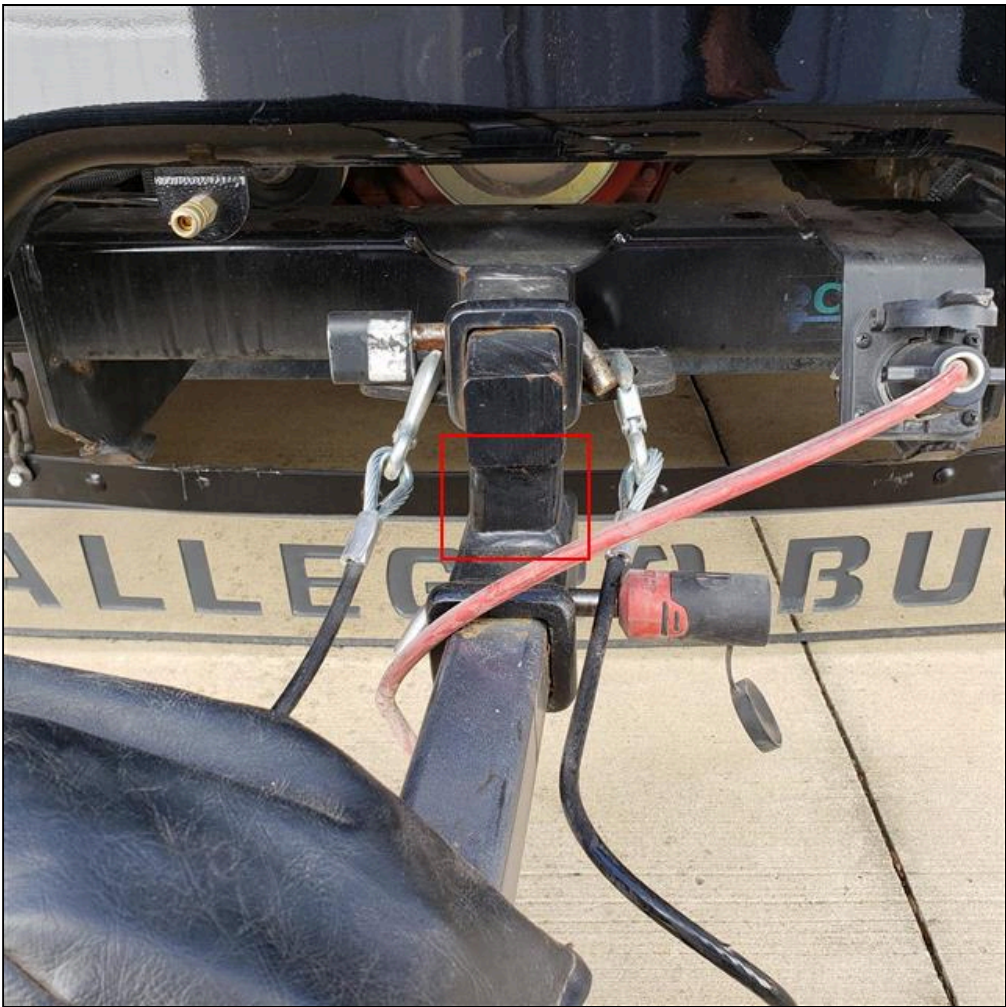
10.5 Hitch Receiver Condition

Note - Hitch is in good condition. Receiver on tow dolly appears bent. Check and have inspected by qualified professional prior to use.
