Inspection Report

Property Address:
2711 Claypool-Alvaton Rd
Bowling Green KY 42103

Foremost RV Inspections

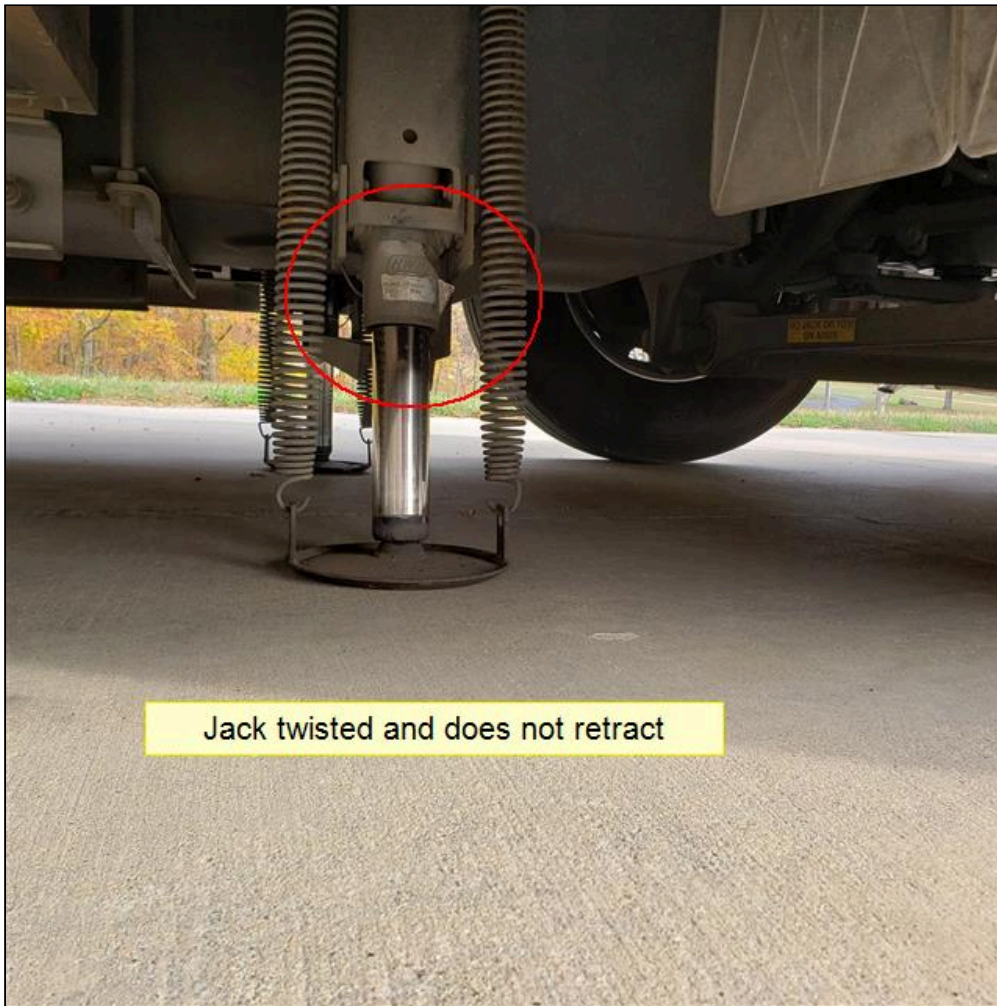
11.0 Leveling System Condition
Poor

Unit tested for leveling. Levelled appropriately but right front jack would not retract.

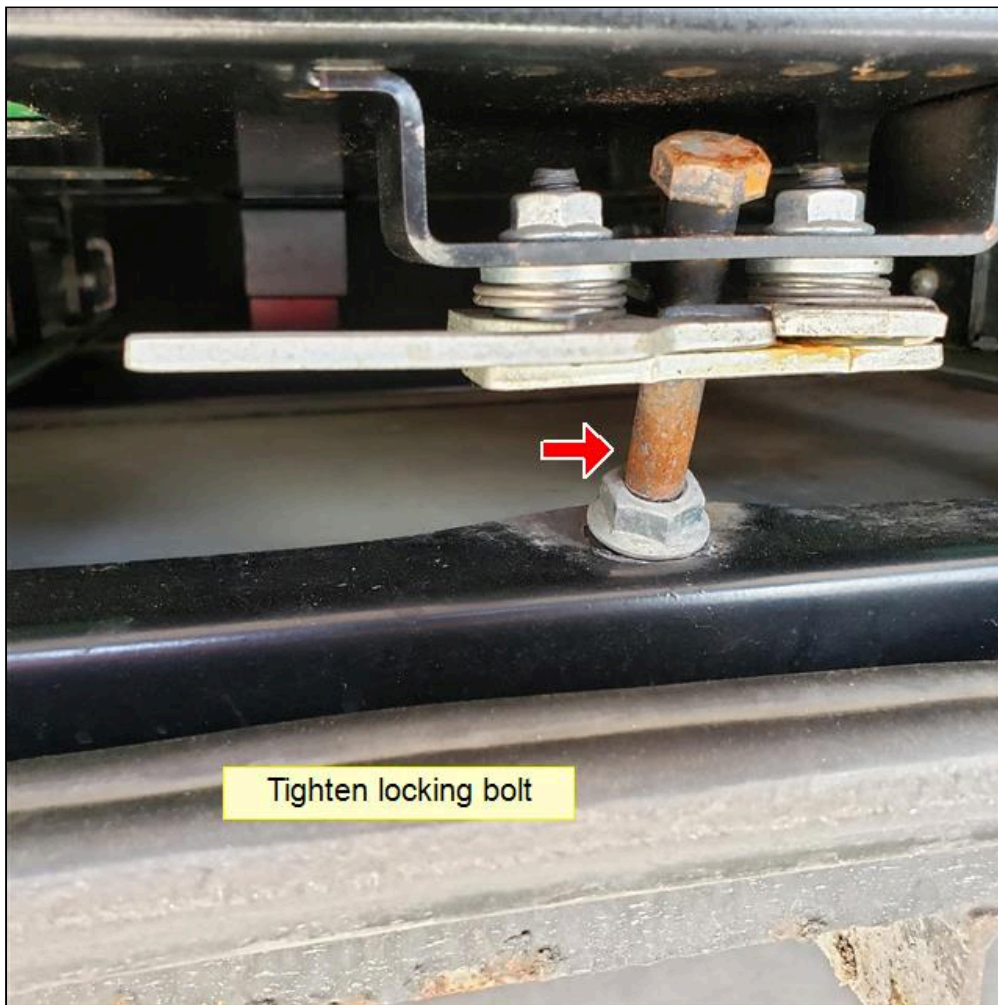
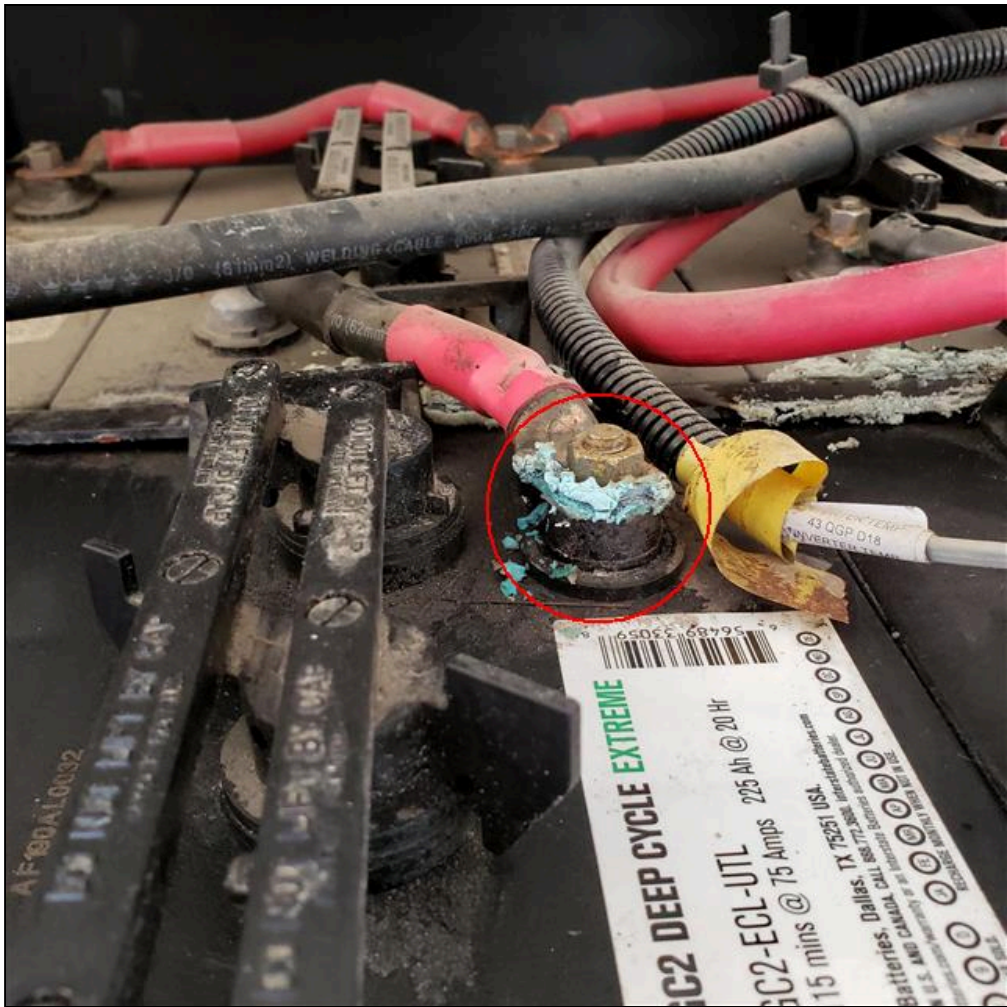
Some corrosion build up on cables. Clean and maintain for maximum performance. Bolt locking battery tray in place is loose and should be tightened.

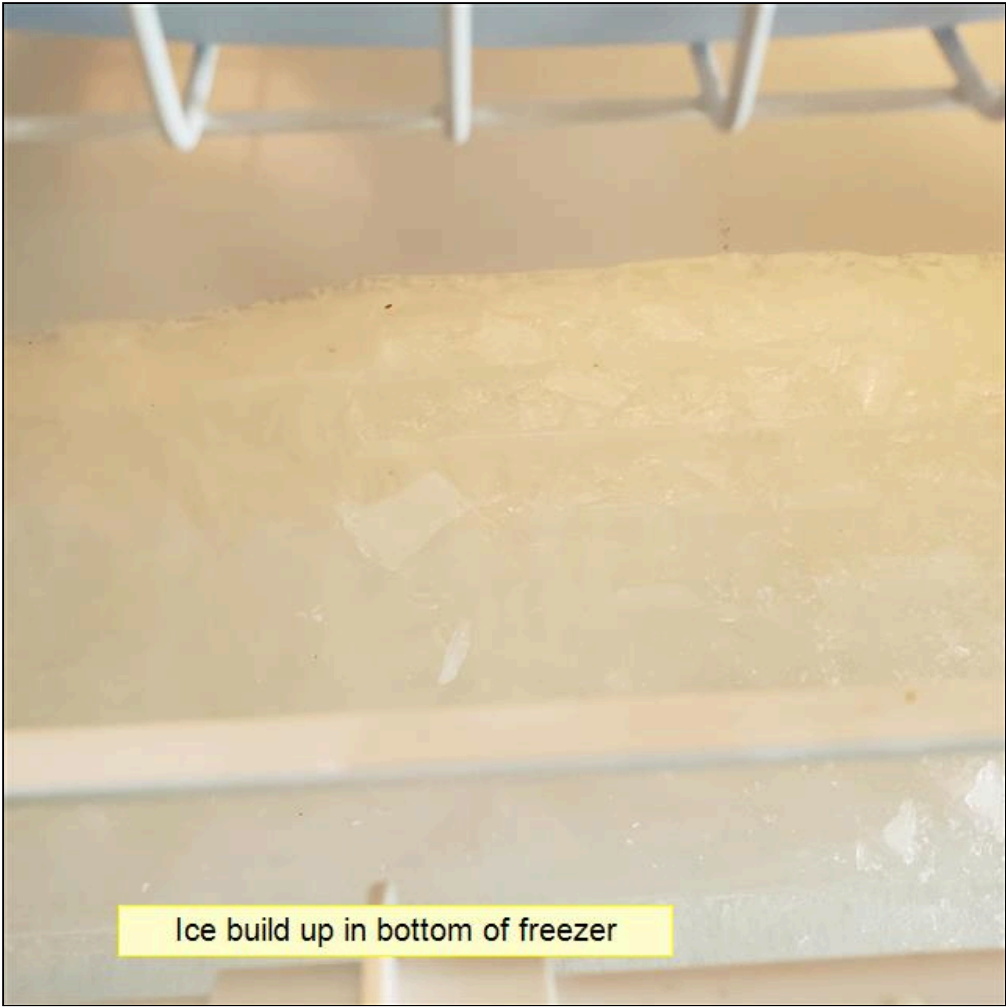
- 15.0 Refrigerator - Control Board
Acceptable
- 15.1 Refrigerator - Front Side Door Panels
Acceptable
- 15.2 Refrigerator - Front Side Door Seals
Acceptable
- 15.3 Refrigerator - Front Side Door Frame
Acceptable
- 15.4 Refrigerator - Inside Freezer Walls
Acceptable
Icing at bottom of freezer. Needs defrosting

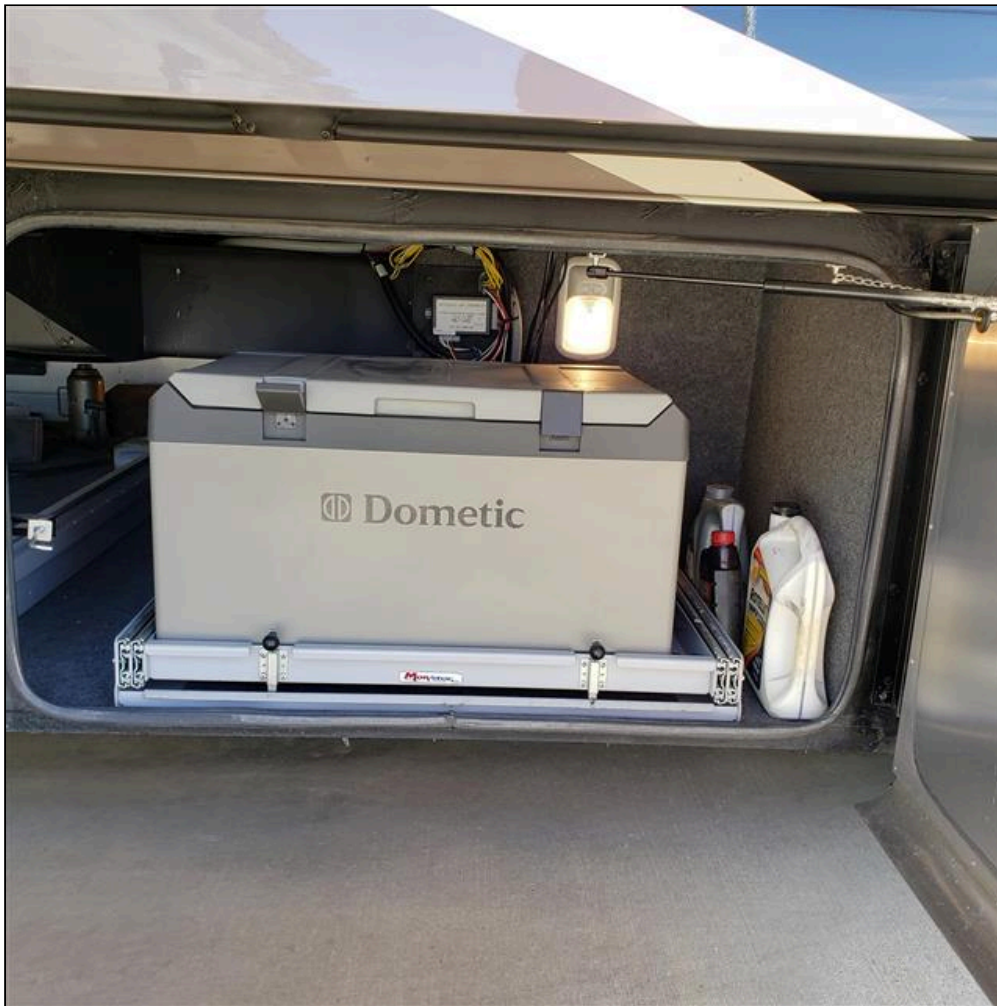
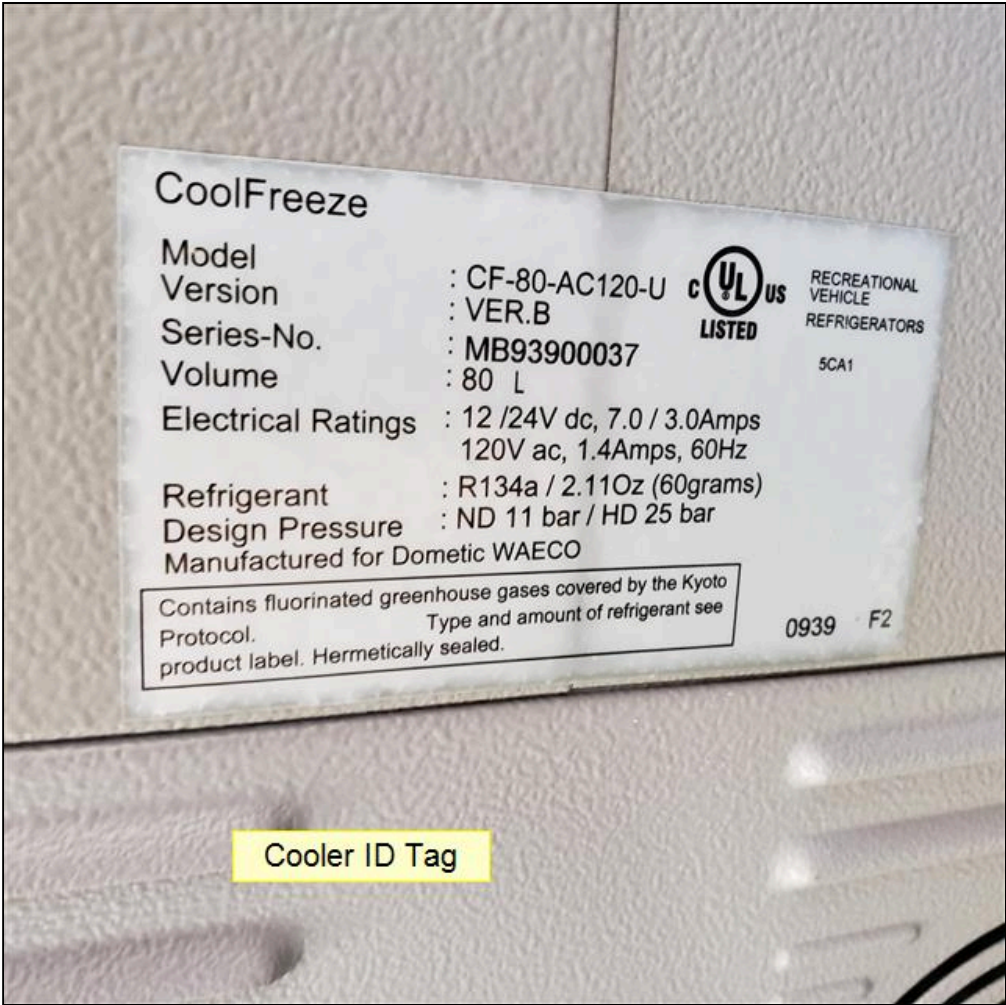
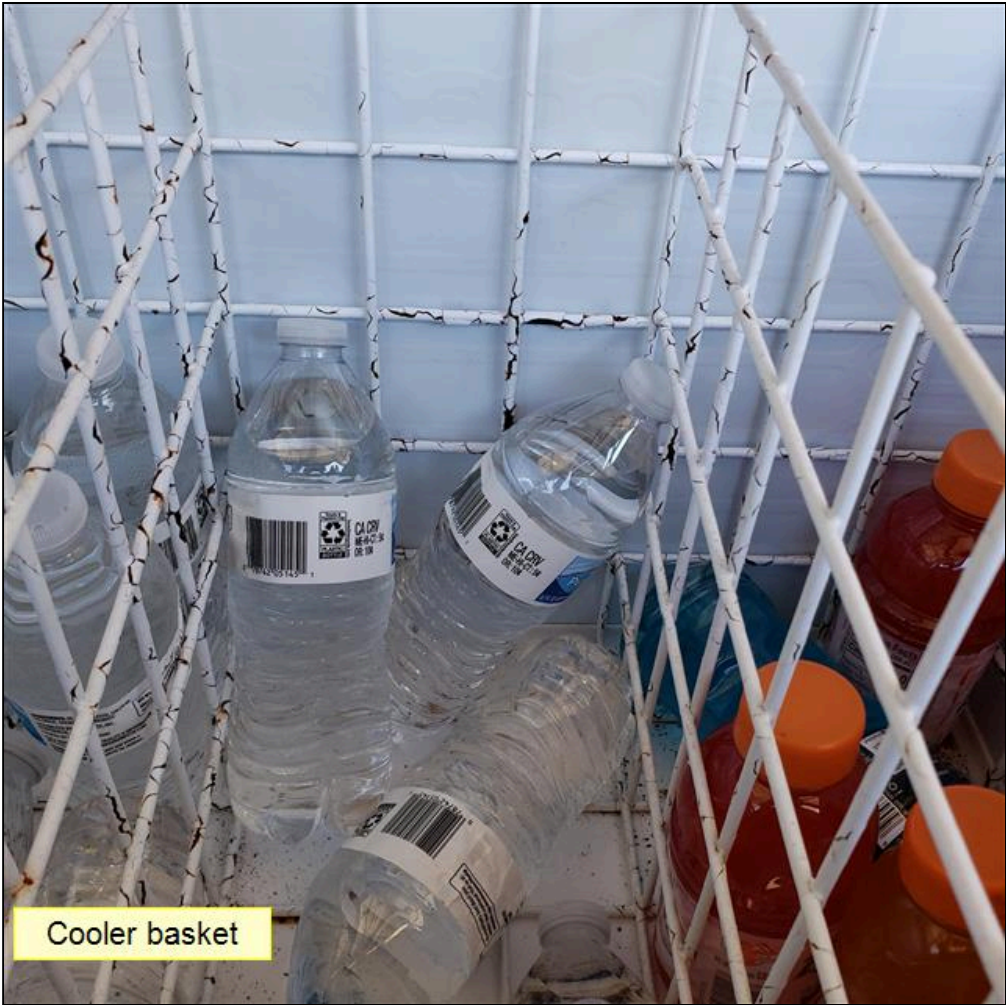
Electric cooler located in right side storage powers on appropriately. Basket is cooler is rusting.

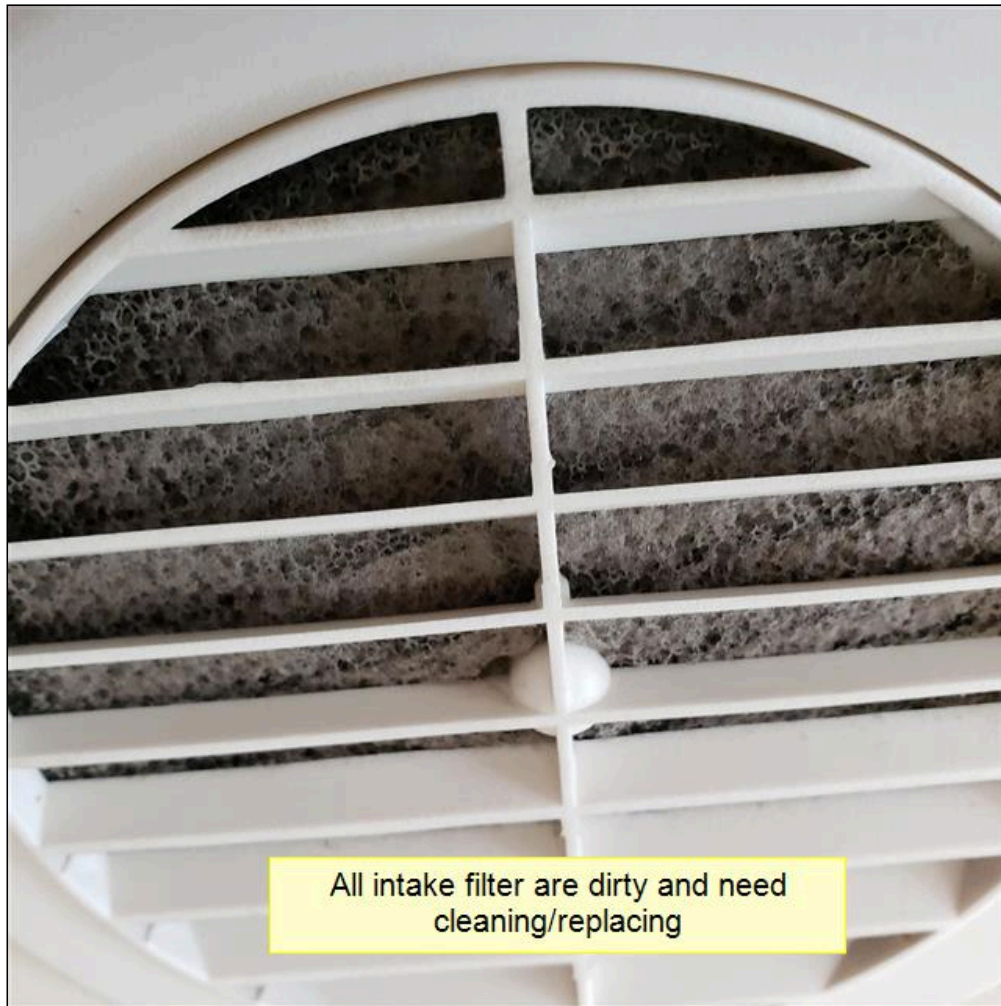
Filters on all 3 units should be clean or replaced

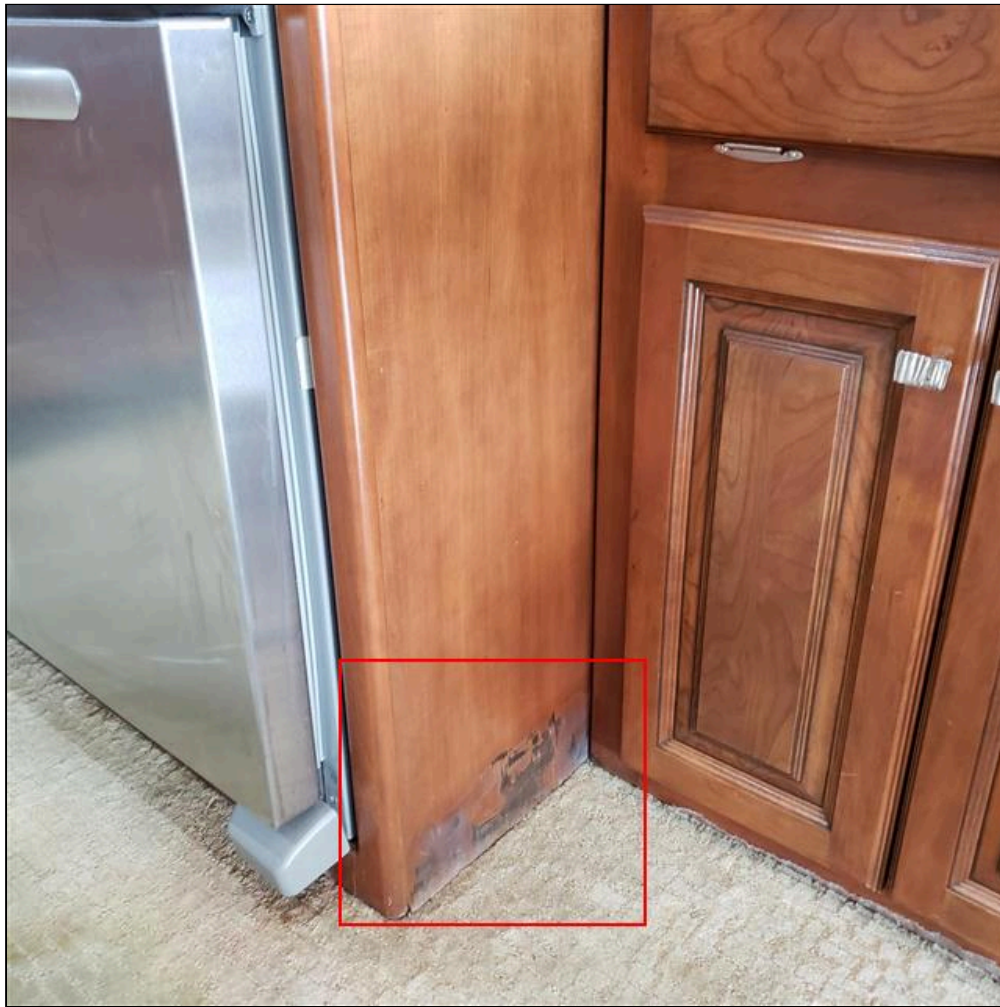
Water damage noted on wall by refrigerator. Seller states refrigerator in-door water line had not been winterized and broke when de-winterizing unit. Wall is not soft. Damage appears cosmetic

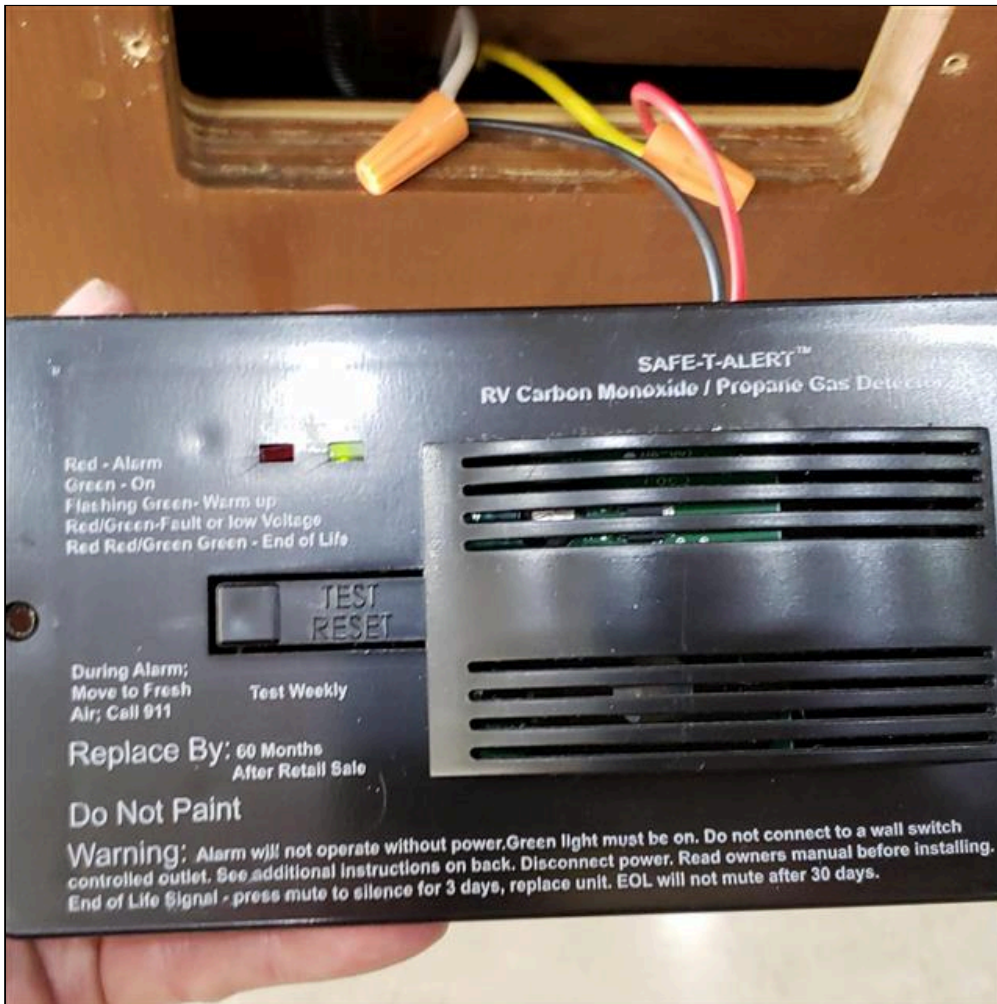
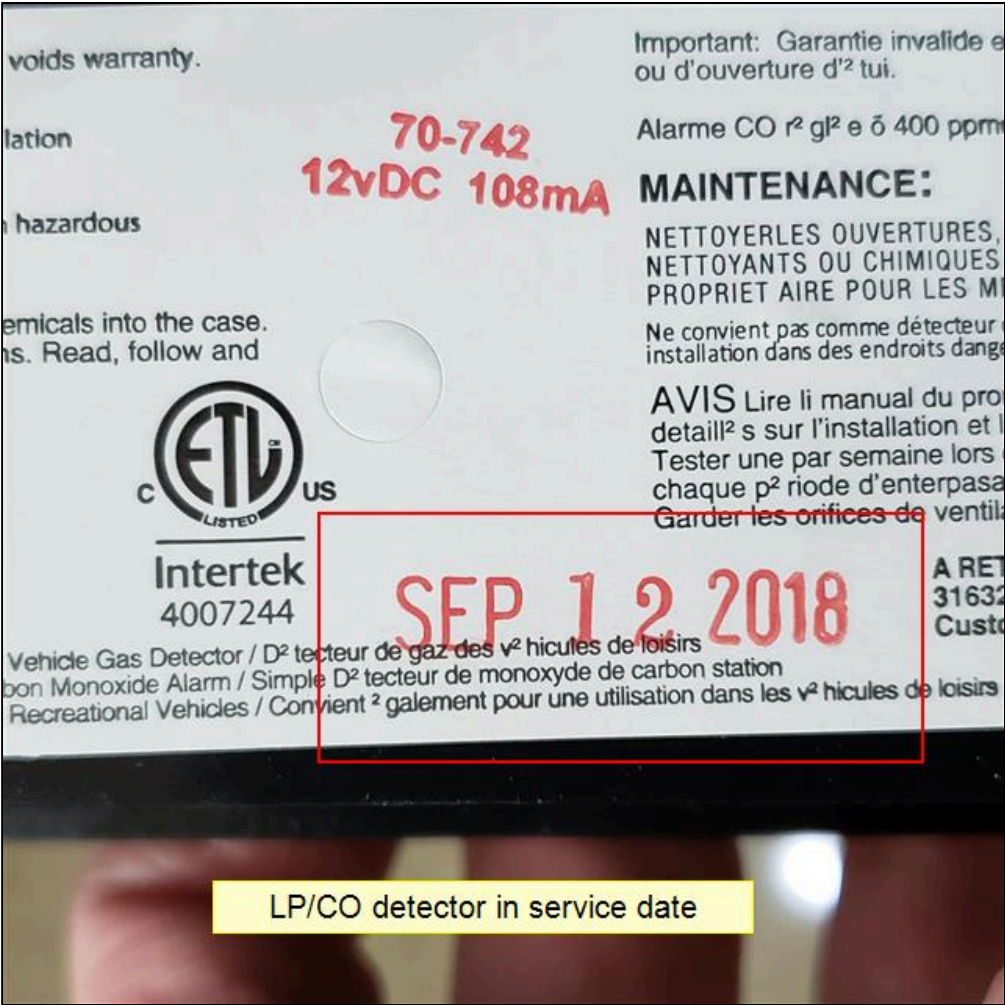
LP/CO detectors located in galley and at forward area of coach arses serviceable and tested appropriately. In service date 9-12-2018 of galley detector is recommend replacement 60 months (9-12-2023). In service date of forward detector 04-13-2022.

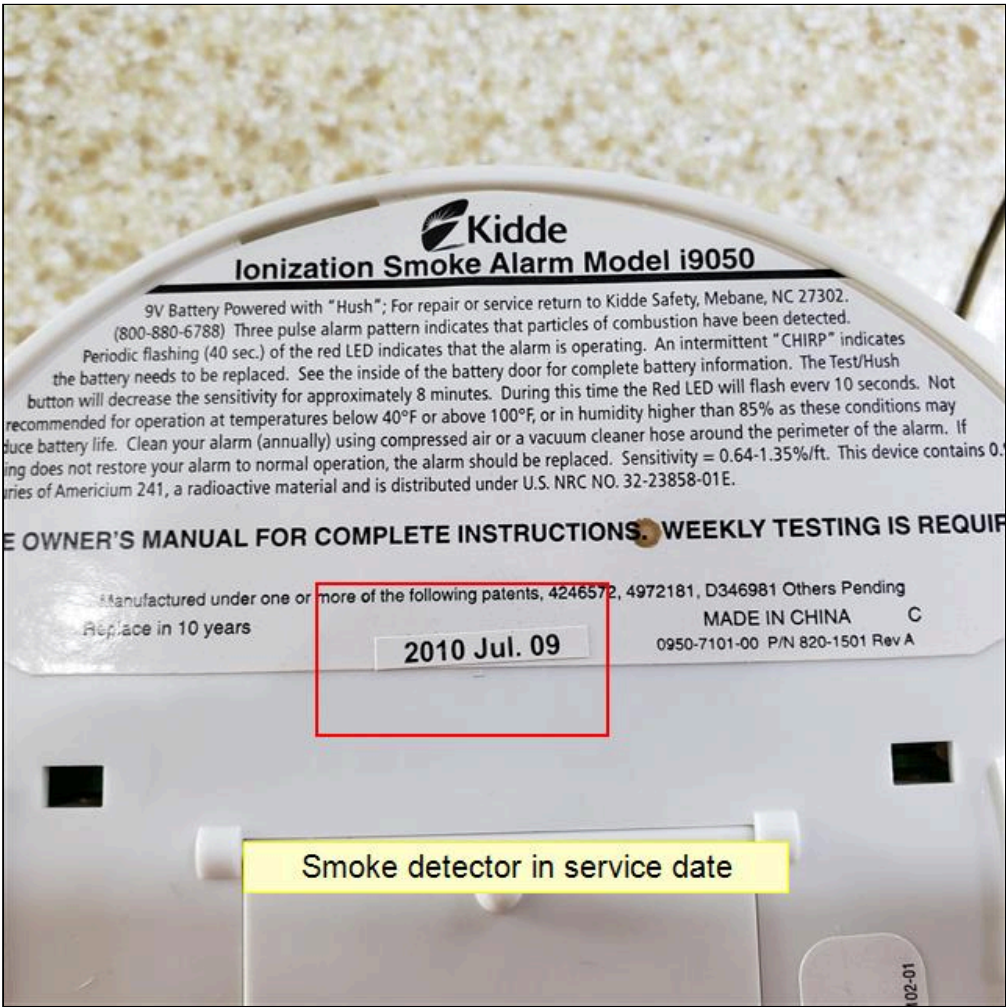
21.1 Smoke detector

Smoke detector over 12 years old. Recommend replacement. It is also highly recommended to have smoke detectors in all separated sleeping compartments.

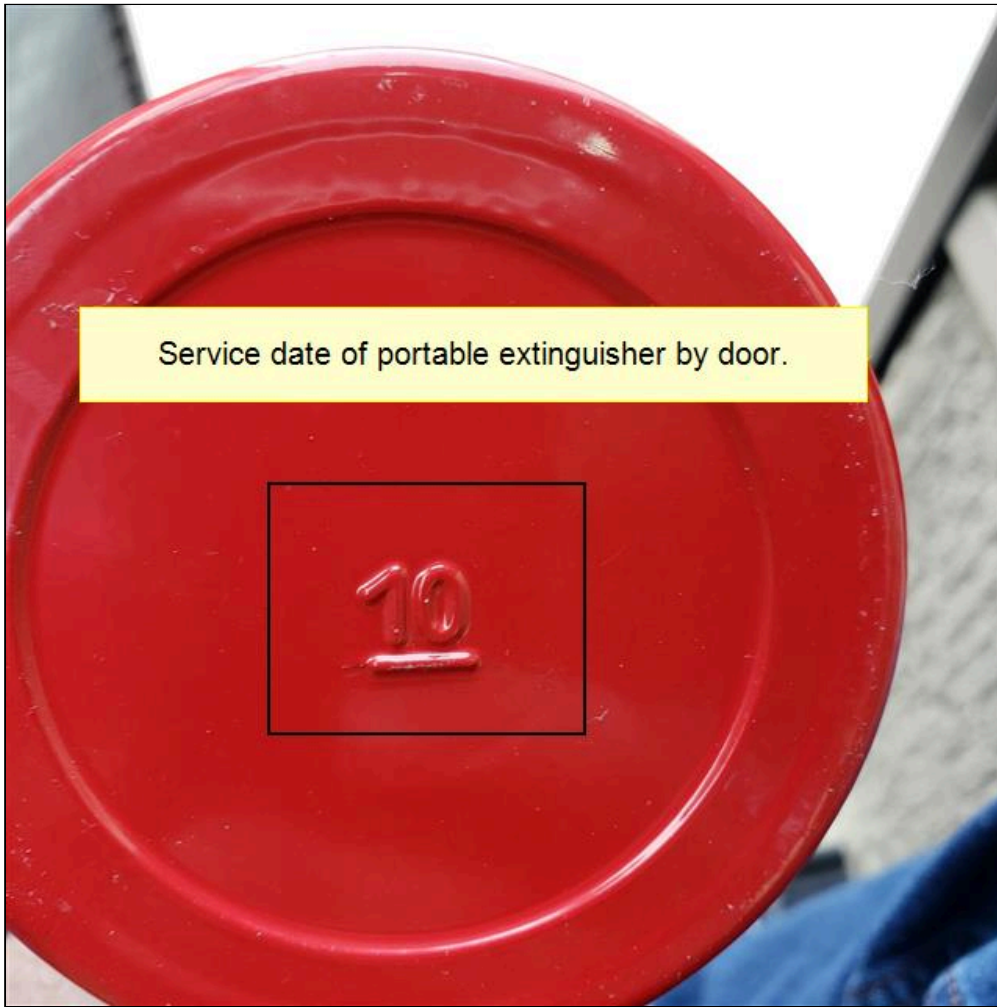
21.2 Fire extinguishers

Extinguisher located at drivers seat has no service tag. Yearly service is recommended. Portable extinguisher located at entry door is 12 years old. Recommend to replace at maximum of 10 years.
