Summary Only

Property Address:
2711 Claypool-Alvaton Rd
Bowling Green KY 42103

This is not the complete home inspection report. It is only the Summary Items.

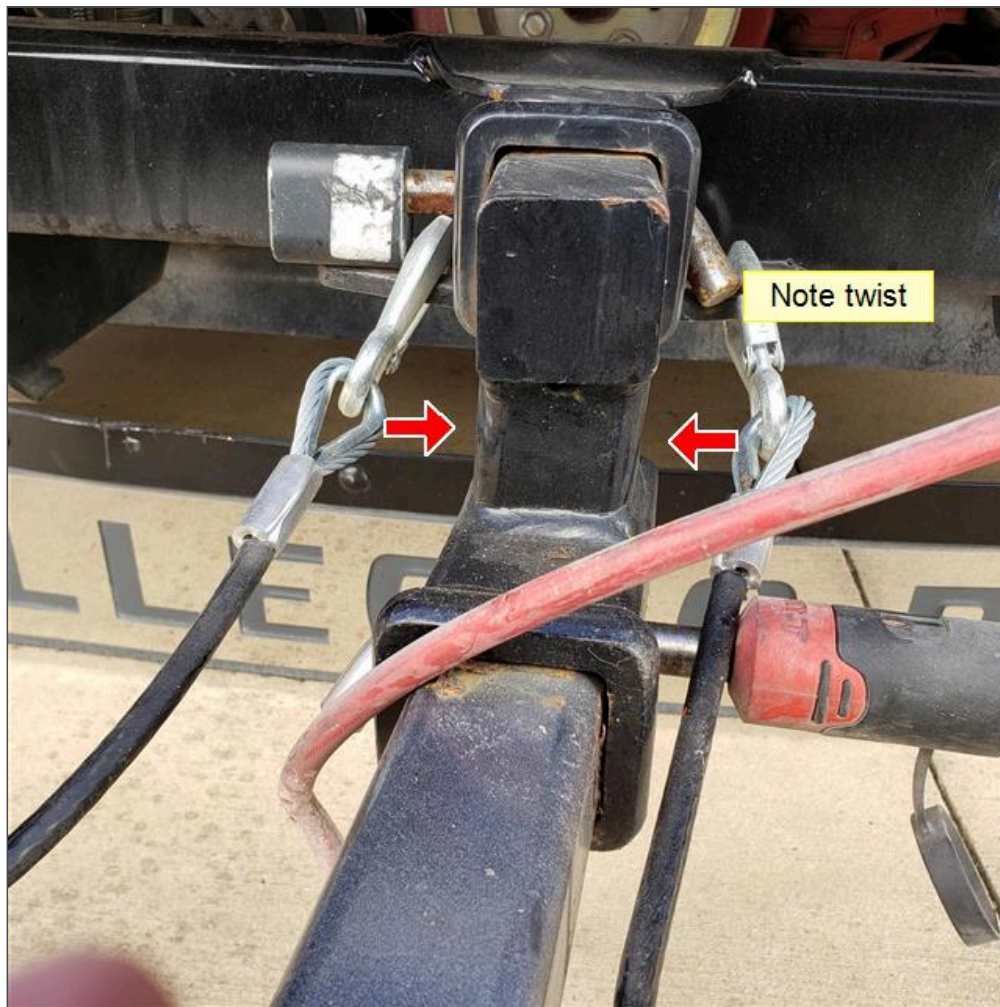
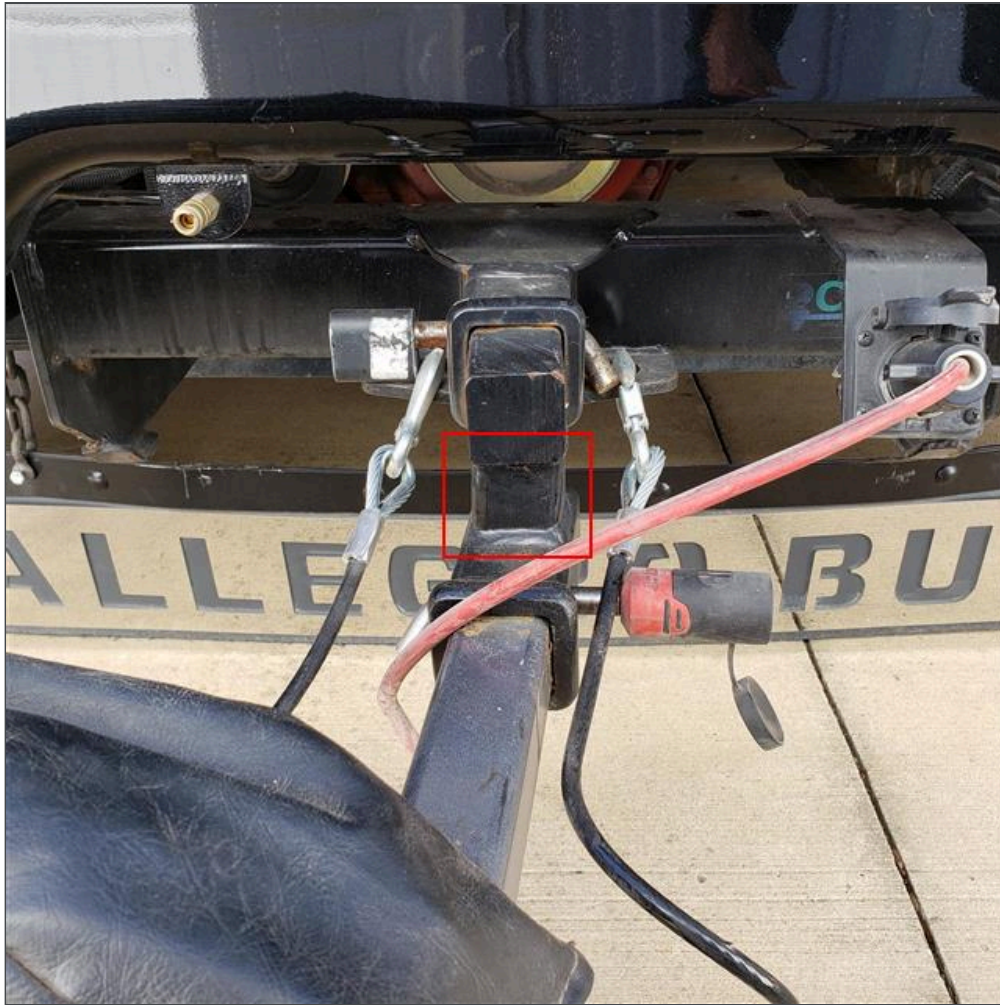
10. Engine, Radiator and Transmission**10.5 Hitch Receiver Condition****Acceptable**

Note - Hitch is in good condition. Receiver on tow dolly appears bent. Check and have inspected by qualified professional prior to use.

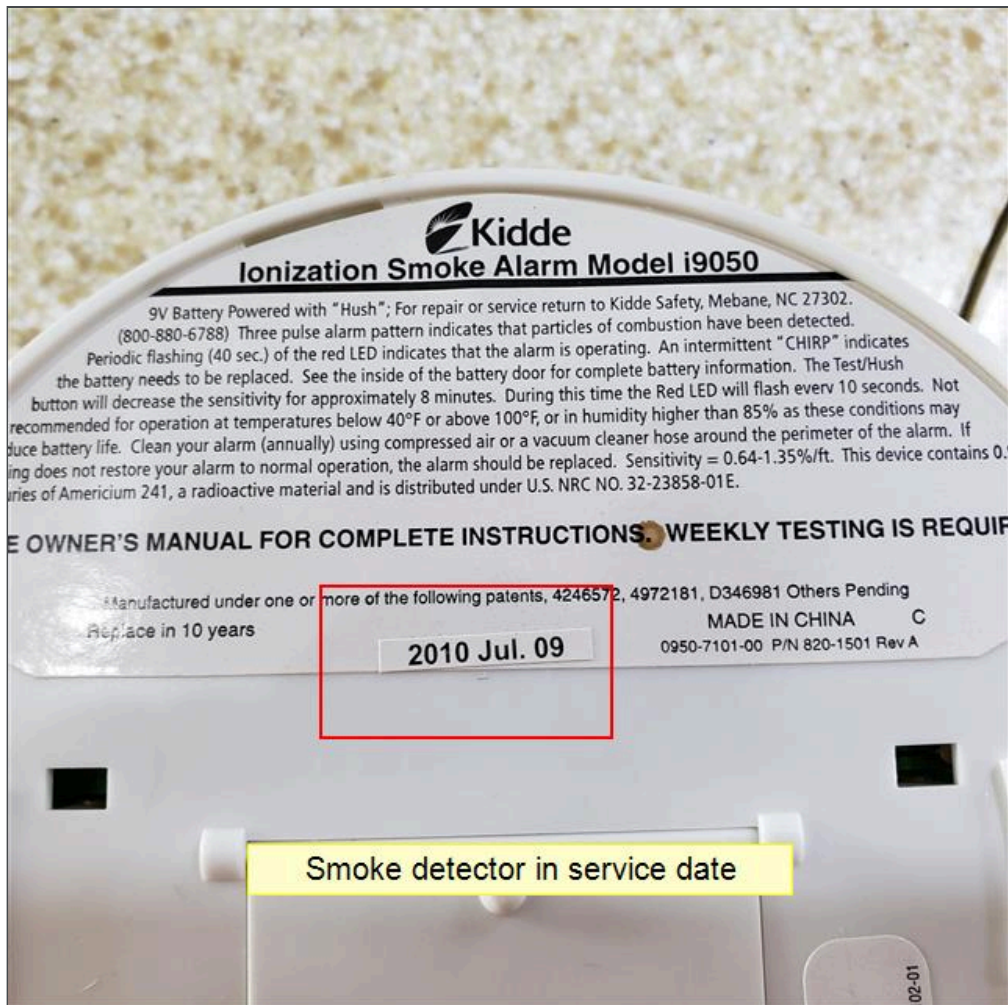
21.1 Smoke detector

Poor

Smoke detector over 12 years old. Recommend replacement. It is also highly recommended to have smoke detectors in all separated sleeping compartments.

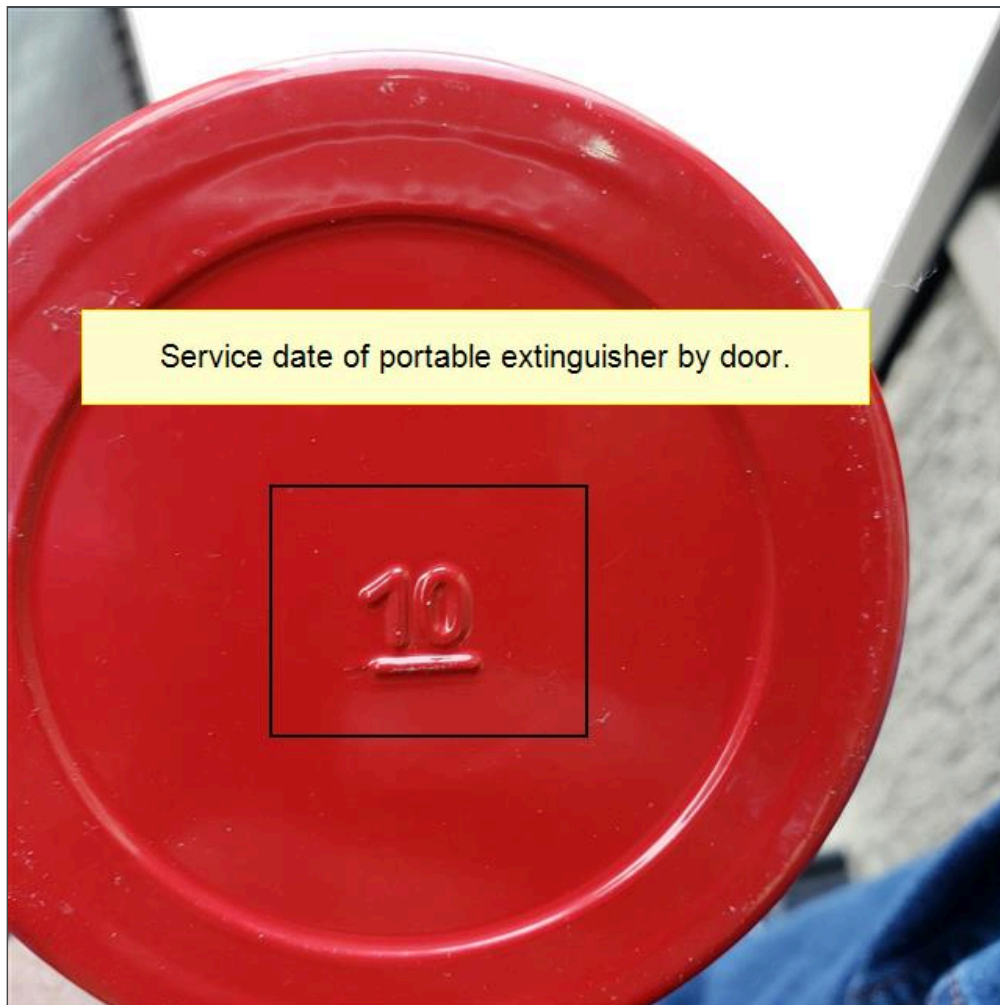
21.2 Fire extinguishers

Poor

Extinguisher located at drivers seat has no service tag. Yearly service is recommended. Portable extinguisher located at entry door is 12 years old. Recommend to replace at maximum of 10 years.

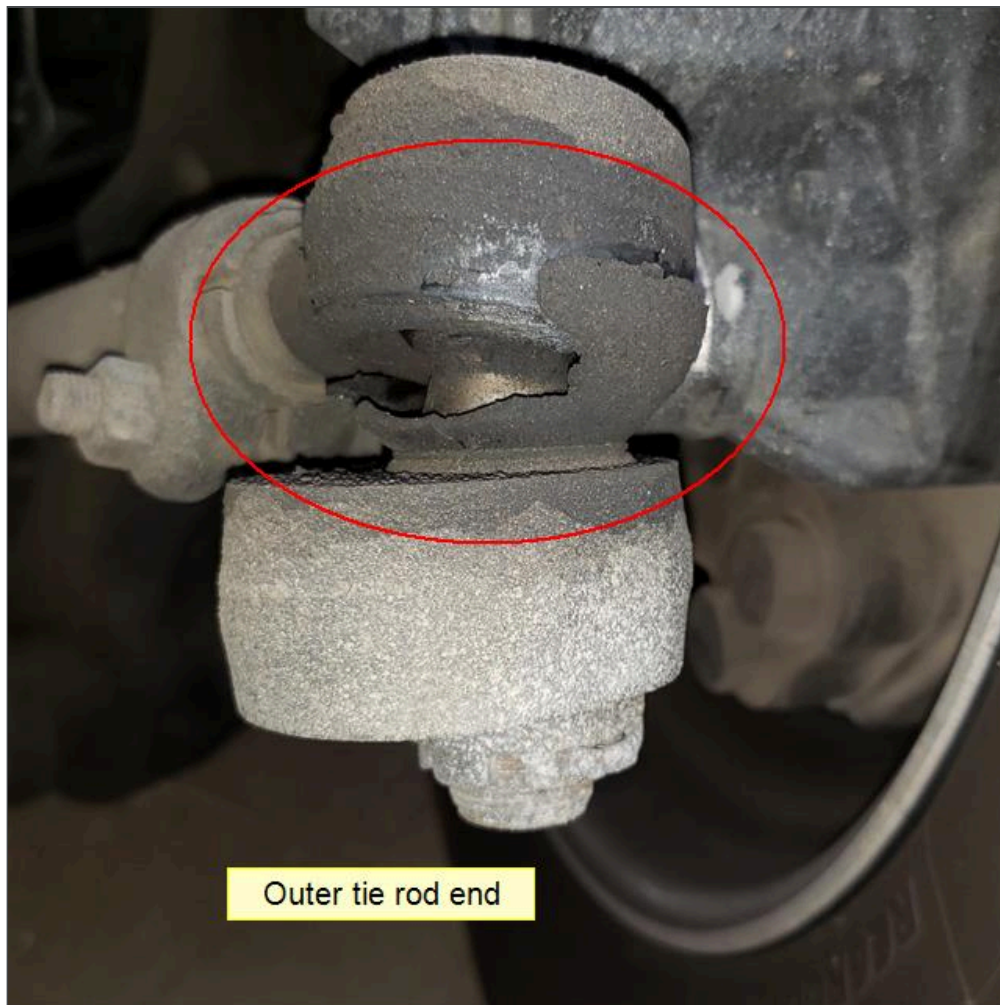
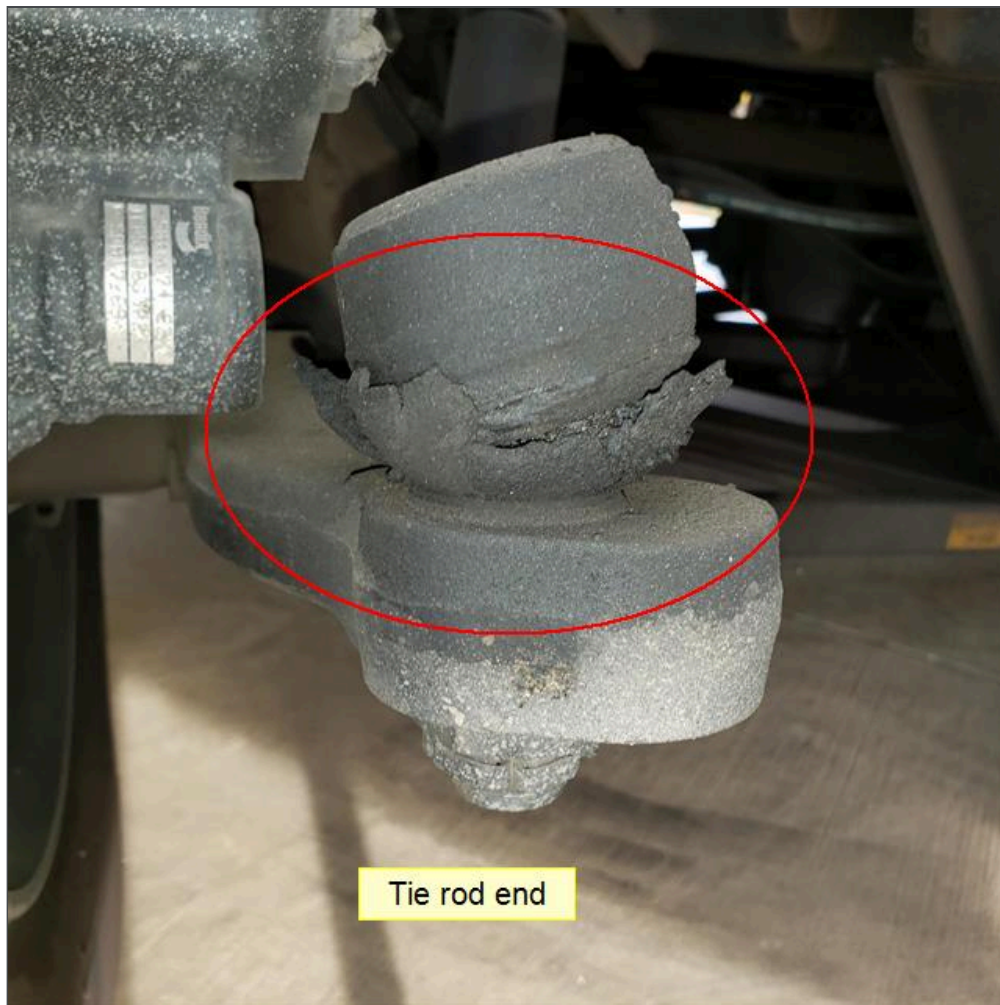
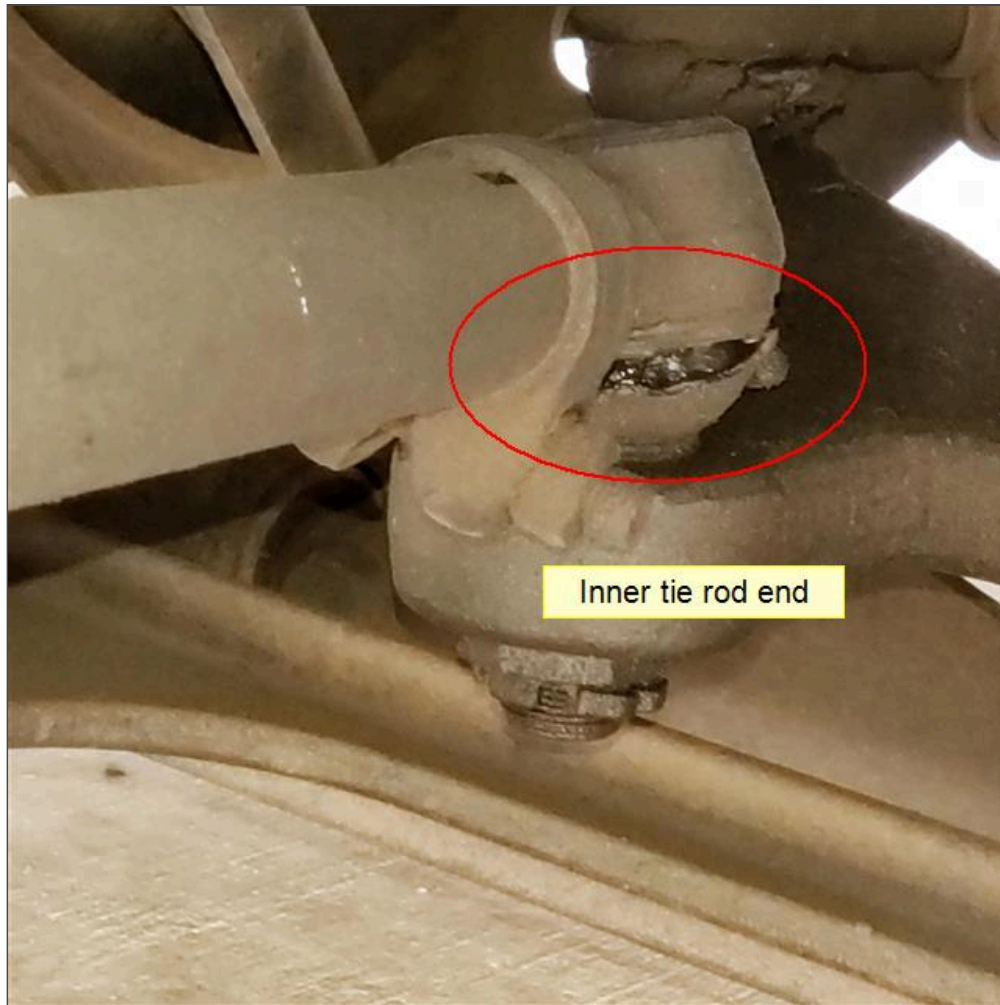
9.3 Steering Components

Fair

Front inner and outer tie-rod end boots dry rotted and broken require replacement

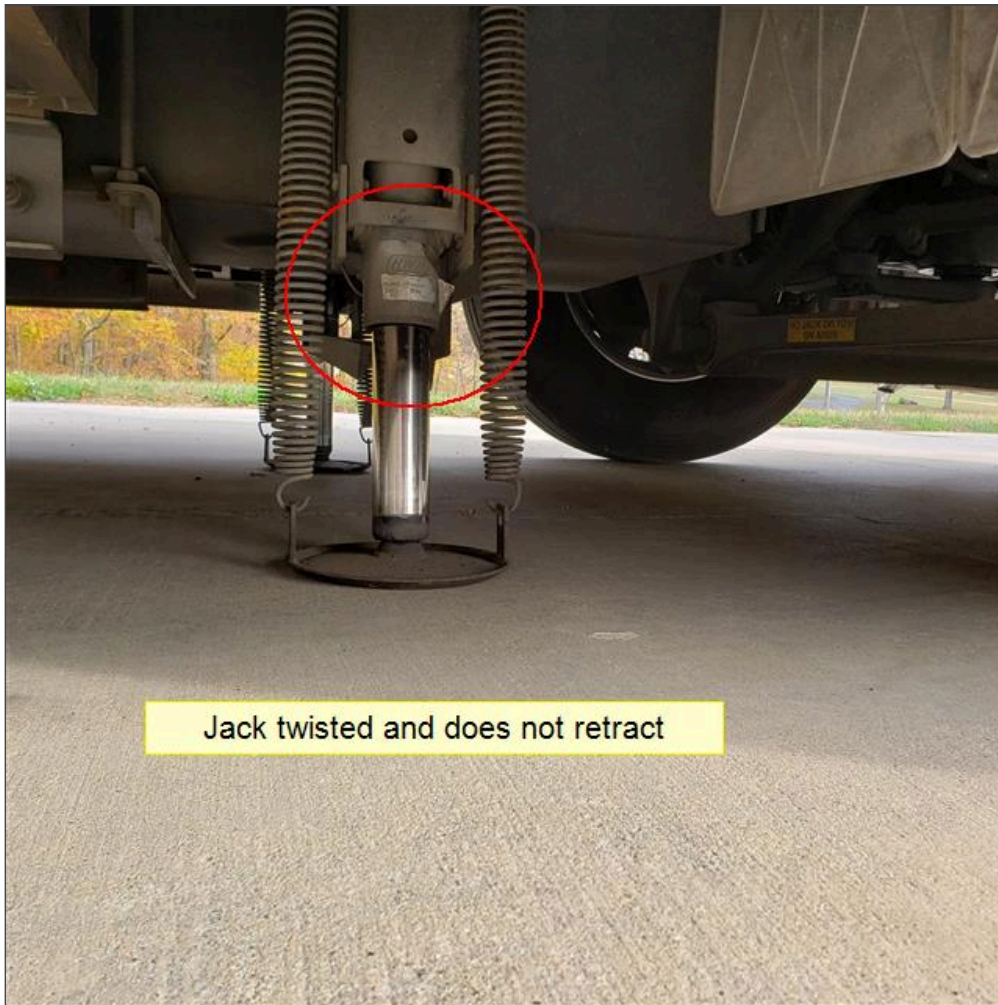
11.0 Leveling System Condition

Poor

Unit tested for leveling. Levelled appropriately but right front jack would not retract.

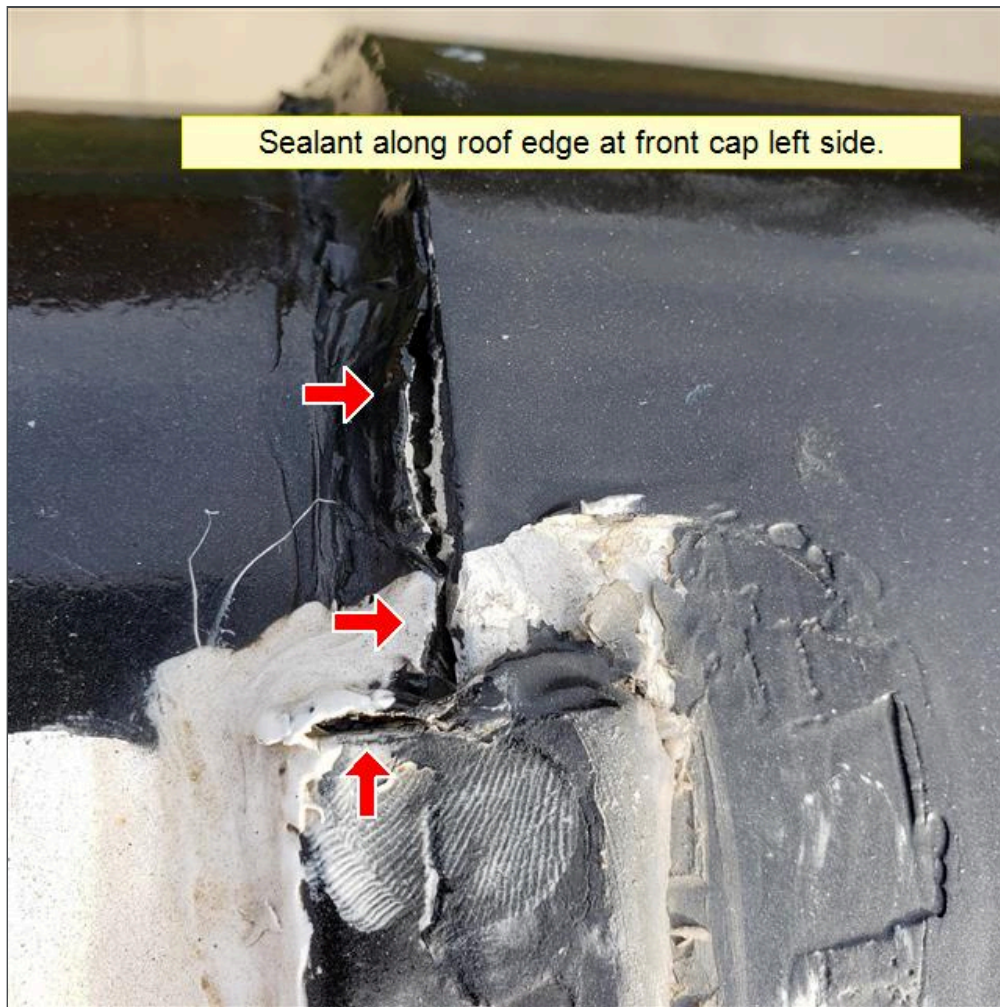
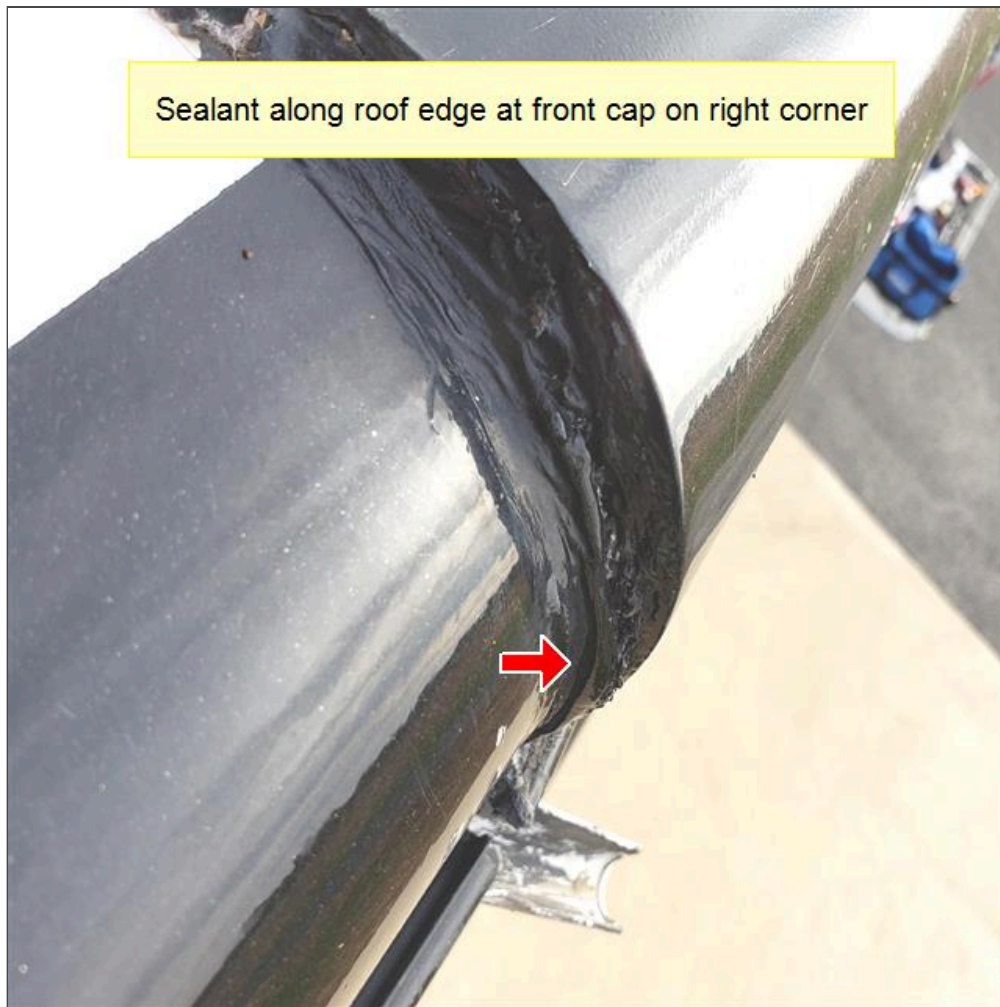
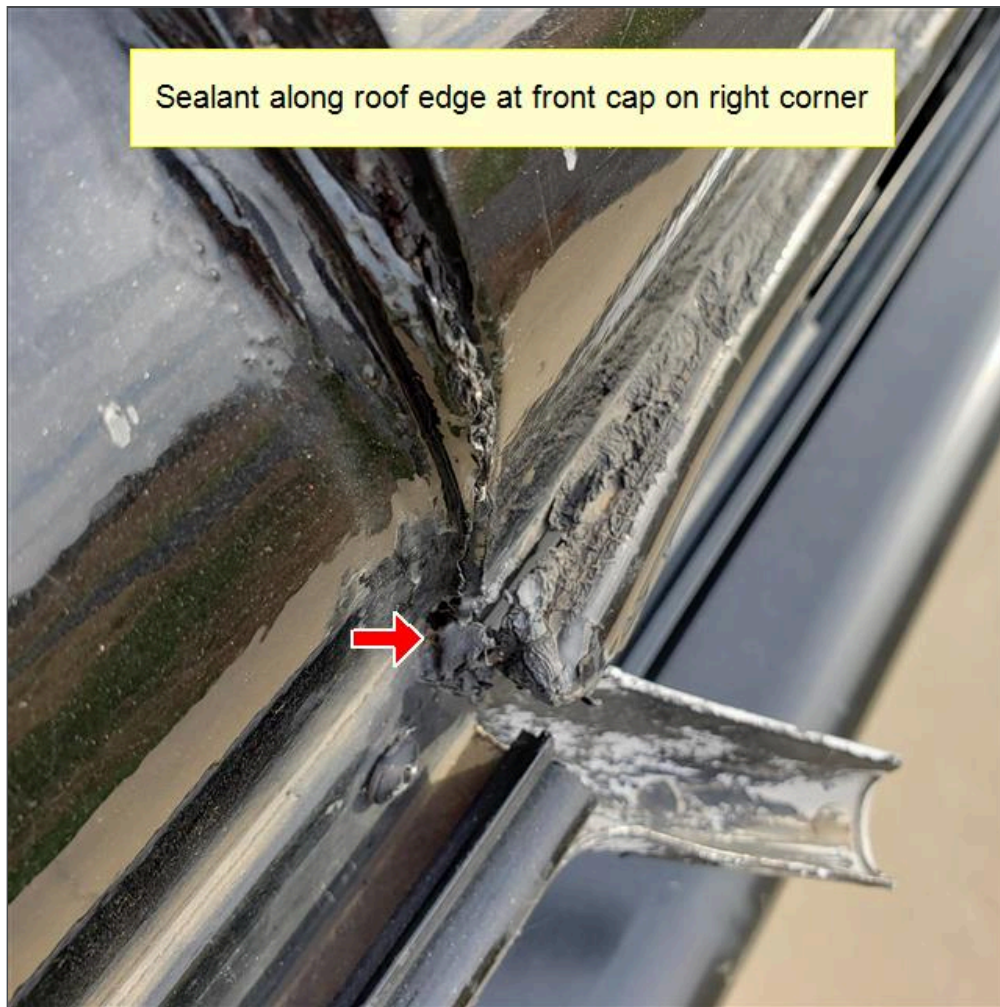
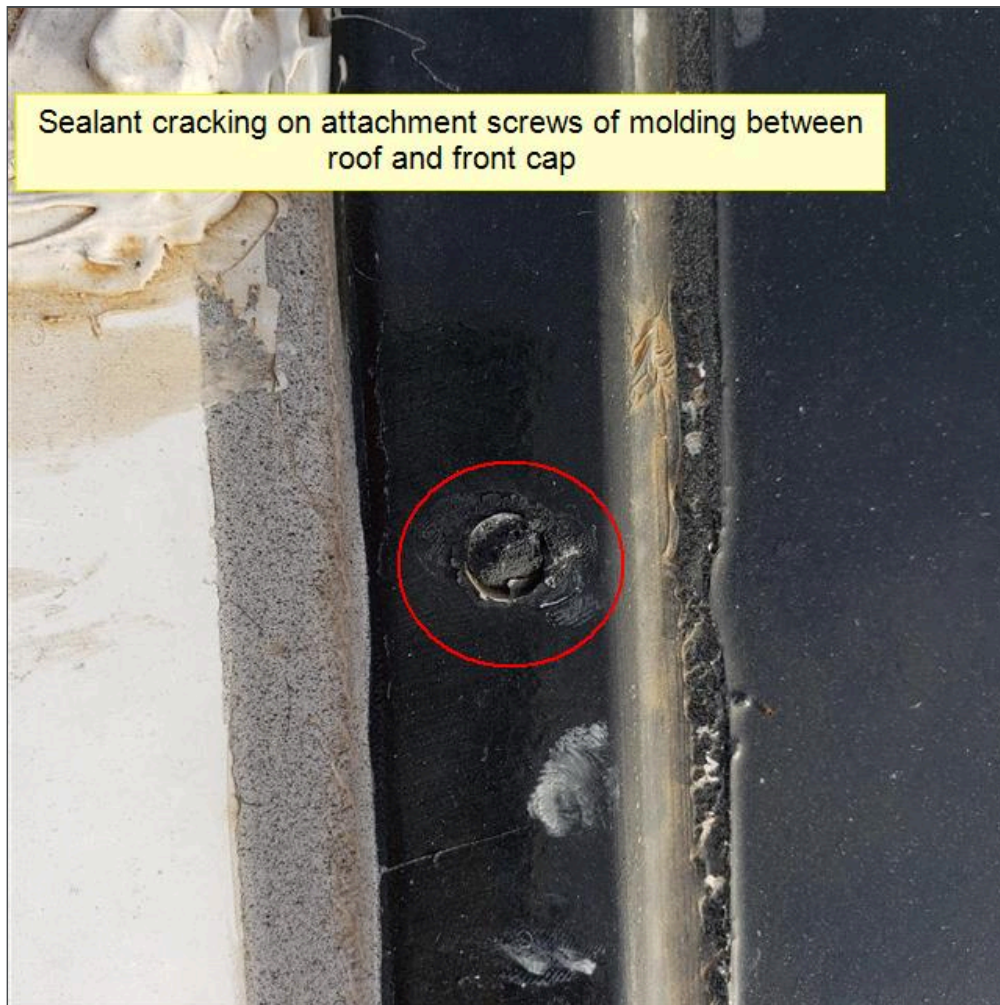
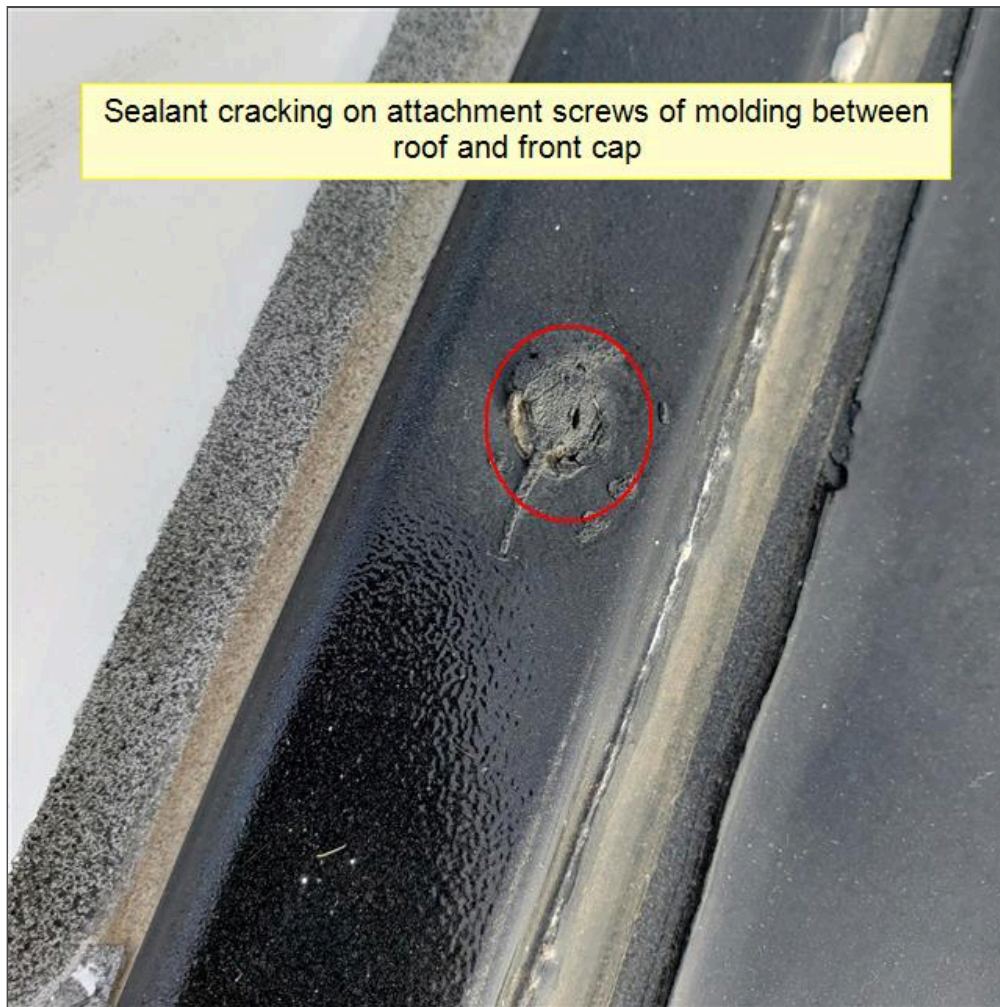
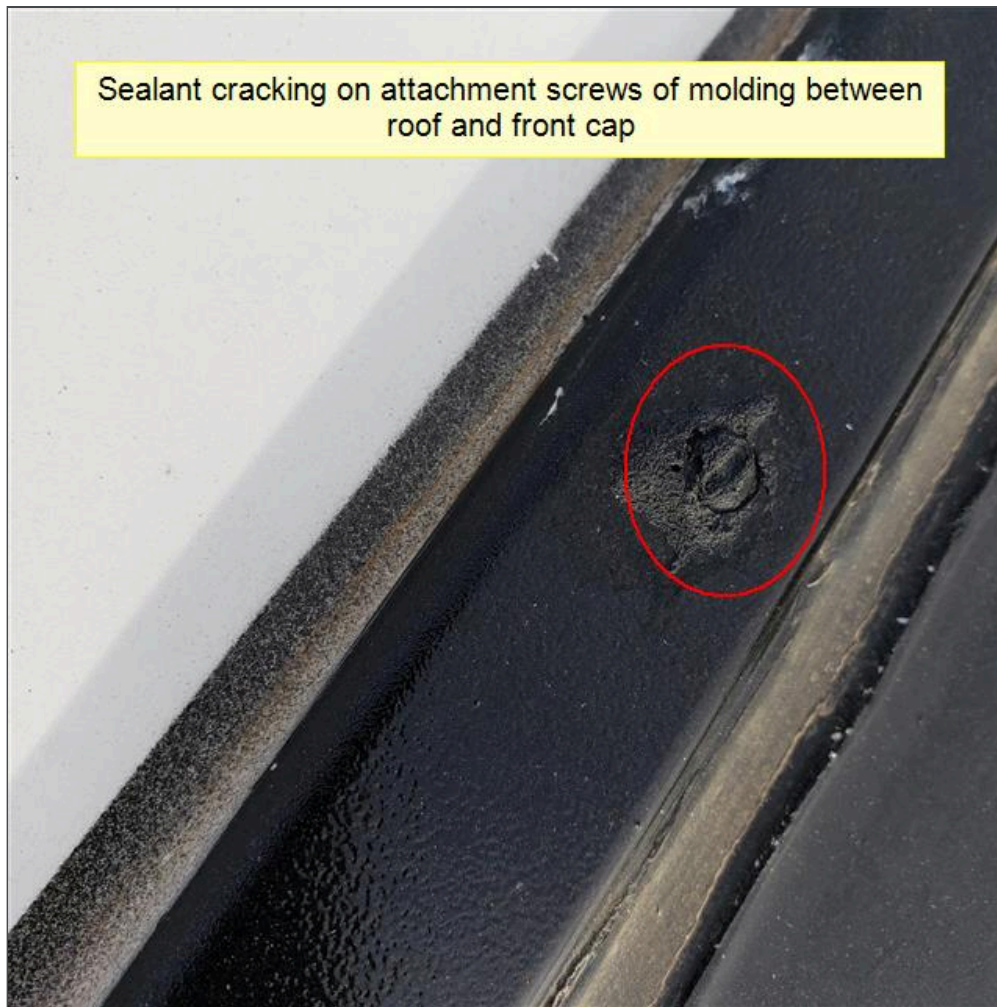
2.1 Front Cap, Joints and Seals

Fair

Sealant along left and right corners and joint molding screws is cracking. Reseal areas to prevent water intrusion.

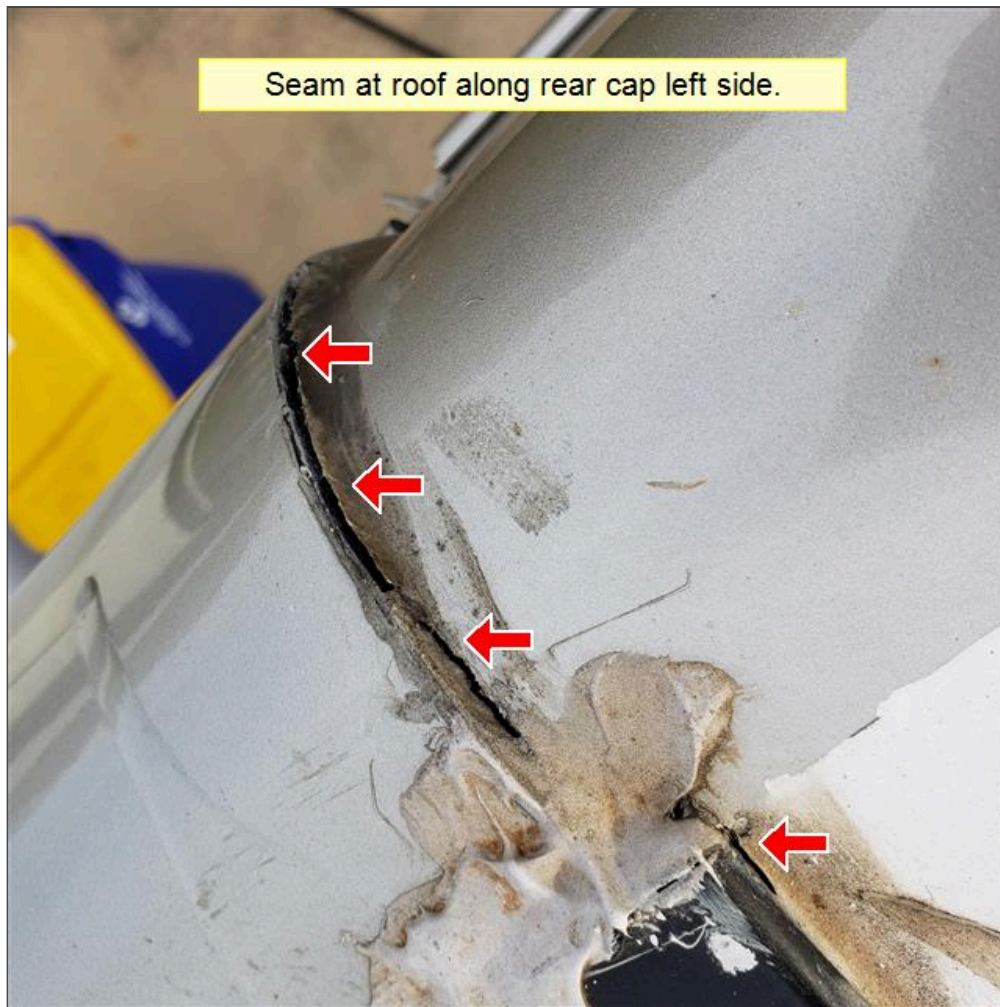
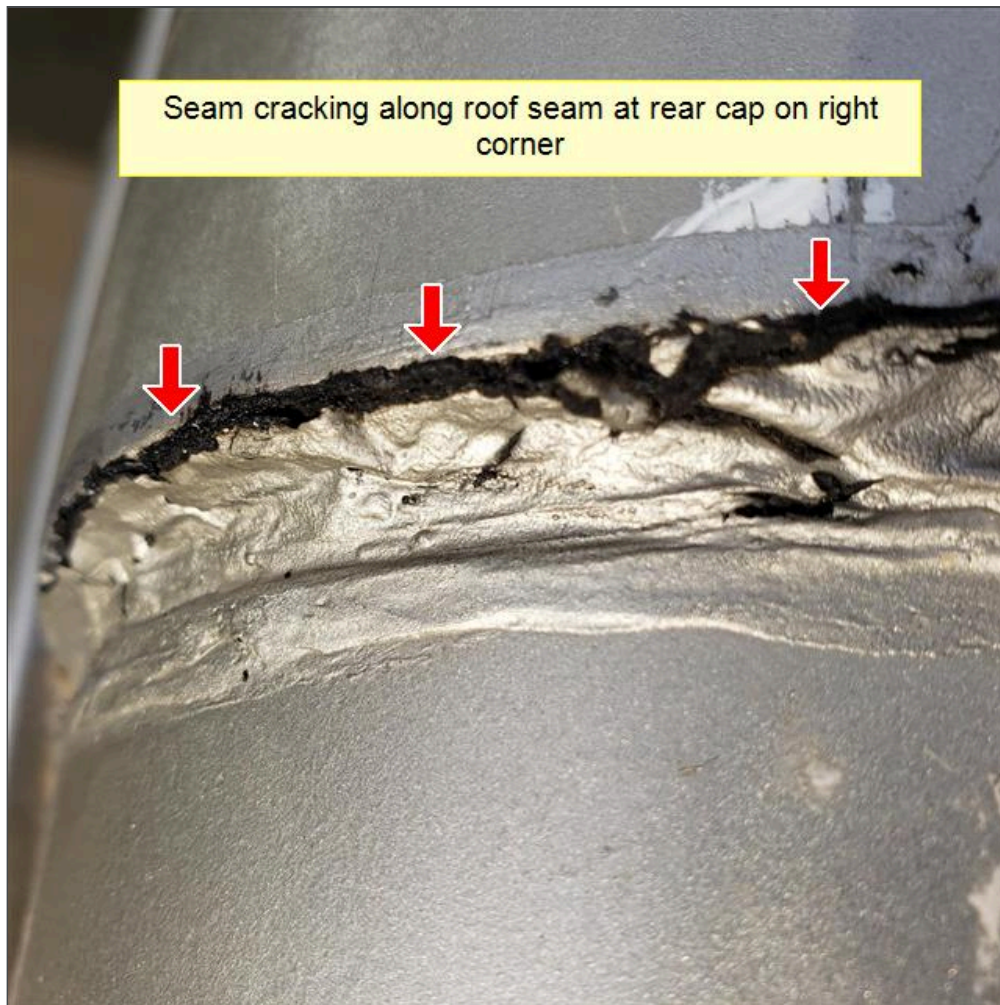
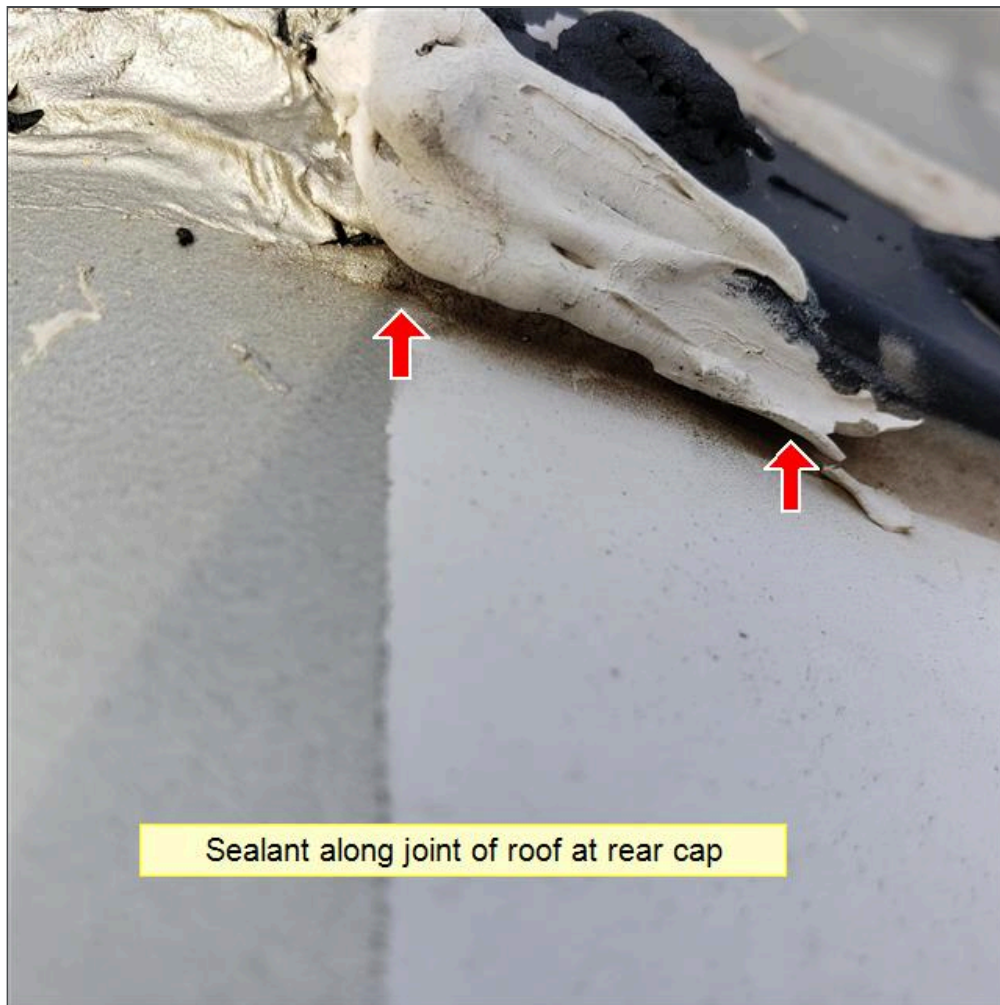
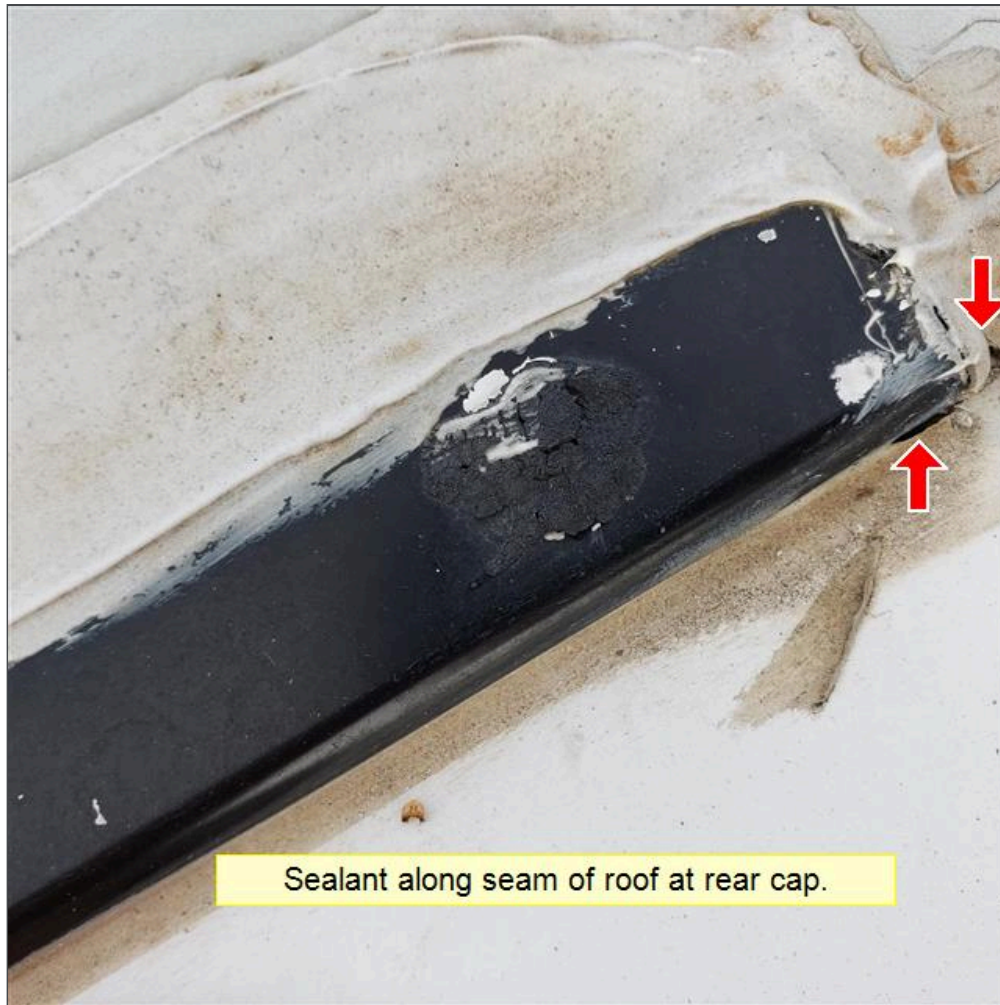
2.3 Rear Cap, Joints and Seals

Fair

Sealant cracking at roof seam along rear cap at corners and along edge

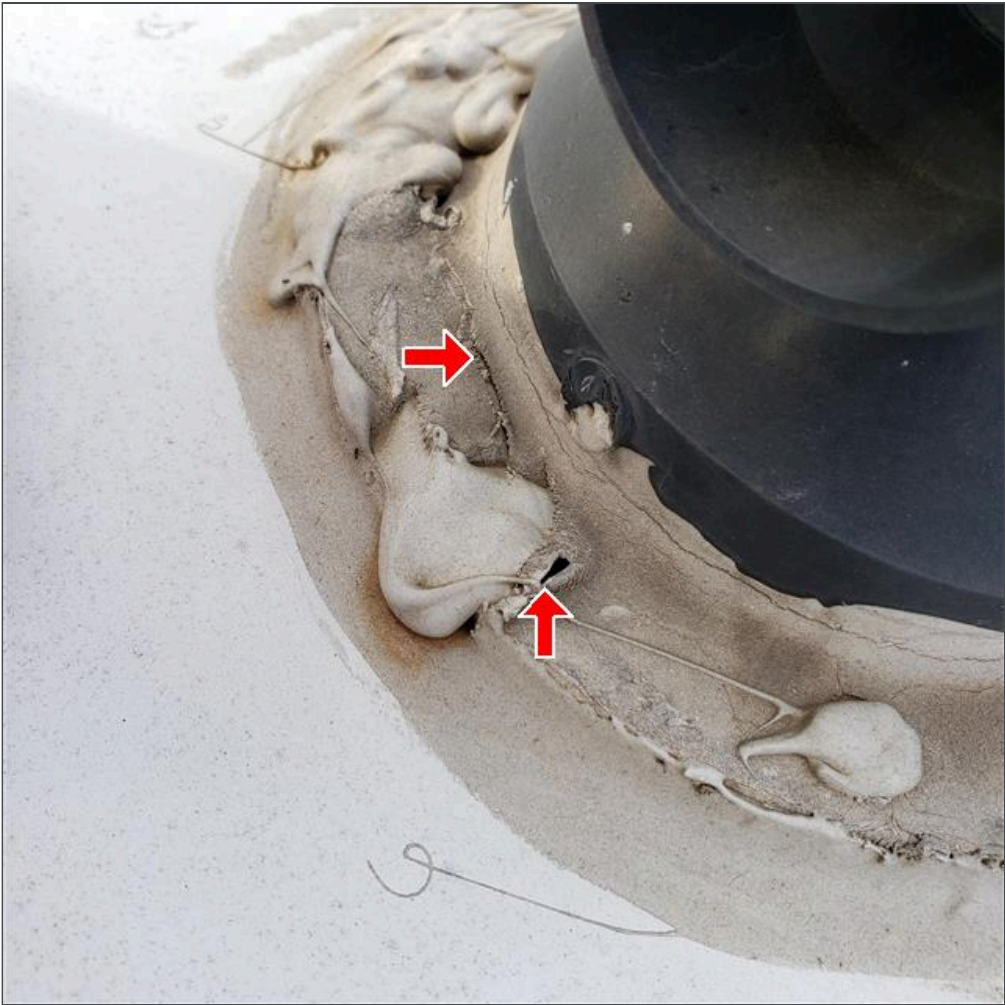
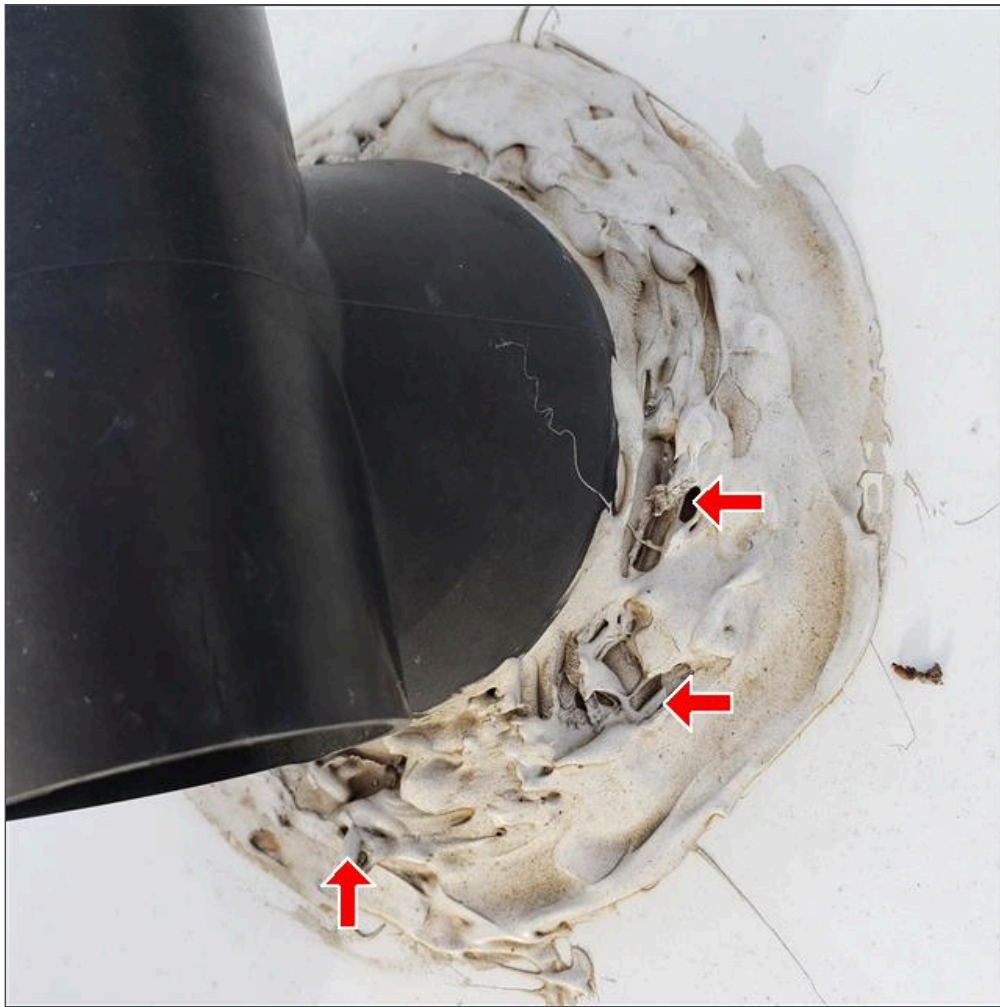
2.7 Plumbing Vent Covers

Fair

Minor cracking/gaps in sealant around plumbing vents

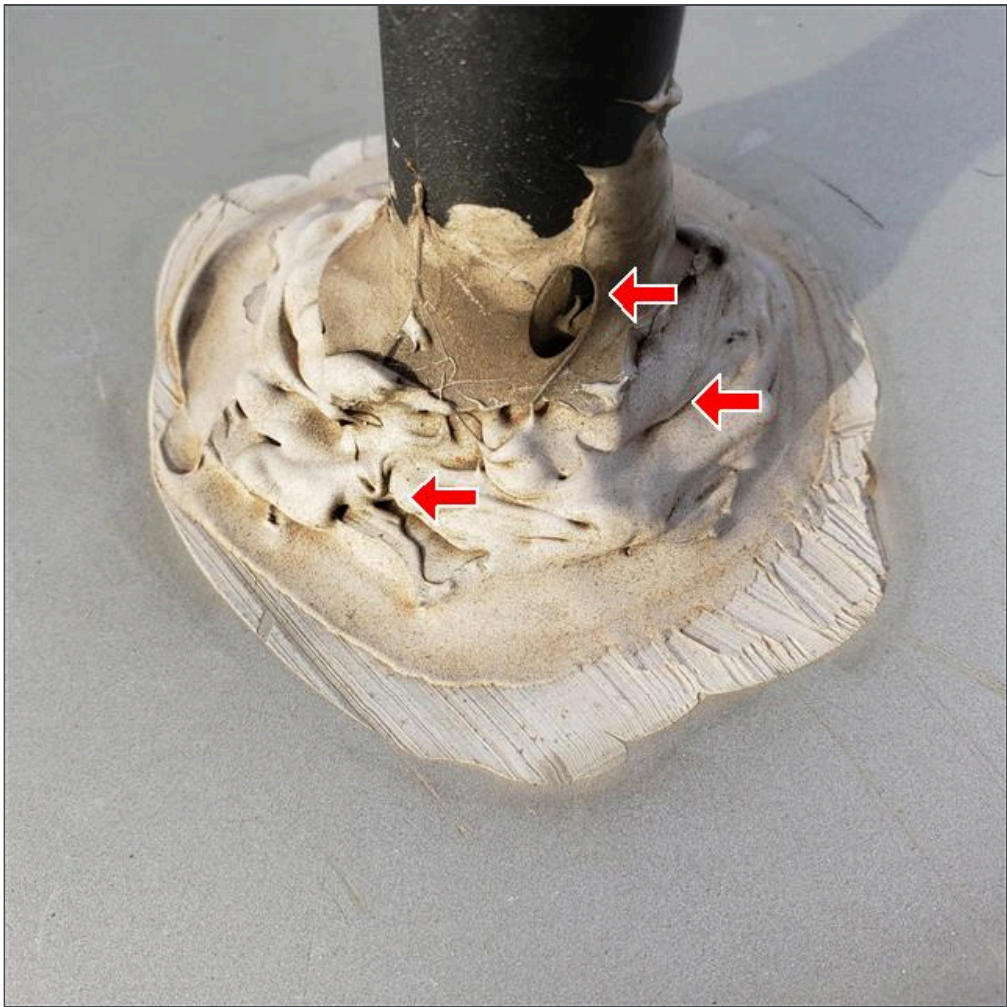
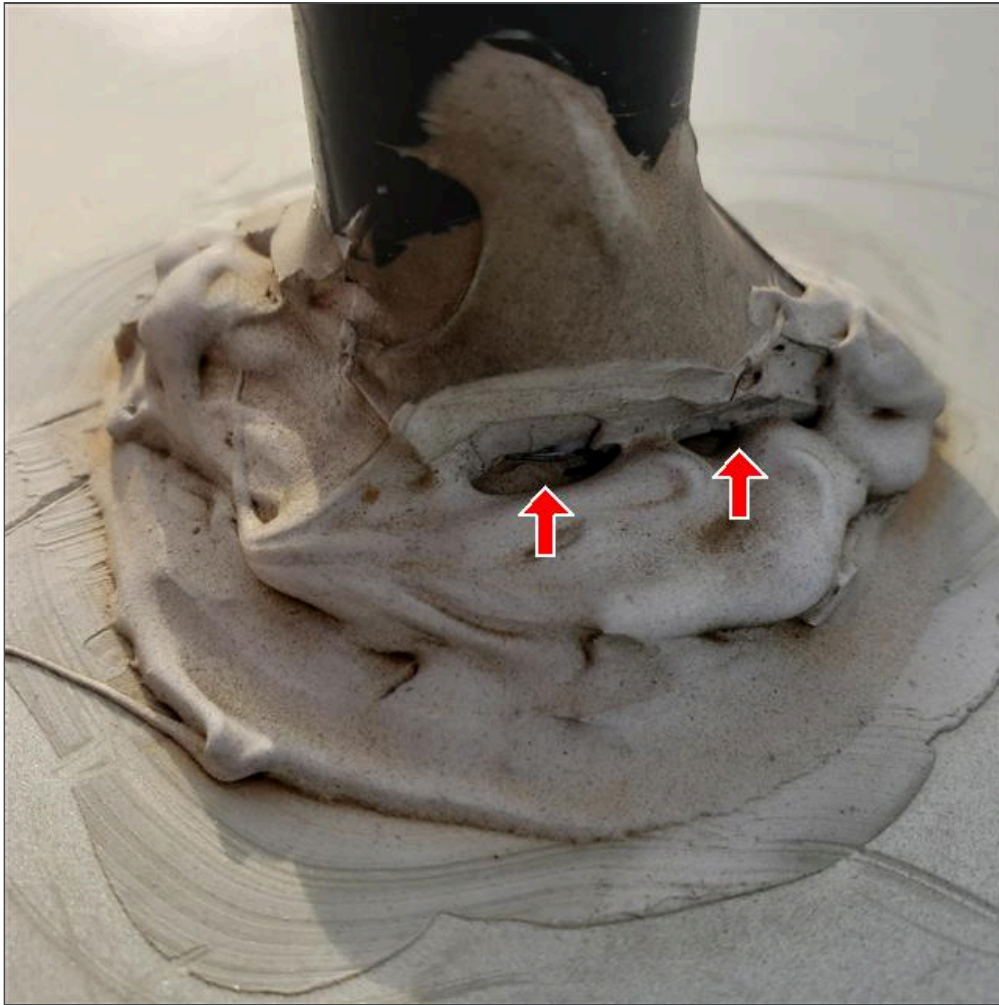
**2.17 Ladder - Roof Access****Fair**

Cracking in sealant around ladder mounts on roof.
