Summary Only

Property Address:
2711 Claypool-Alvaton Rd
Bowling Green KY 42103

This is not the complete home inspection report. It is only the Summary Items.

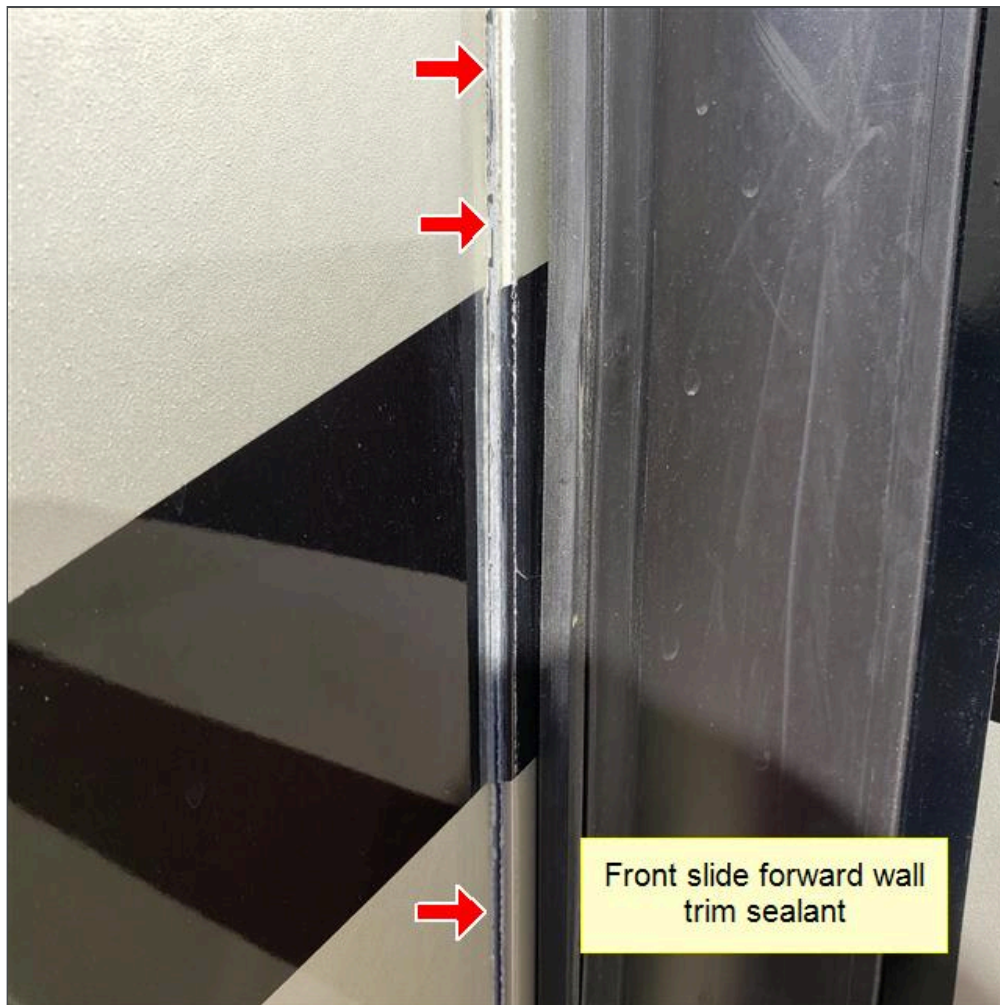
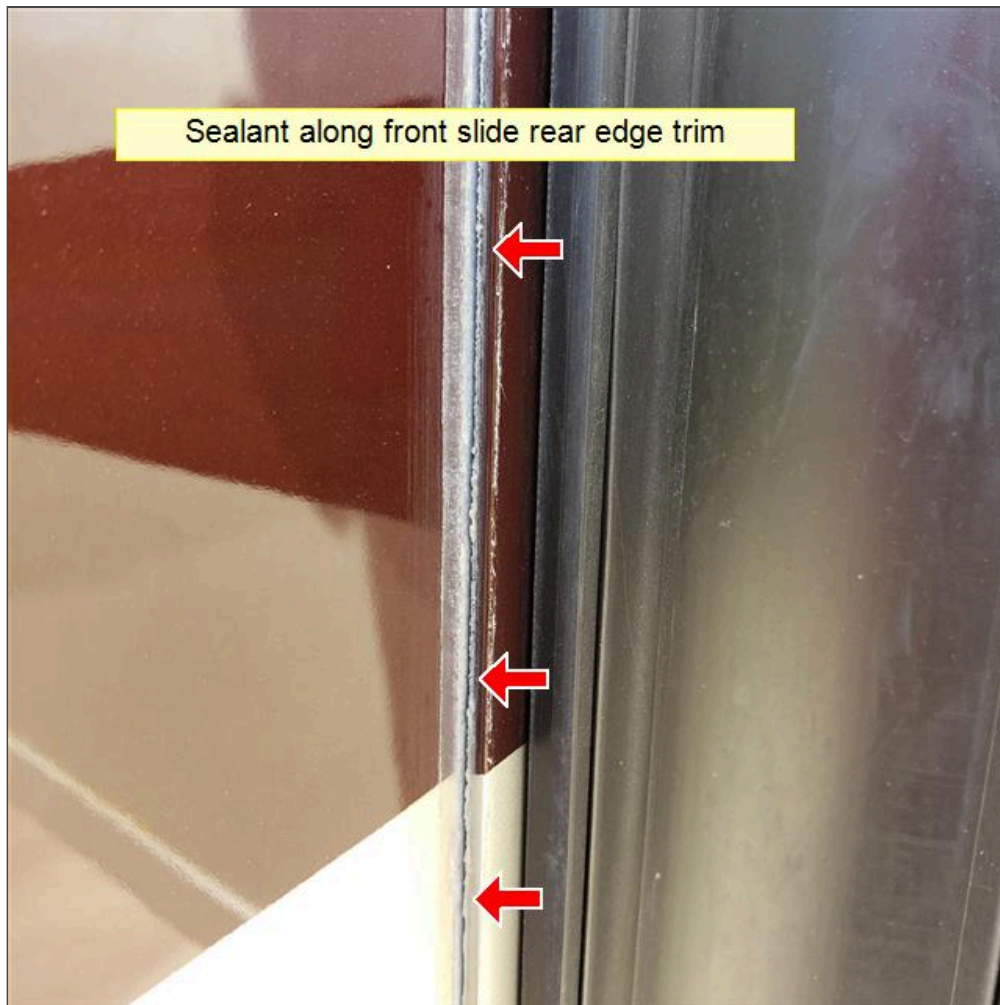
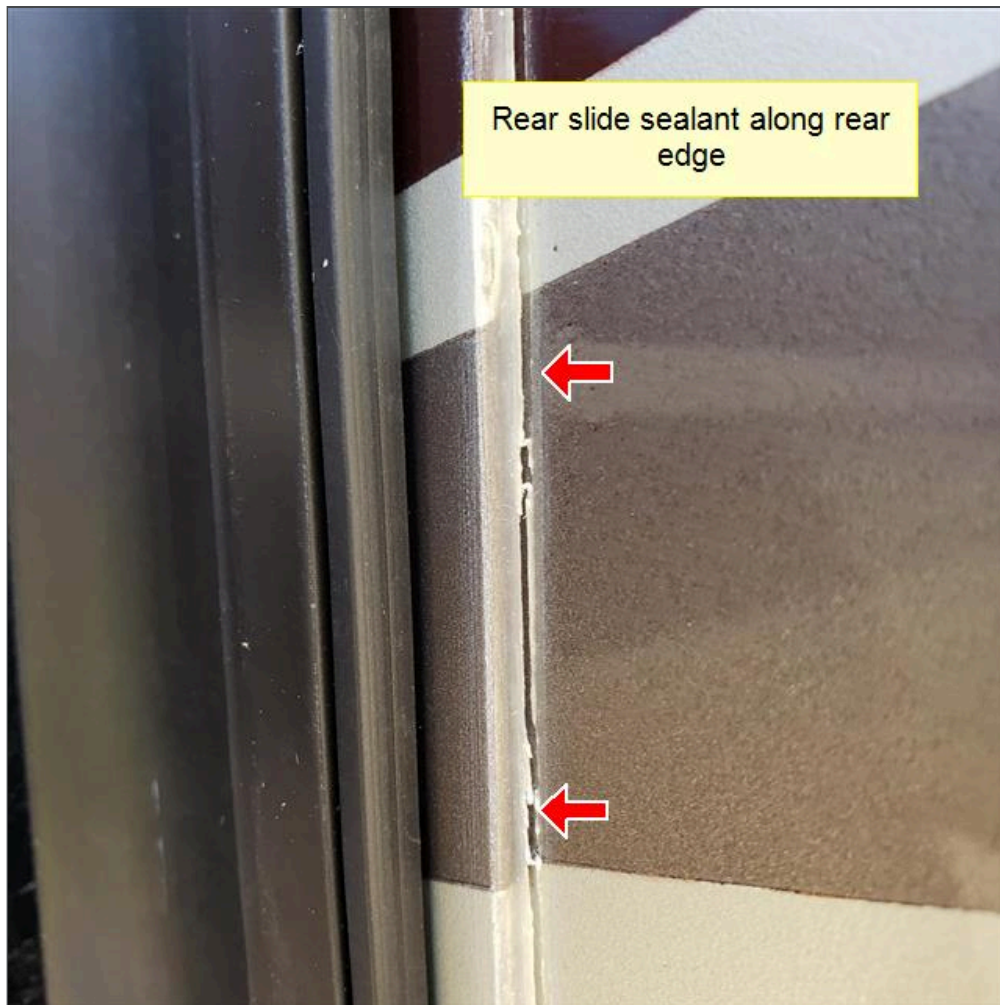
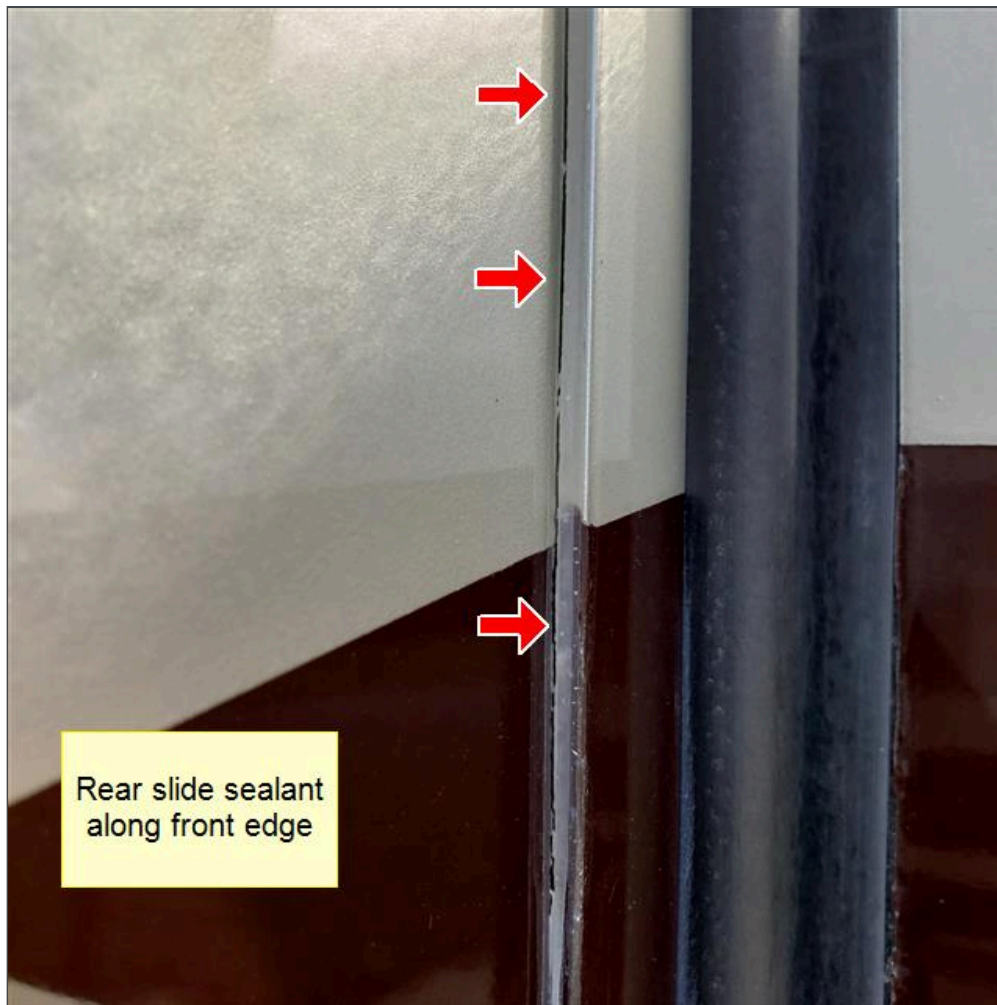
4.0.B Sidewall Condition

Acceptable

Sealant cracking along front and rear slide trim along sidewall. Reseal to prevent water intrusion

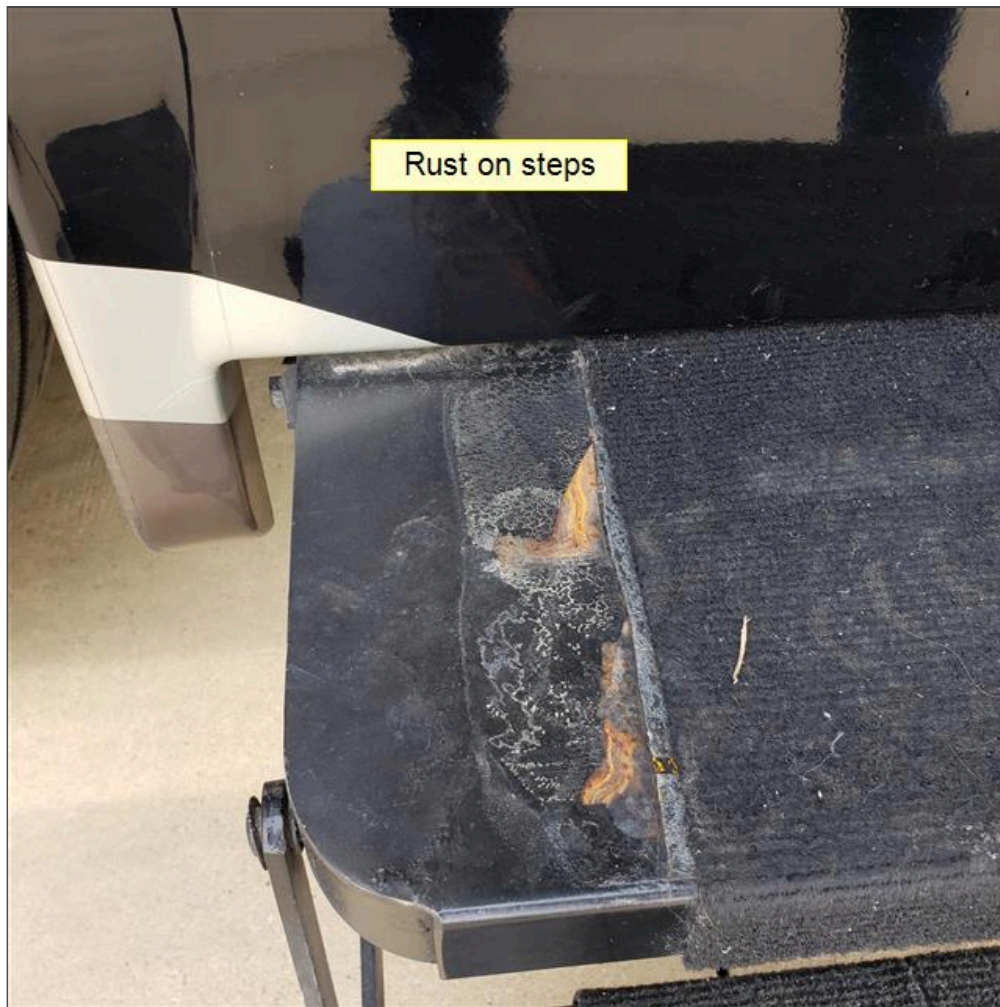
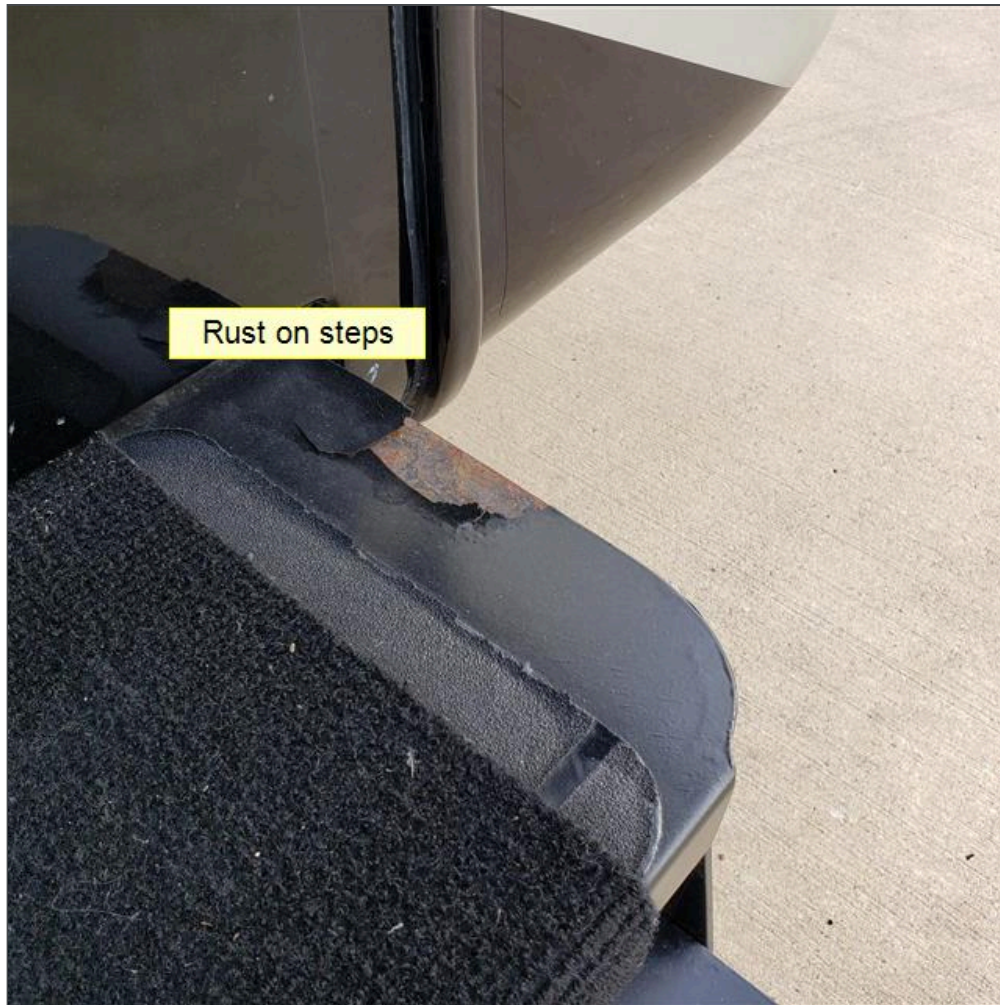
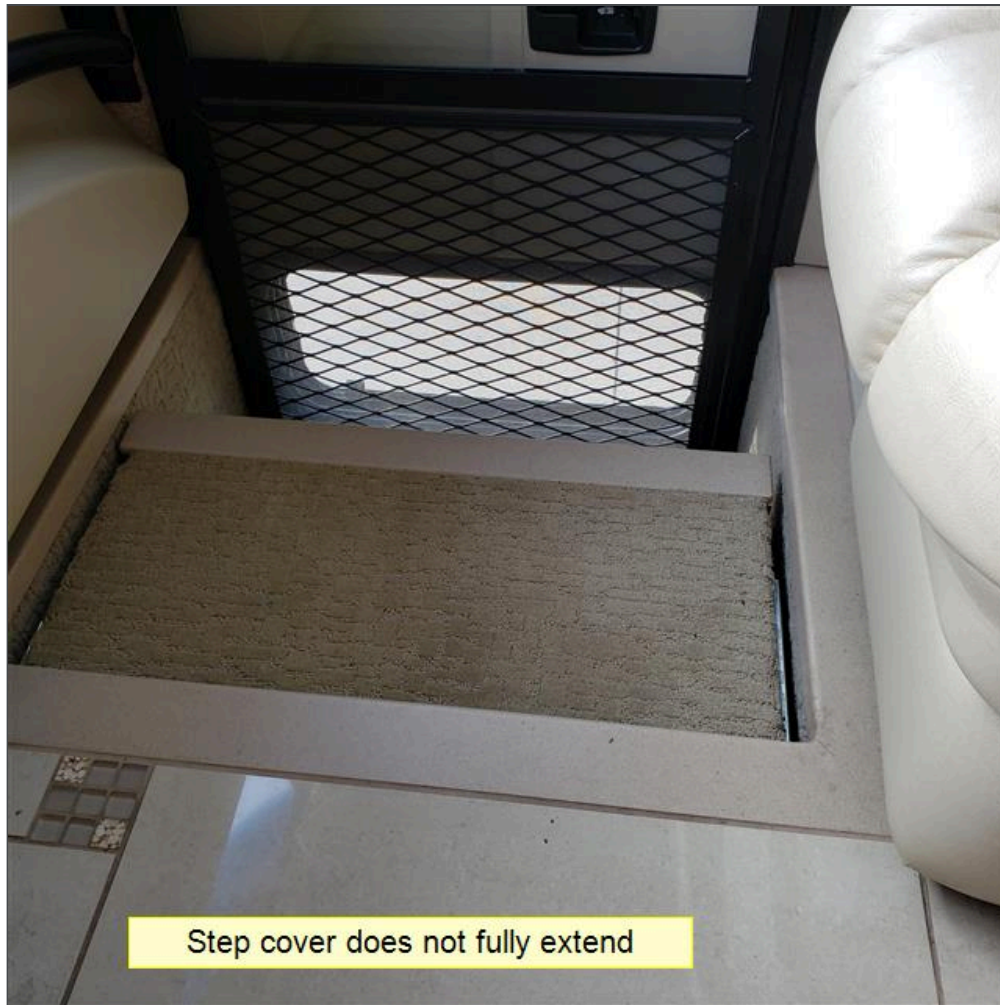
5.0 Door Condition

Keyless entry did not operate from key fob.

Interior step cover did not work appropriately, only partially closed. Had to manually close. Exterior steps showing some surface rust.

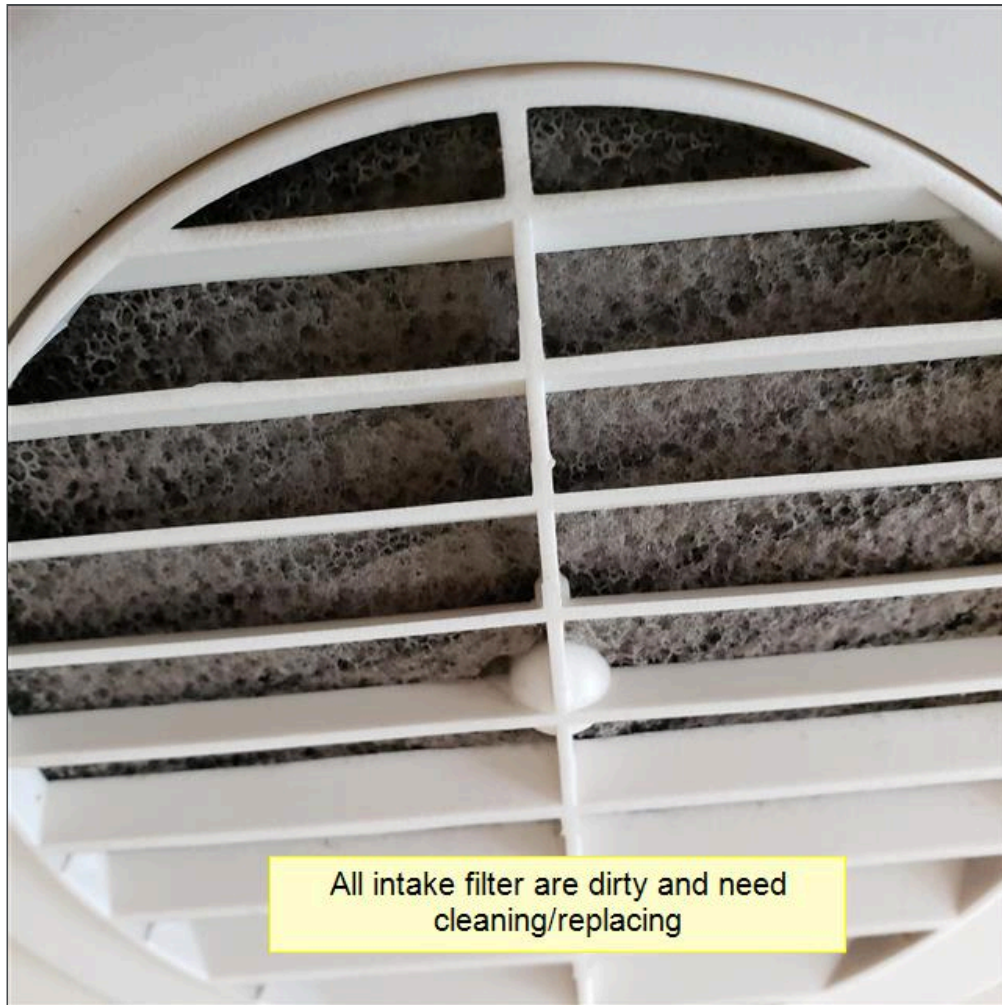
17.1.A Air Conditioner - Filter Condition

Fair

Filters on all 3 units should be clean or replaced

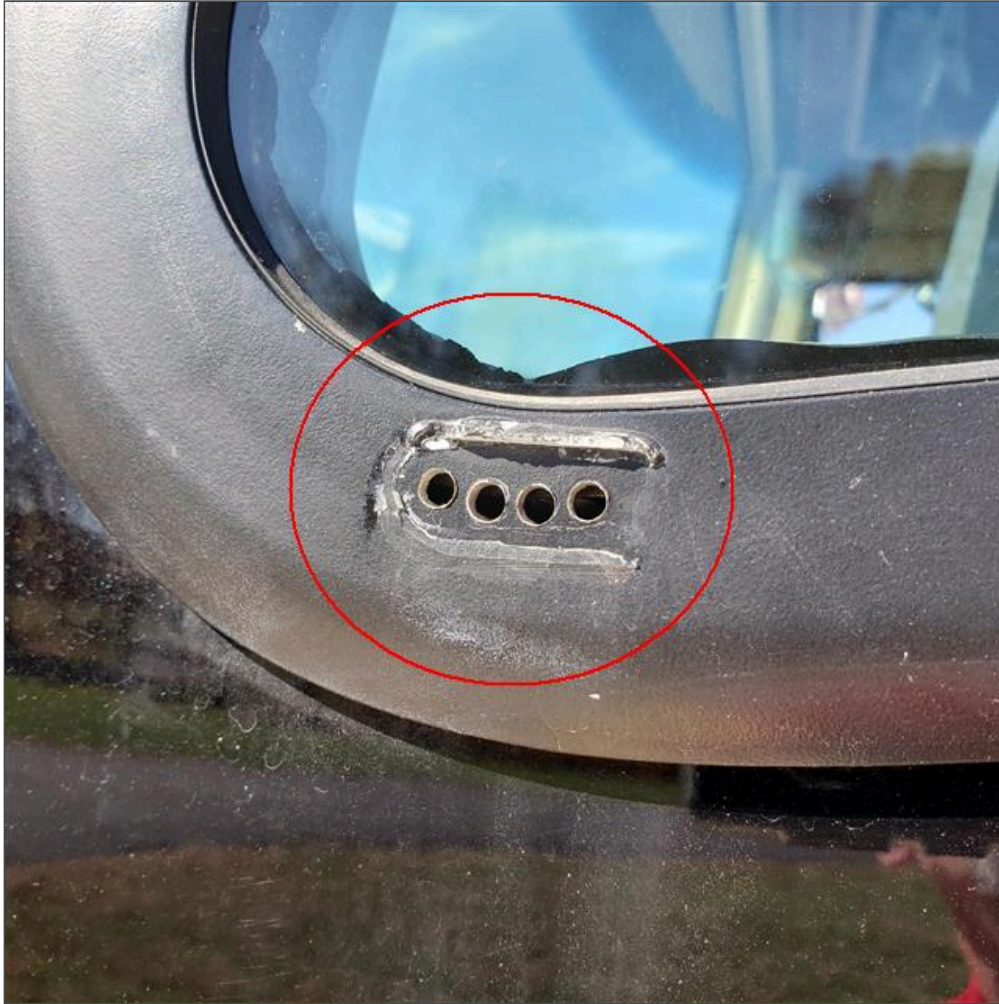
4.2.B Windows

Driver side window has holes that should be sealed to prevent water/air intrusion

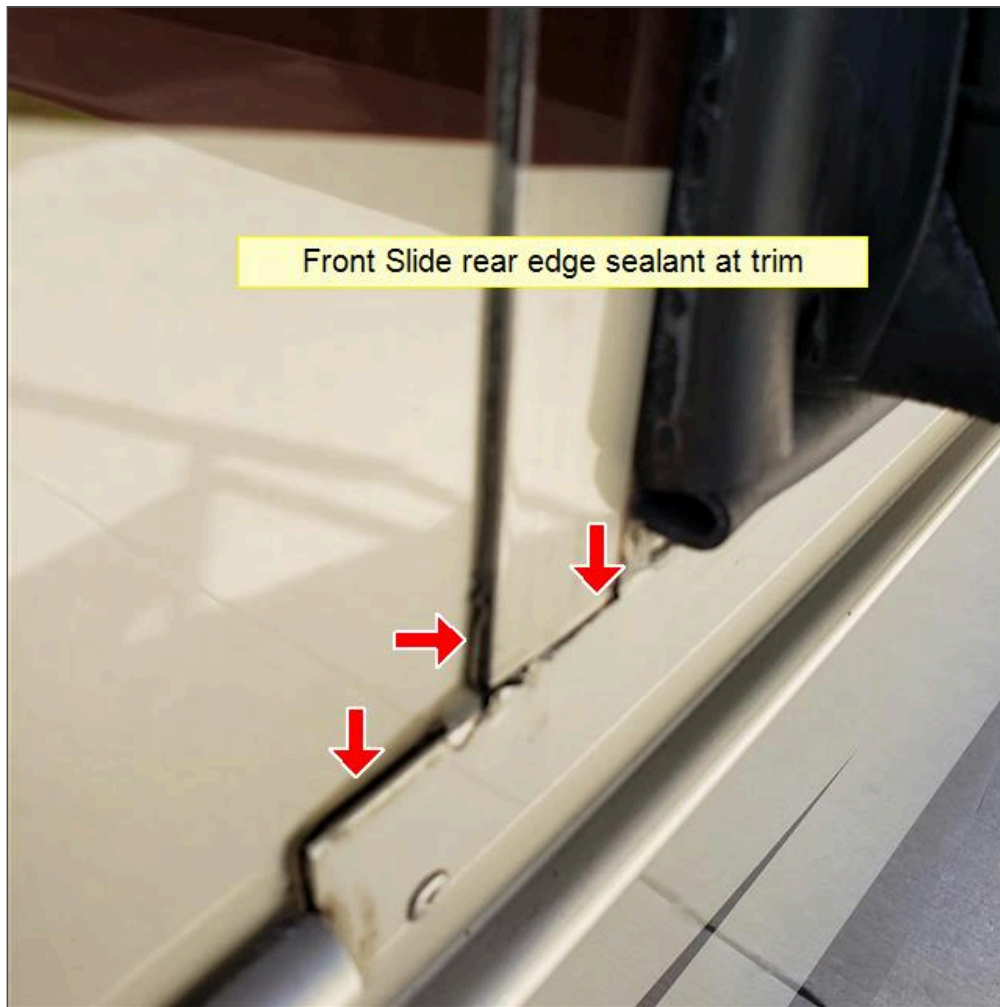
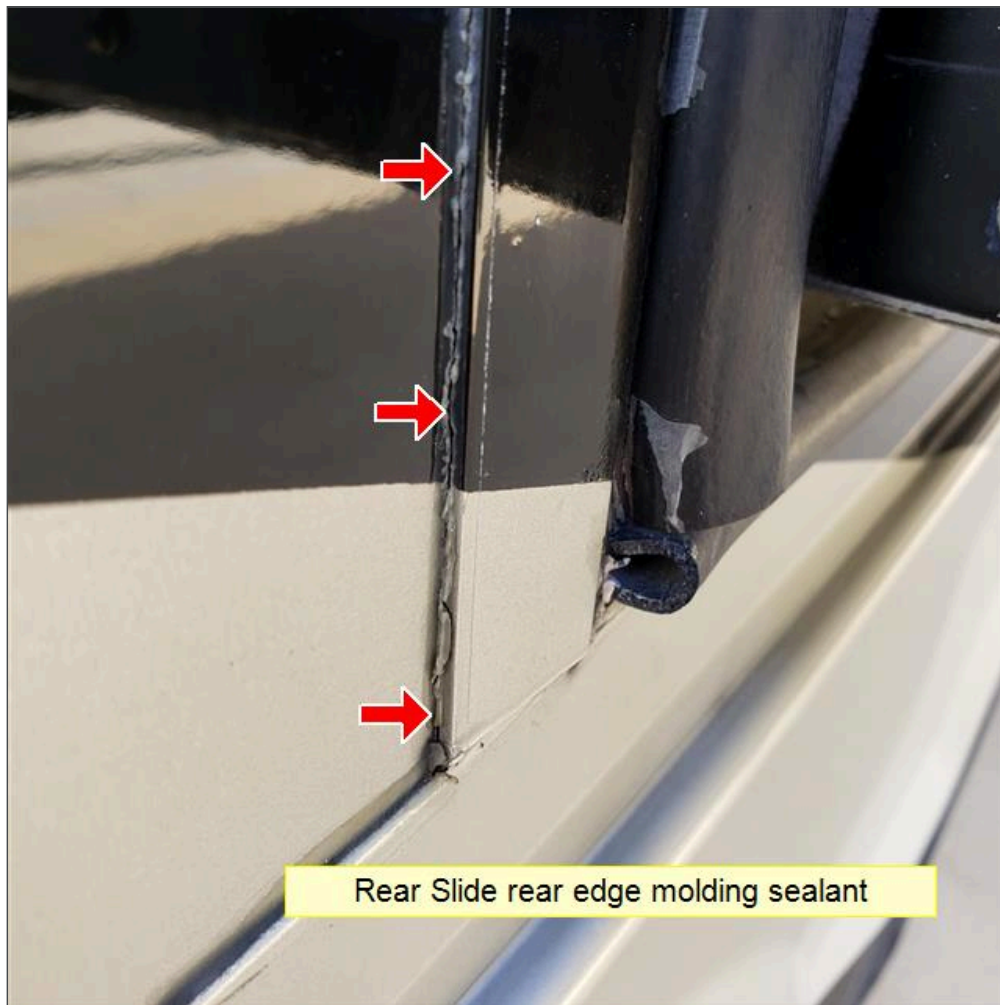
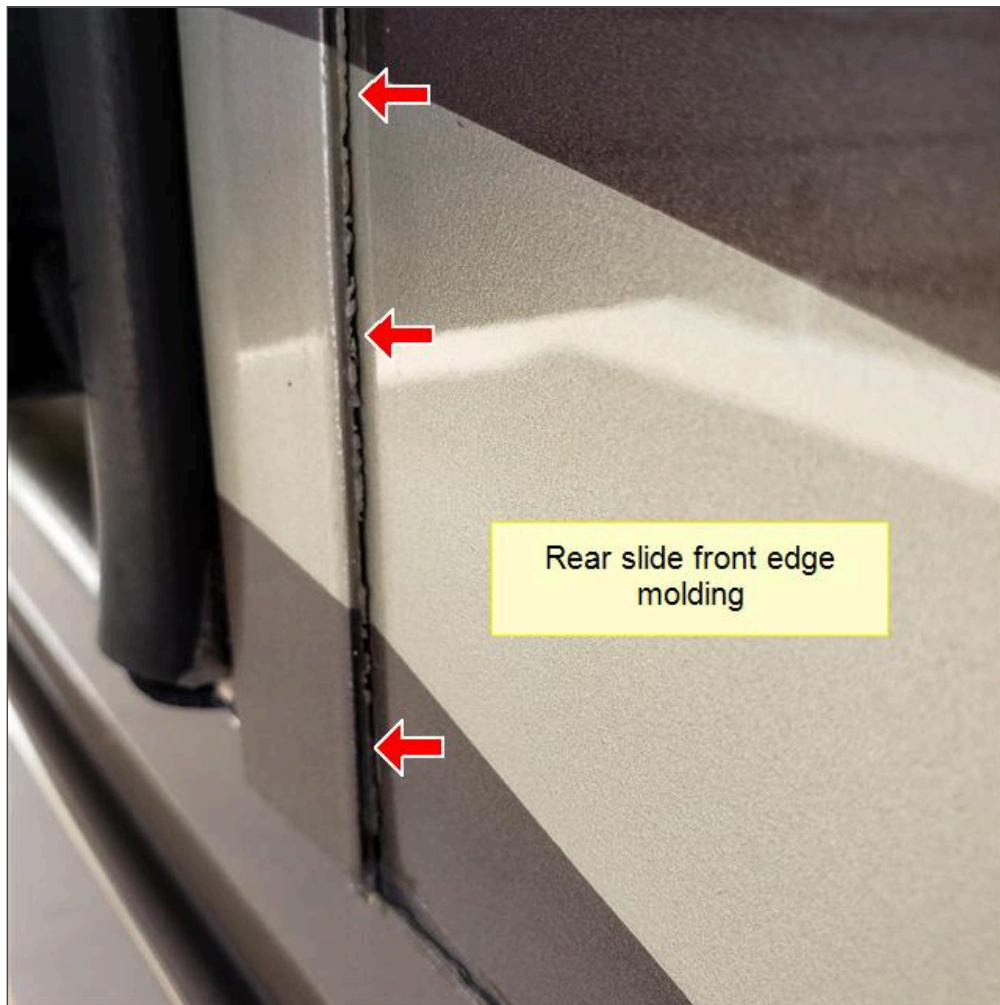
**4(C) . Streetside Sidewall****4.0.C Sidewall Condition****Acceptable**

Sealant cracking along trim on slides. Misaligned bulb seal on forward slide at rear had rubbed paint off.

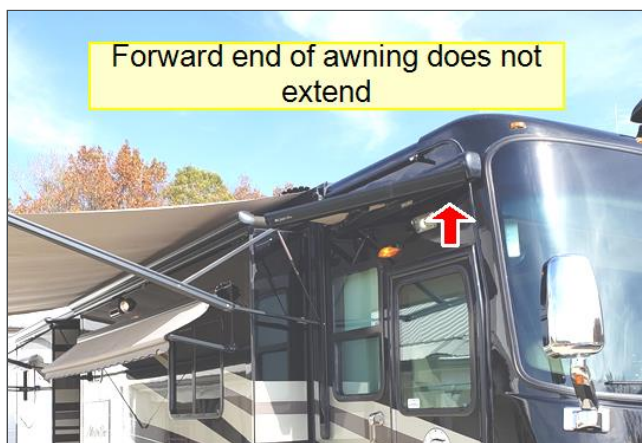
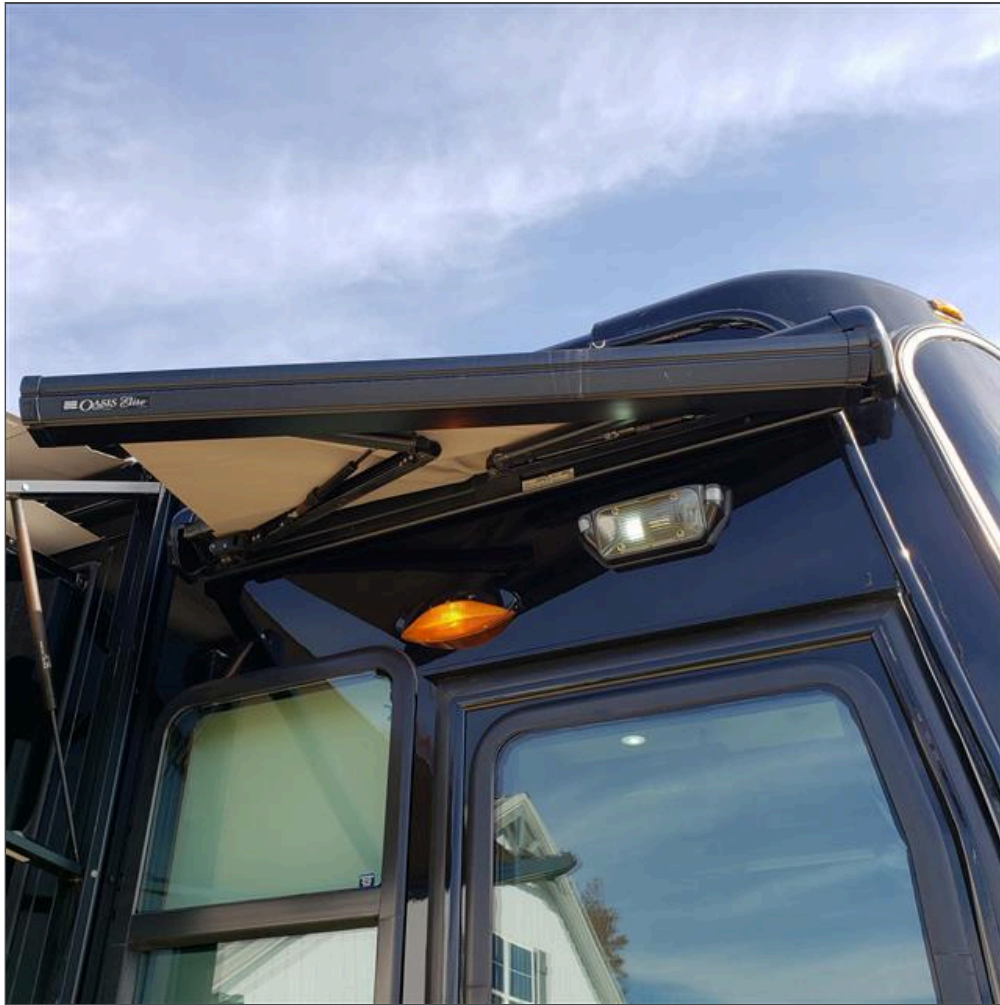
6.2.B Awning Operation

Poor

Door awning does not extend properly.

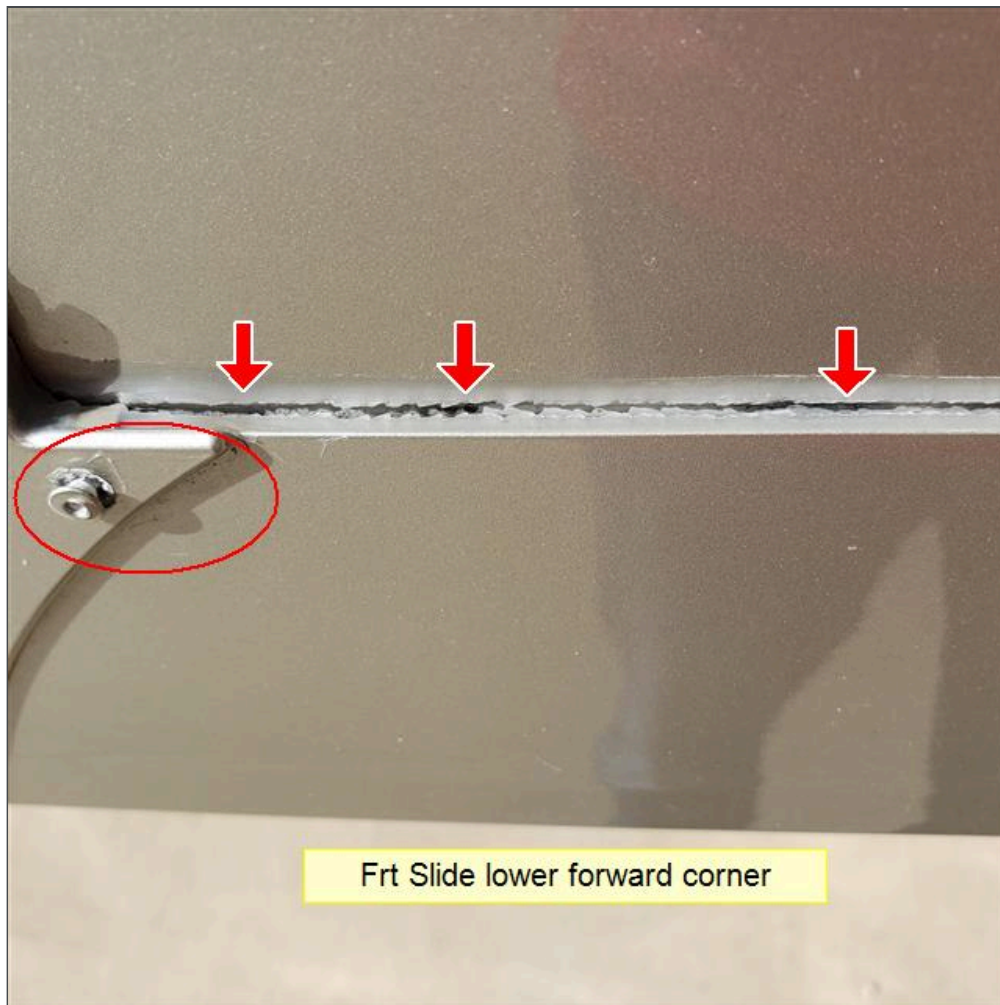
7.1.A Slideout T-Molding Trim

Fair

Molding at lower forward corner cracked and sealant pulled loose.

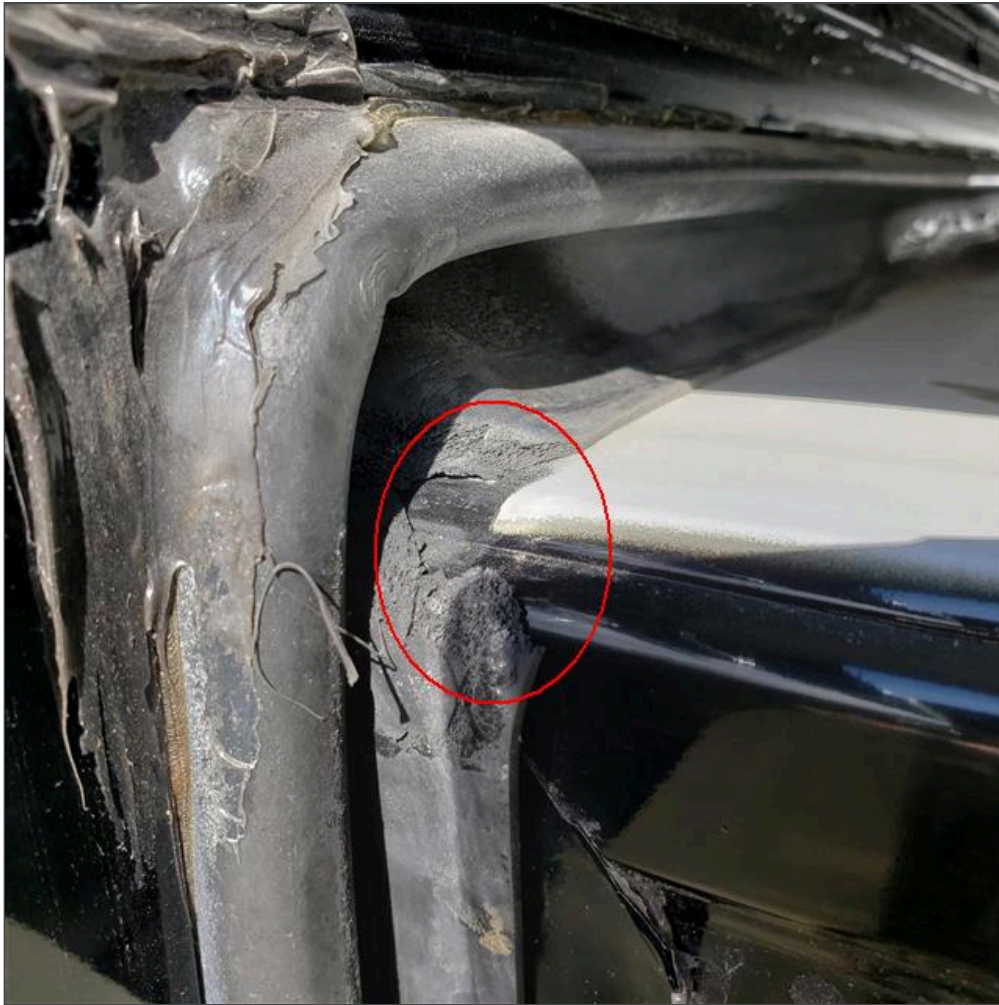
7.2.B Seals, Sweeps and Gaskets

Fair

Worn/tear top forward corner

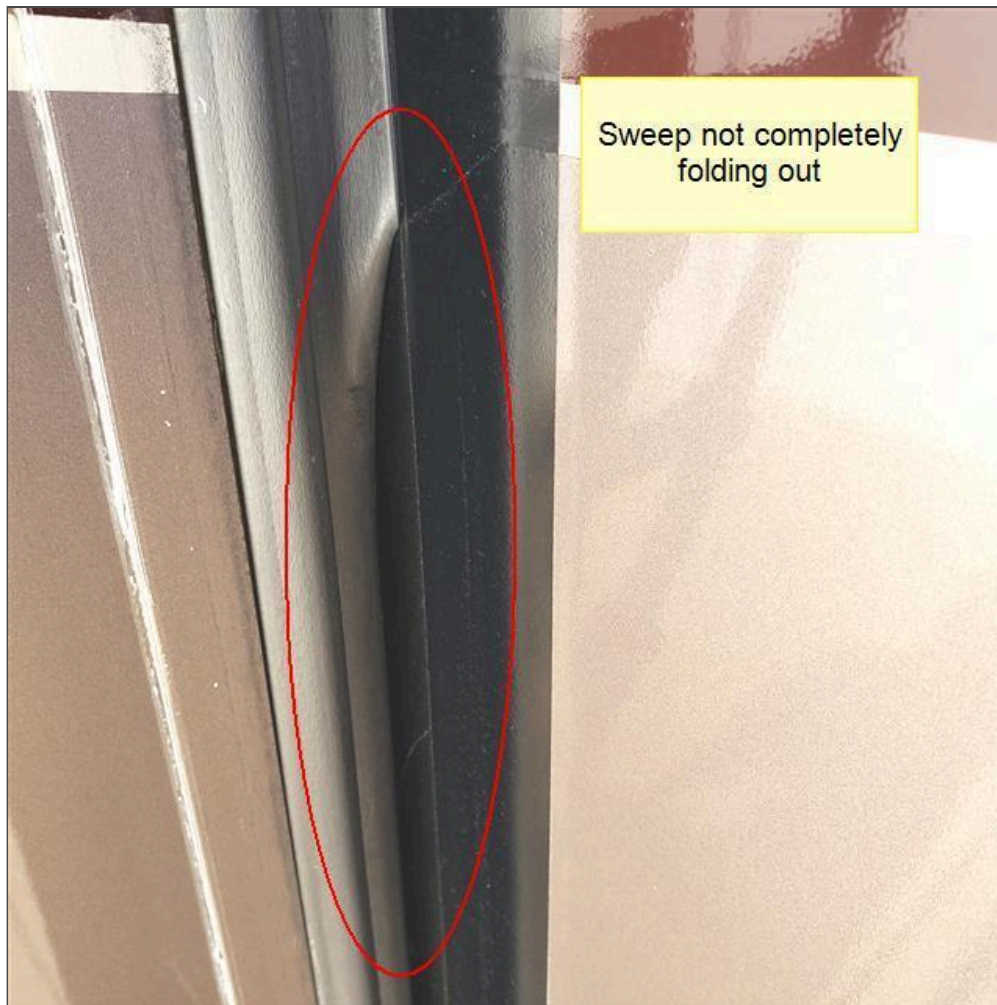
7.2.C Seals, Sweeps and Gaskets

Clean and lubricate sweeps to fold in and out easily

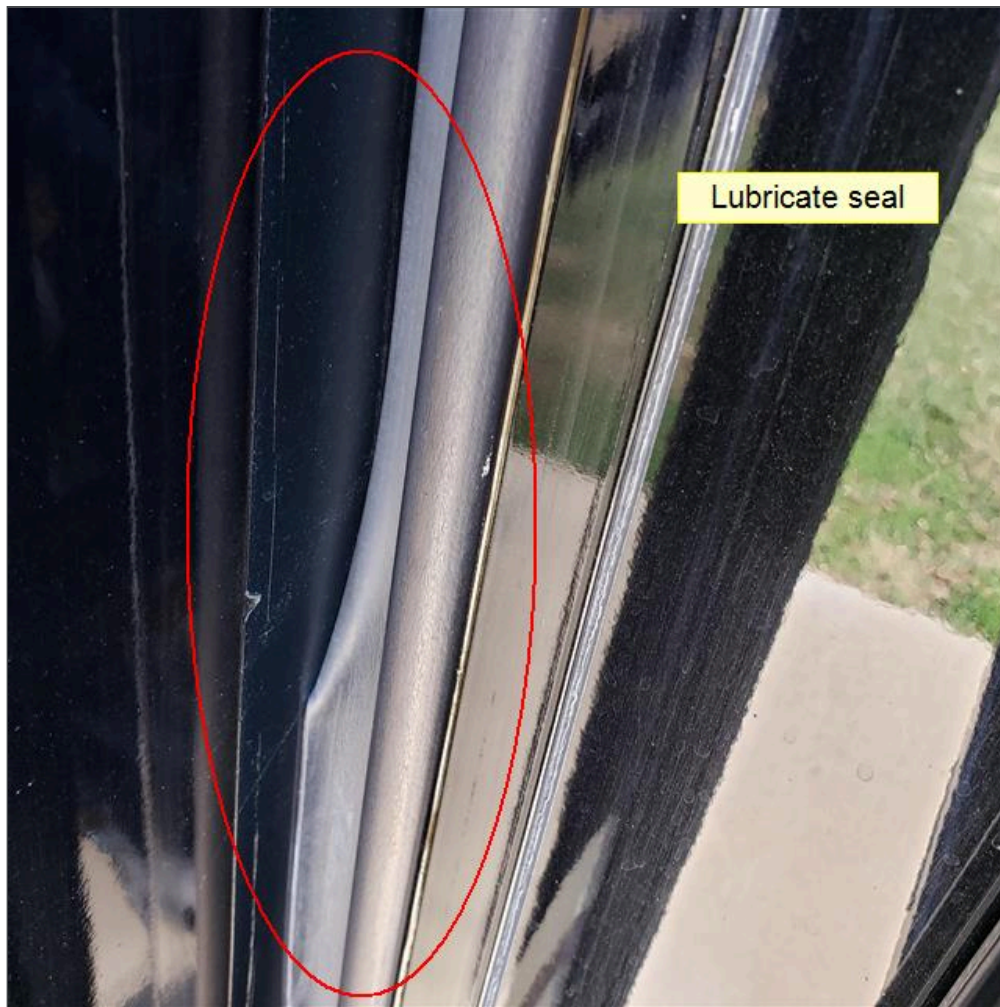
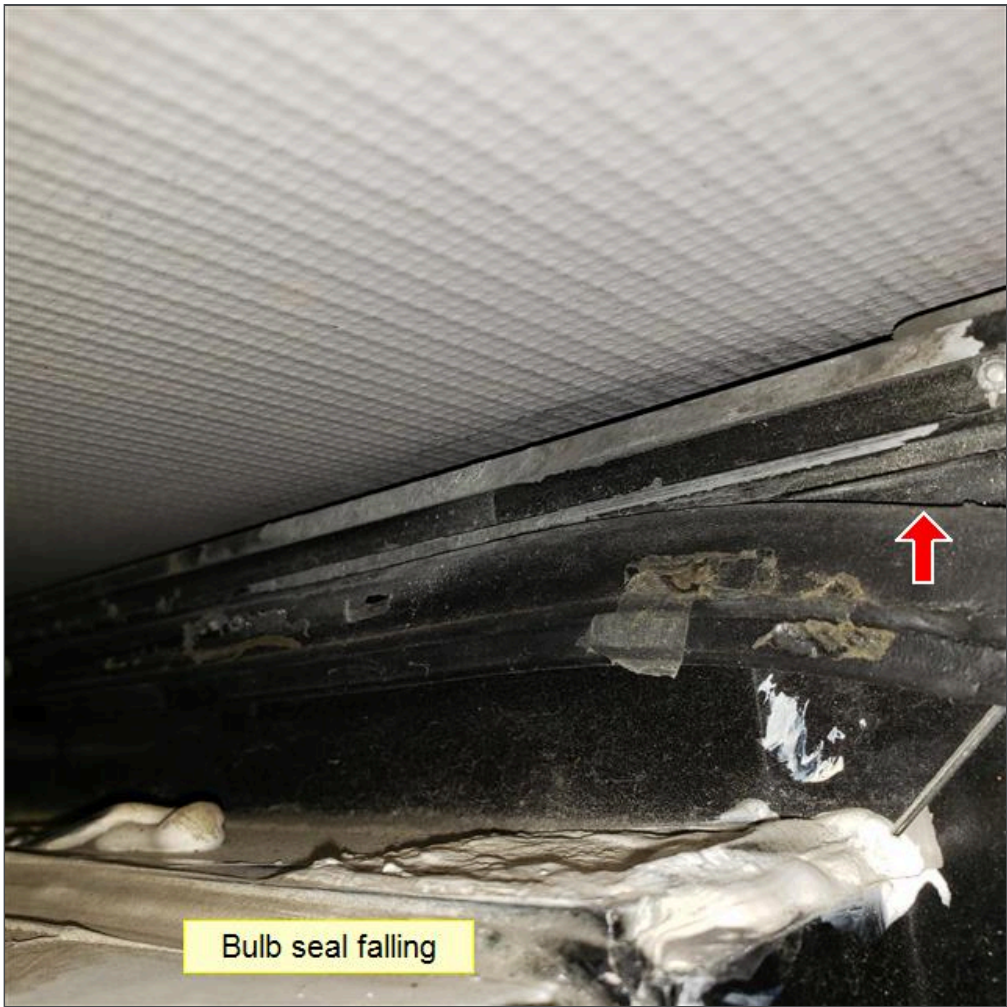
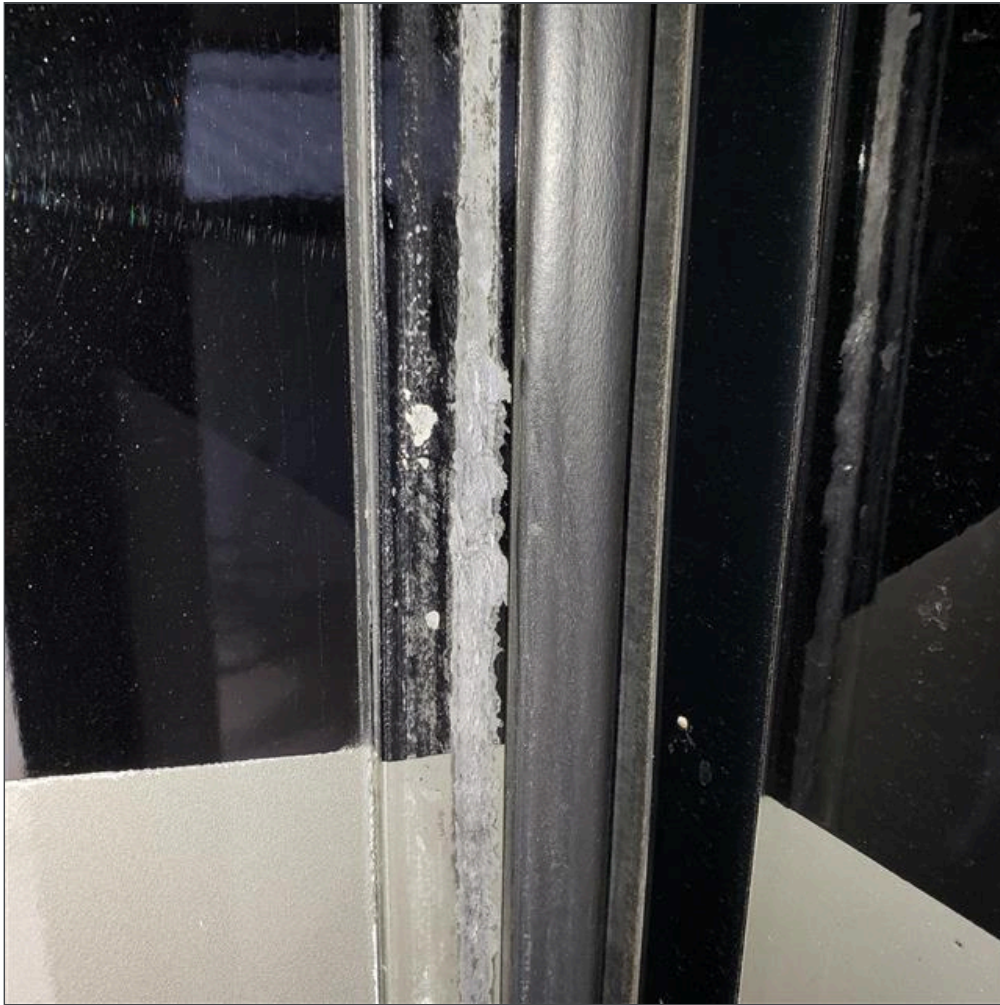
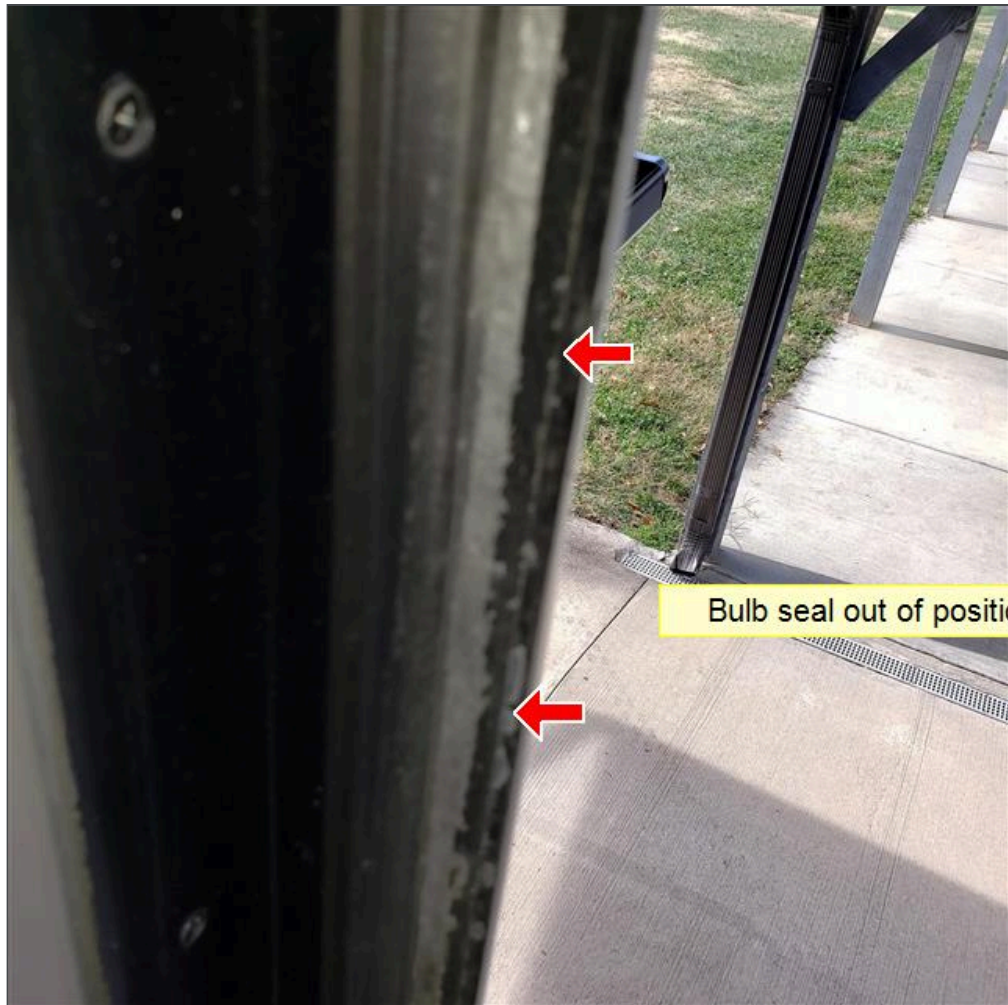
7.2.D Seals, Sweeps and Gaskets

Fair

Bulb seal out of position along rear edge and roof. Lubricate sweep to properly fold in and out

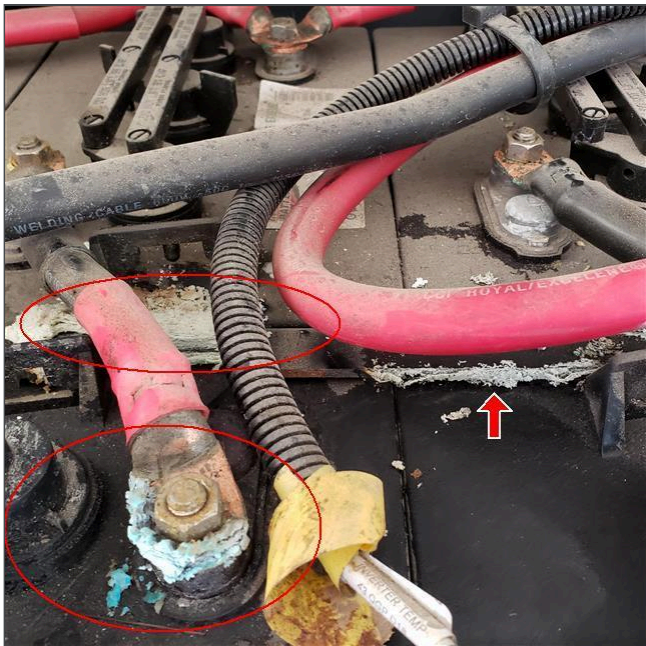
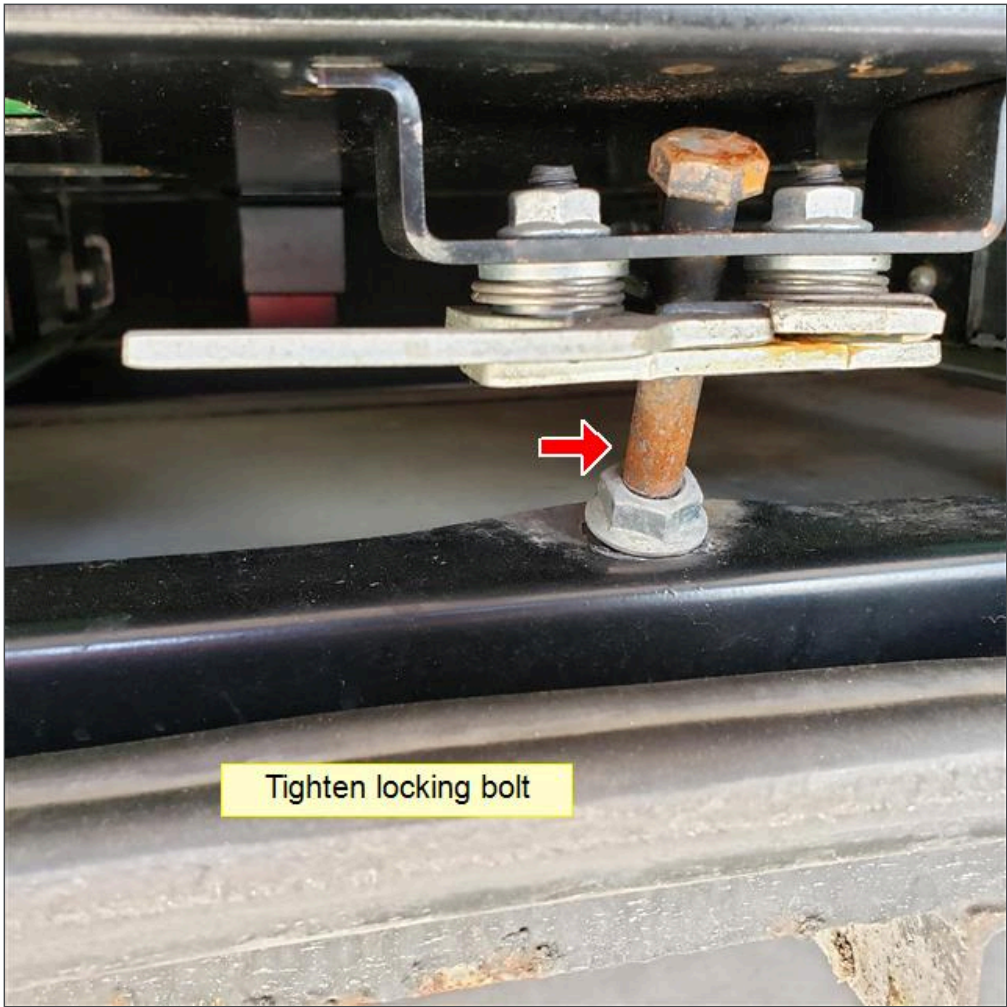
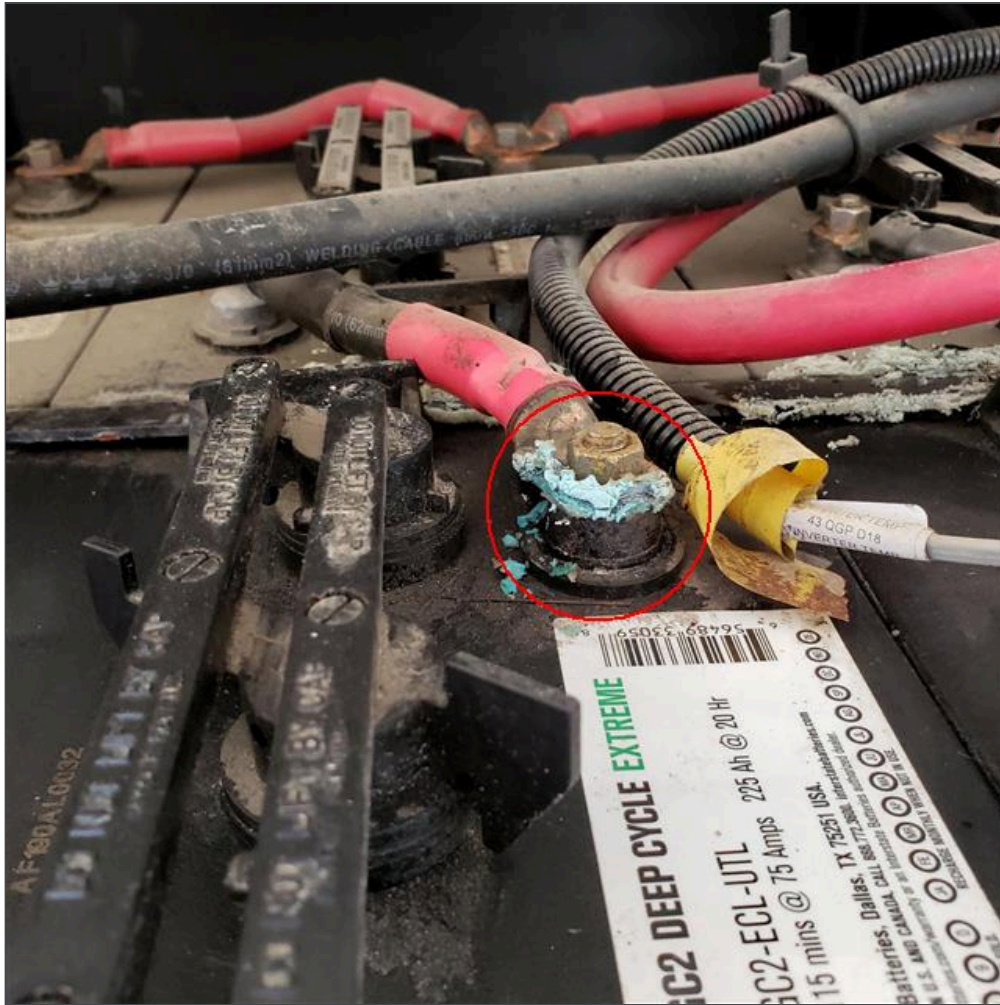
13.36 12 Volt DC House Battery(s) - Have They Been Maintained?

Some corrosion build up on cables. Clean and maintain for maximum performance. Bolt locking battery tray in place is loose and should be tightened.
