Summary Only

Property Address:
2711 Claypool-Alvaton Rd
Bowling Green KY 42103

This is not the complete home inspection report. It is only the Summary Items.

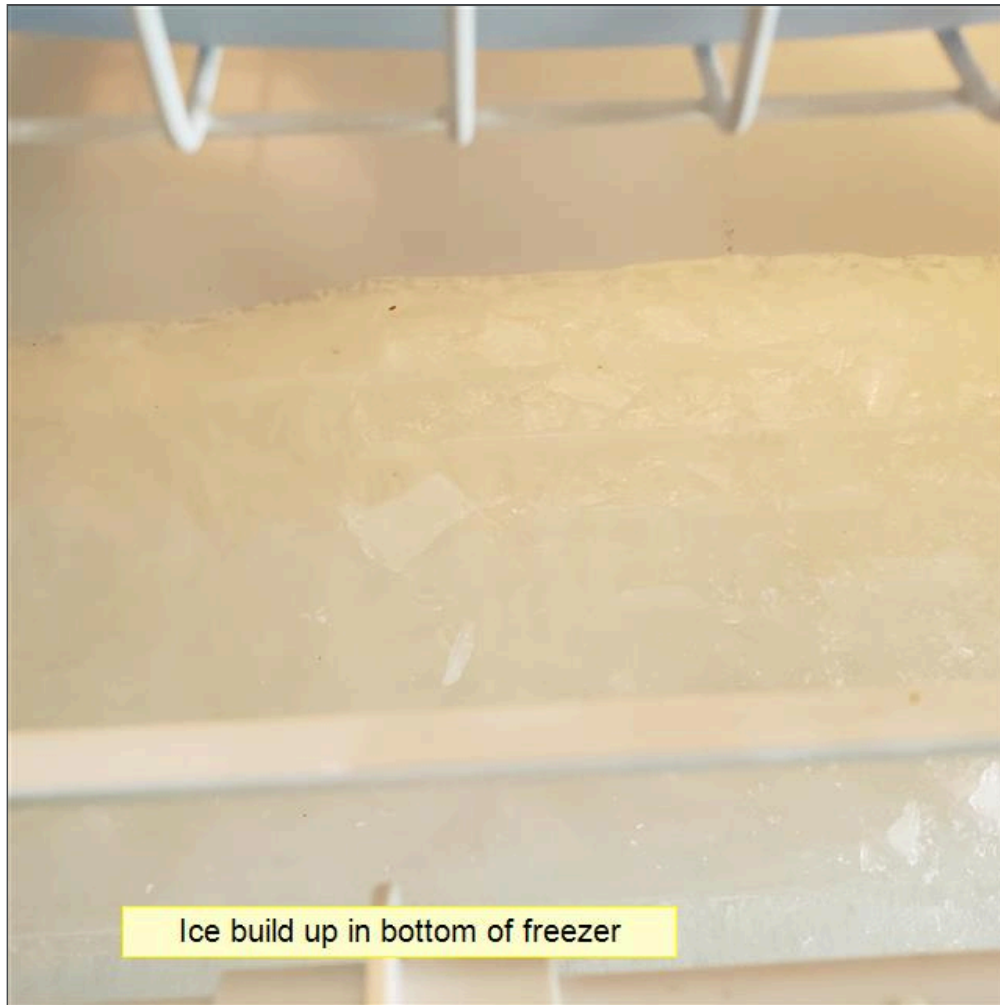
15.4 Refrigerator - Inside Freezer Walls

Icing at bottom of freezer. Needs defrosting

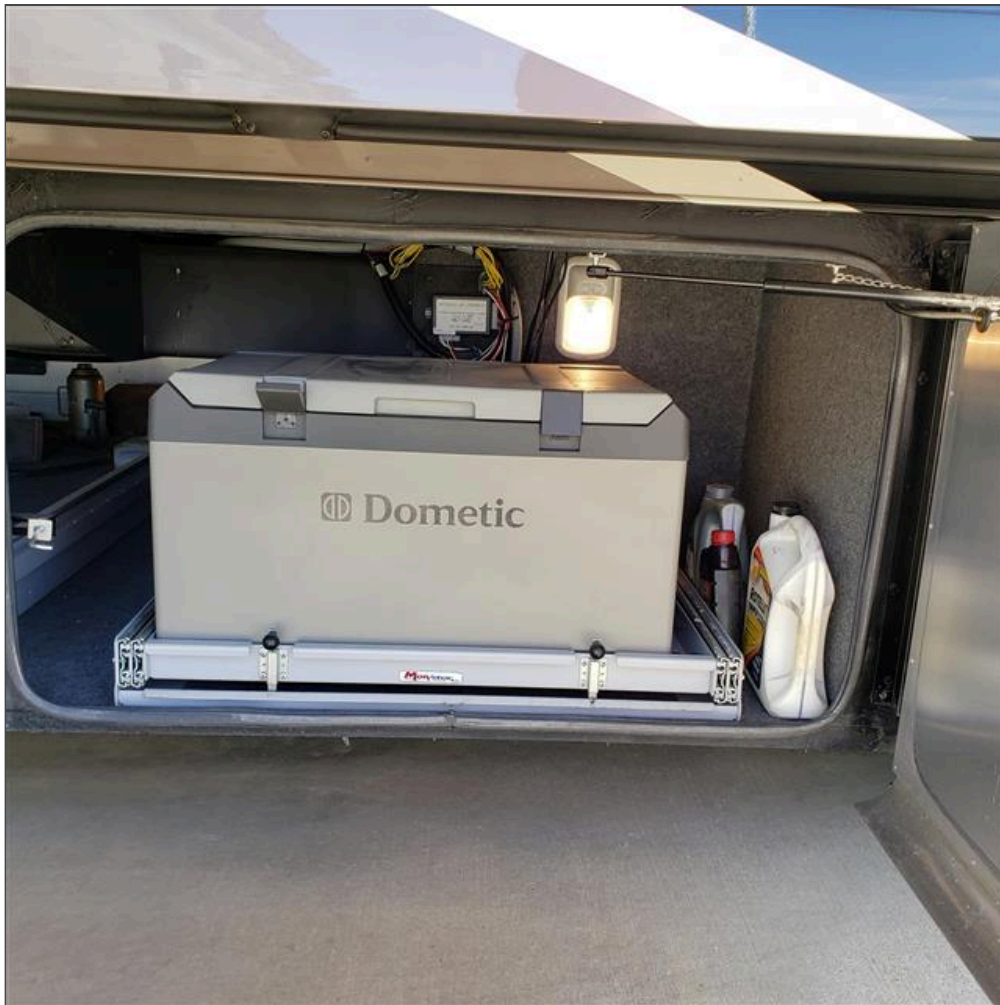
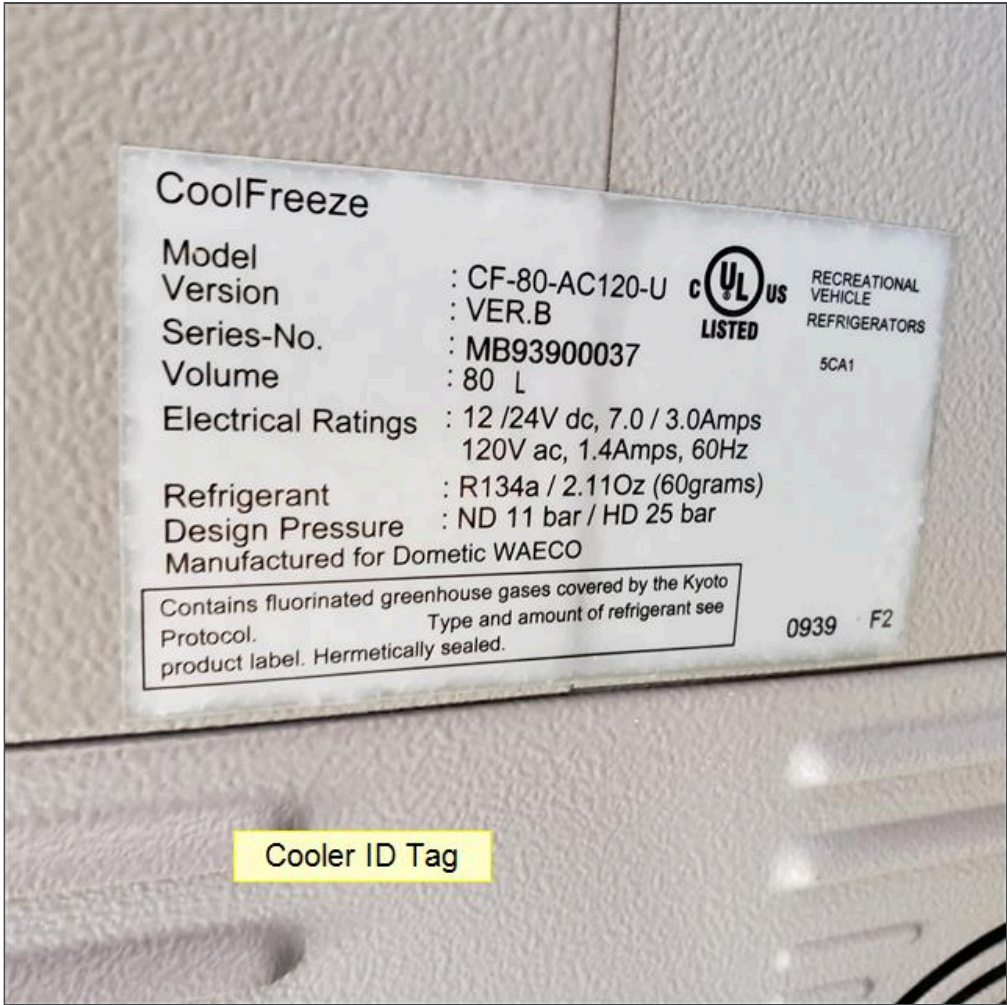
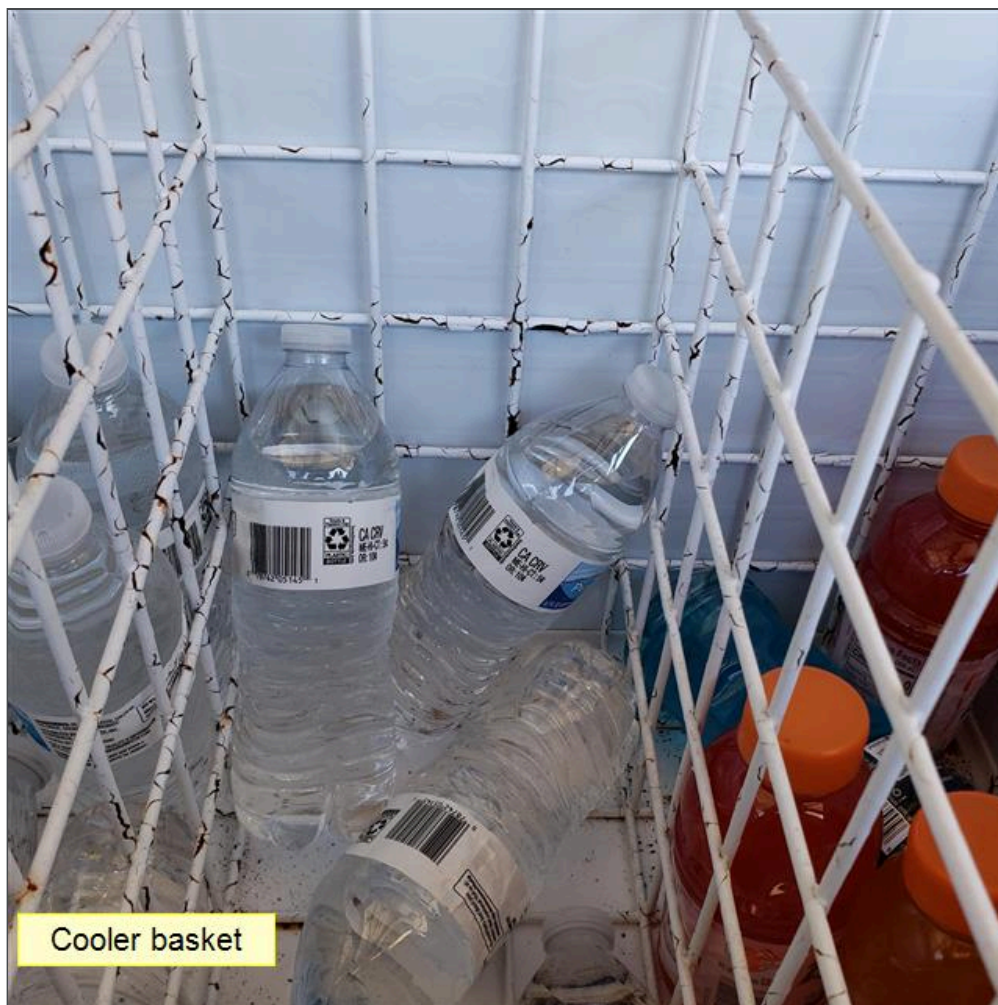
16.2 Cooler

Fair

Electric cooler located in right side storage powers on appropriately. Basket in cooler is rusting.

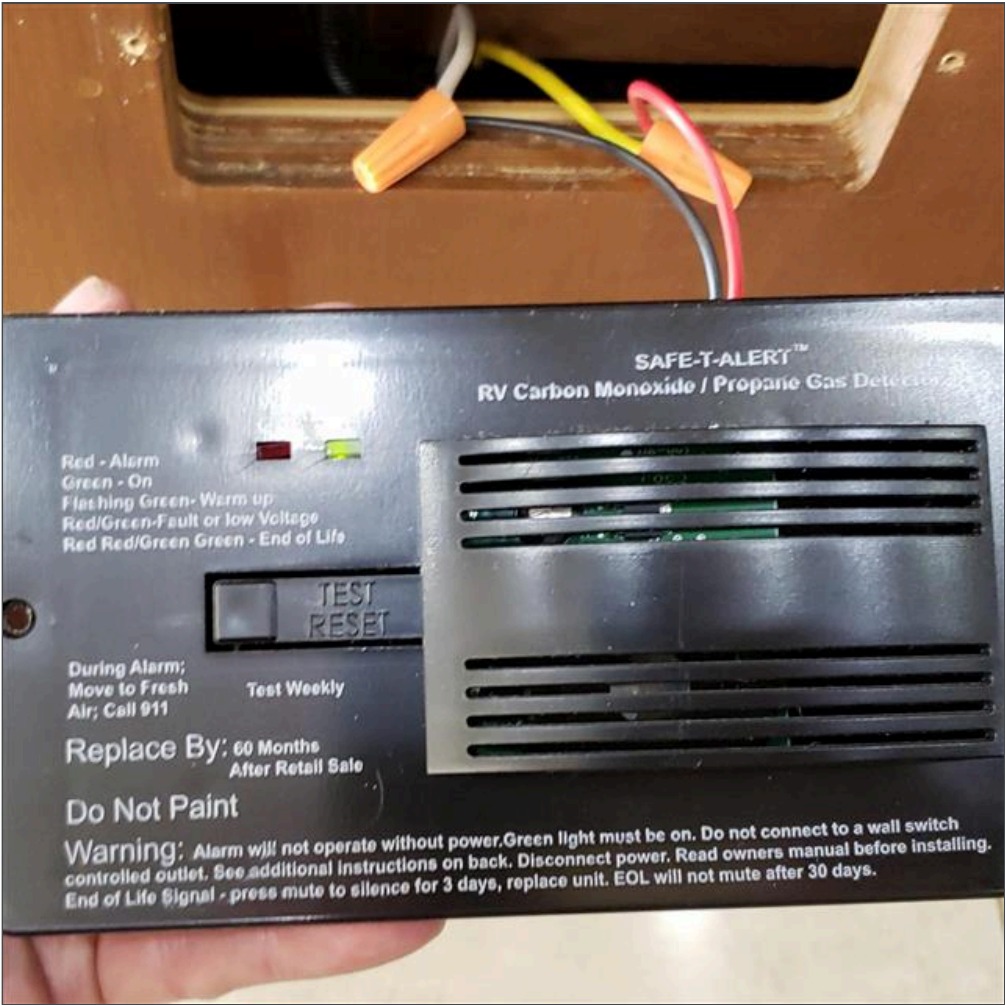
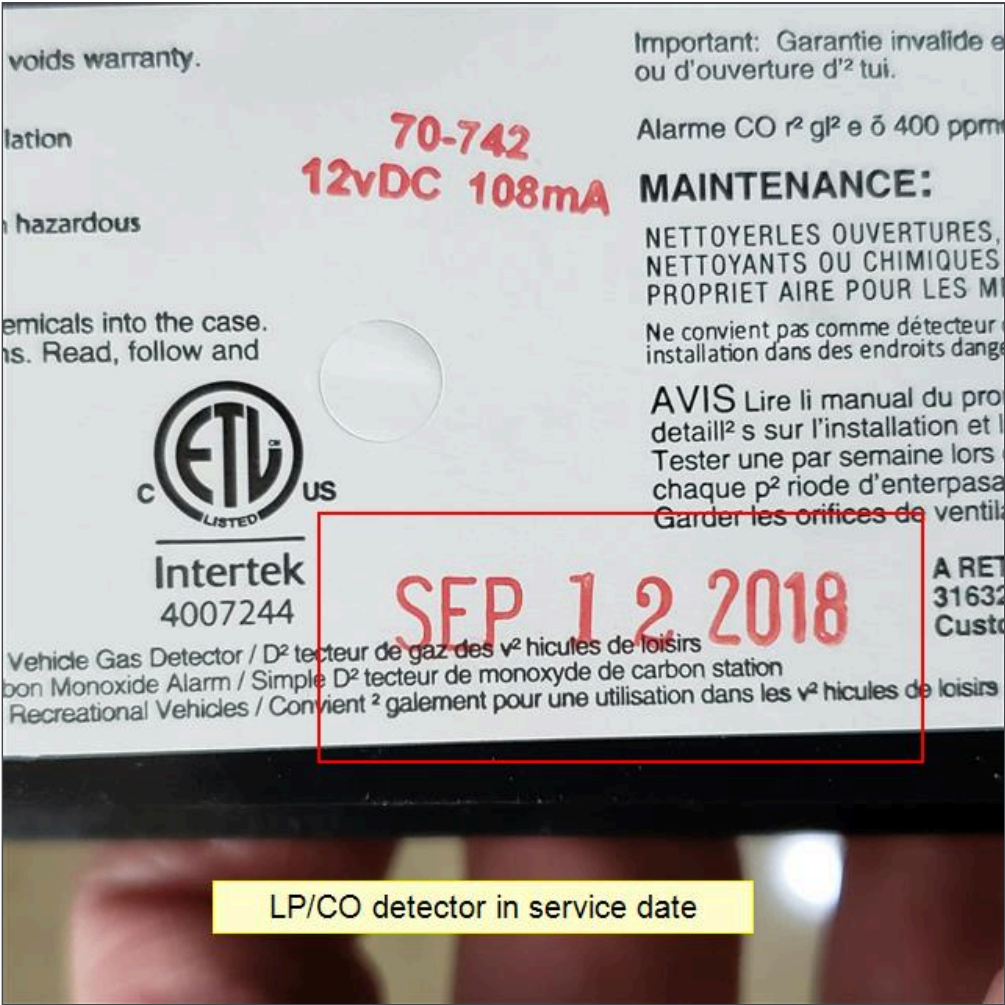
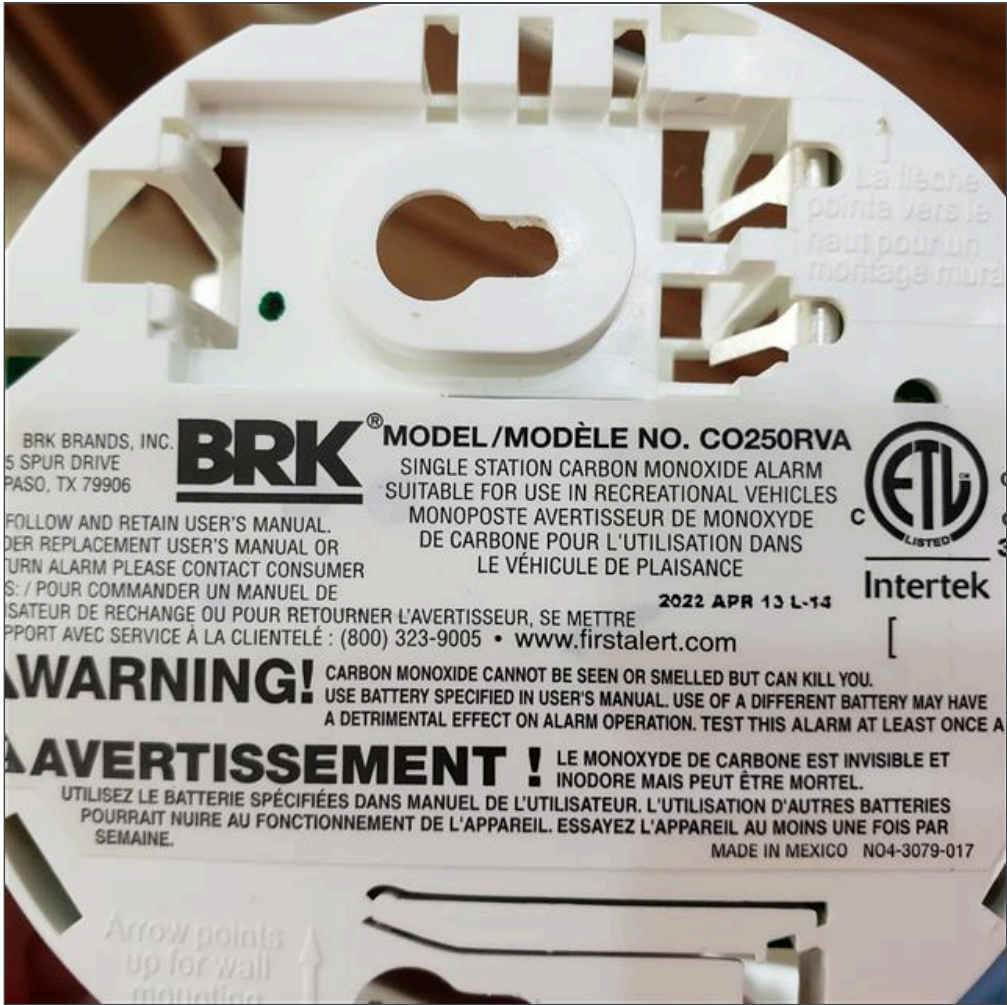
21.0 LP/CO Detector

LP/CO detectors located in galley and at forward area of coach are serviceable and tested appropriately. In service date 9-12-2018 of galley detector is recommend replacement 60 months (9-12-2023). In service date of forward detector 04-13-2022.
