**MAJOR REPAIR AND ALTERATION**  
**(Airframe, Powerplant, Propeller, or Appliance)**

| 1. AIRCRAFT | MAKE<br>CESSNA | MODEL<br>177 |
| | SERIAL NO.<br>17700512 | NATIONALITY AND REGISTRATION MARK<br>N3212T |

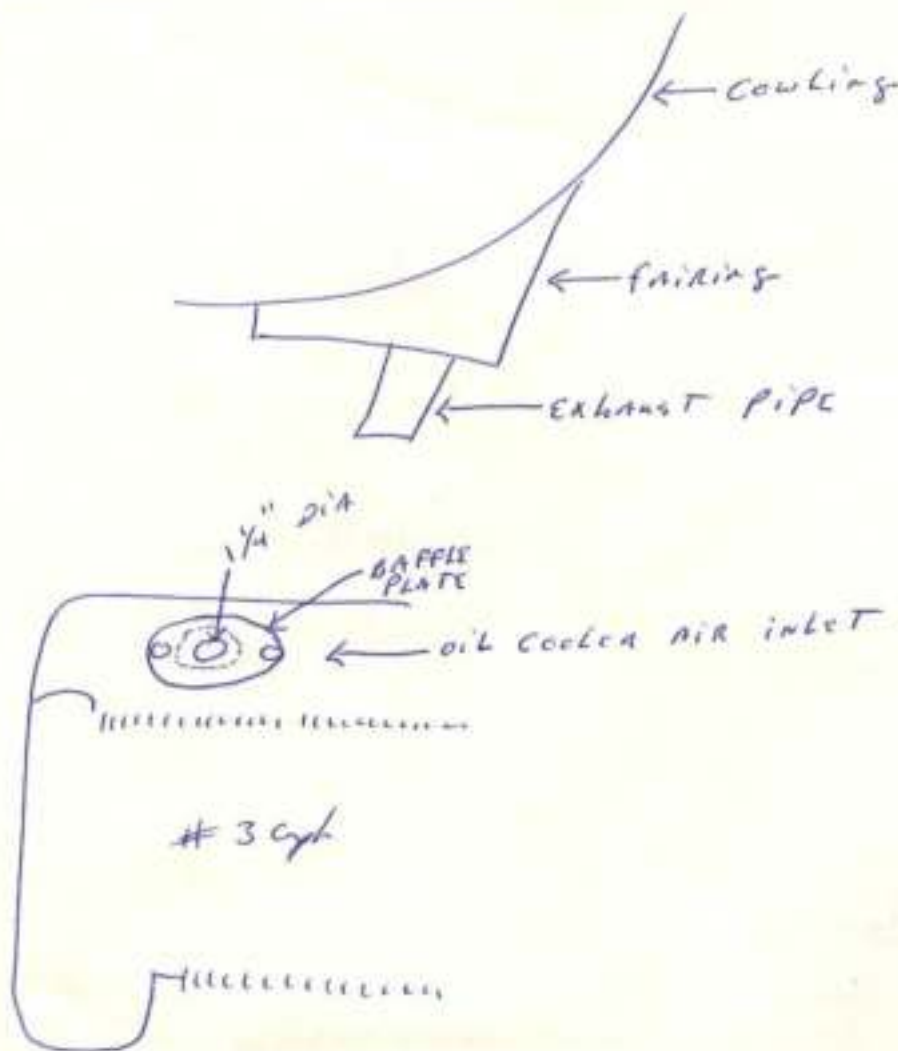
Added fairing to cowling around exhaust pipe. Fabricated from fiberglass and high temperature epoxy resin I/A/W Canadian MOT approval. Attached #8 CS screws and MS21059 self locking nut plates. I/A/W AC43.13-2A Ch.1 Para.4-10

An oil cooler baffle must be installed when ambient temperatures are below 20 degrees F. Baffle consist of a plate installed in the oil cooler air intake behind the number 3 cylinder with a  $1\frac{1}{4}$ " dia. hole centered in the plate. Appropriate placards to be installed in the POH and the instrument panel near the oil temp gauge.

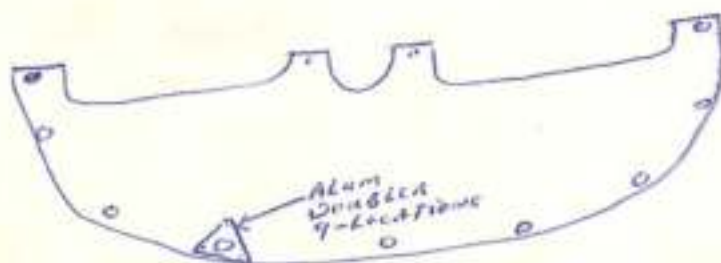
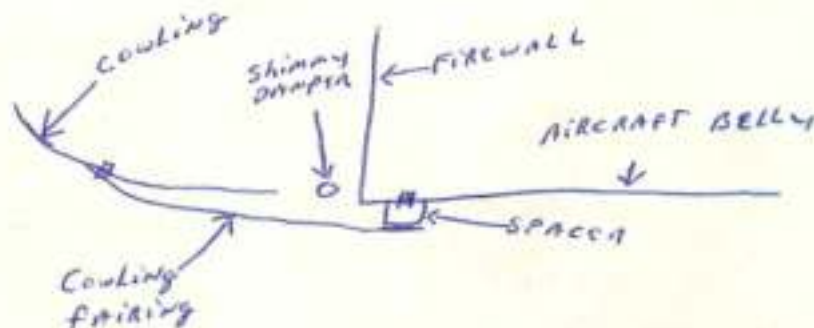
Added lower cowling fairing fabricated from fiberglass and polyester resin. Attached fairing to bottom cowl using 8-32 cs screws and MS-21059 self locking nut plates. Added alum reinforcing plates at 9 locations on added fairing. Installed spacers as required to clear Fancy Pants installation. All work accomplished I/A/W 43.13-2A Ch.1 para 4-10 and suggested installation procedures supplied by Maple Leaf Aviation Ltd P.O. Box 160 Brandon, Manitoba R7A 5Y8

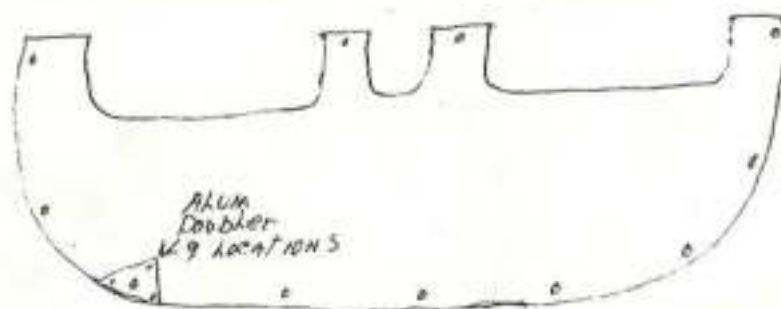
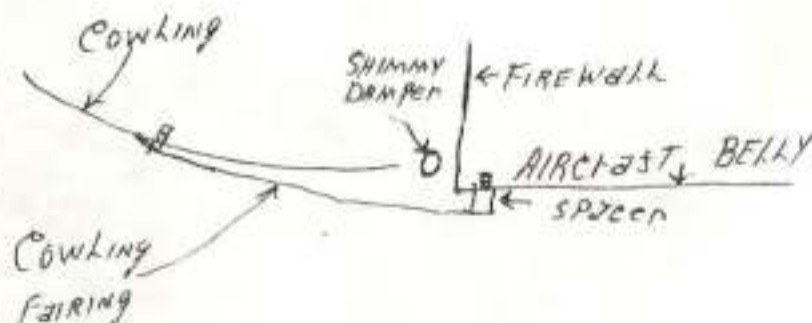
Added lower cowl fairing fabricated from fiberglass and polyester resin. Attached fairing to bottom cowl using 8-32 cs screws and M321059 self locking nut plates. Added alum reinforcing plates at 9 locations on added fairing. Installed spacers as required to clear Fancy Pants installation. All work accomplished IAW 43.13-2A Ch. 1 para 4-10 and suggested installation procedures supplied by Maple Leaf Aviation Ltd P.O. Box 160 Brandon, Manitoba R7A 5Y8.

Drill To Clear  
8-32 MACHINE SCREW  
#40 DRILL  
3 PLATES

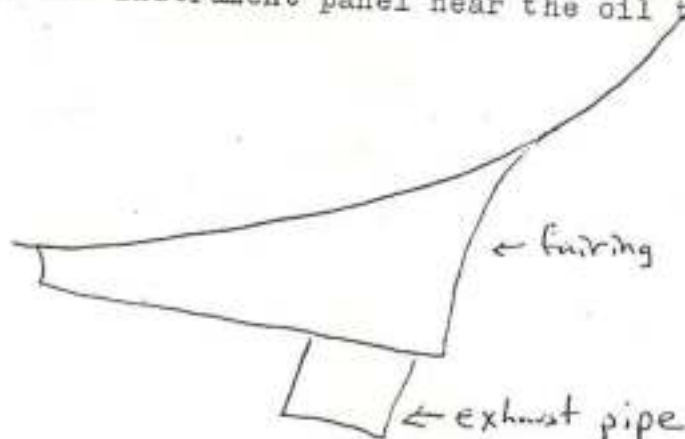
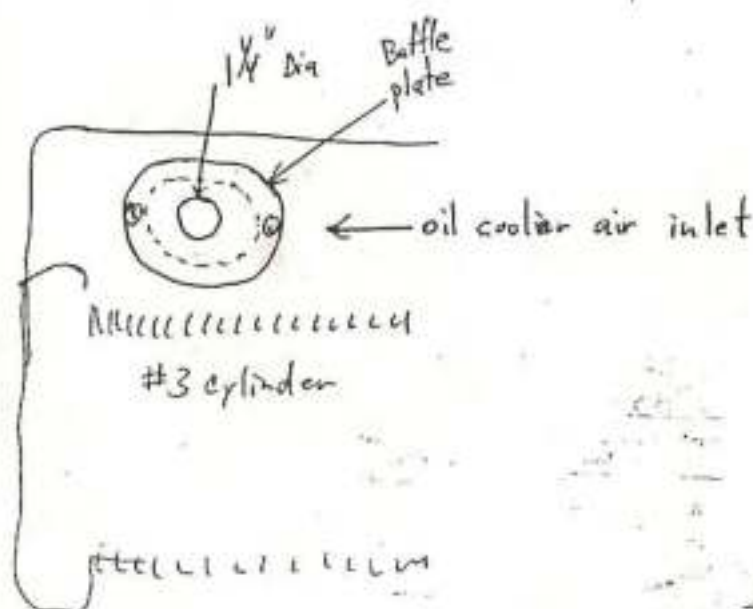
A:  
Added fairing to cowl around exhaust pipe. Fabricated from fiberglass and high temperature epoxy resin IAW Canadian MOT approval. Attached with #8 CS screws and MS21059 self locking plate nuts. IAW AC 43.13-2A Ch. 1 Para. 4 - 10.

An oil cooler baffle must be installed when ambient temperatures are below 20 F. Baffle consists of a plate installed in the oil cooler air intake behind the number 3 cylinder with a 1 1/4" dia. hole centered in the plate. Appropriate placards to be installed in the POH and the instrument panel near the oil temp gauge.
