# single-engine SERVICE LETTER

SE73-40

**SUBJECT:** VERTICAL FIN ATTACHMENT IMPROVEMENT

**AIRCRAFT AFFECTED:** Model 177, 177RG and F177RG's in the following serial blocks:

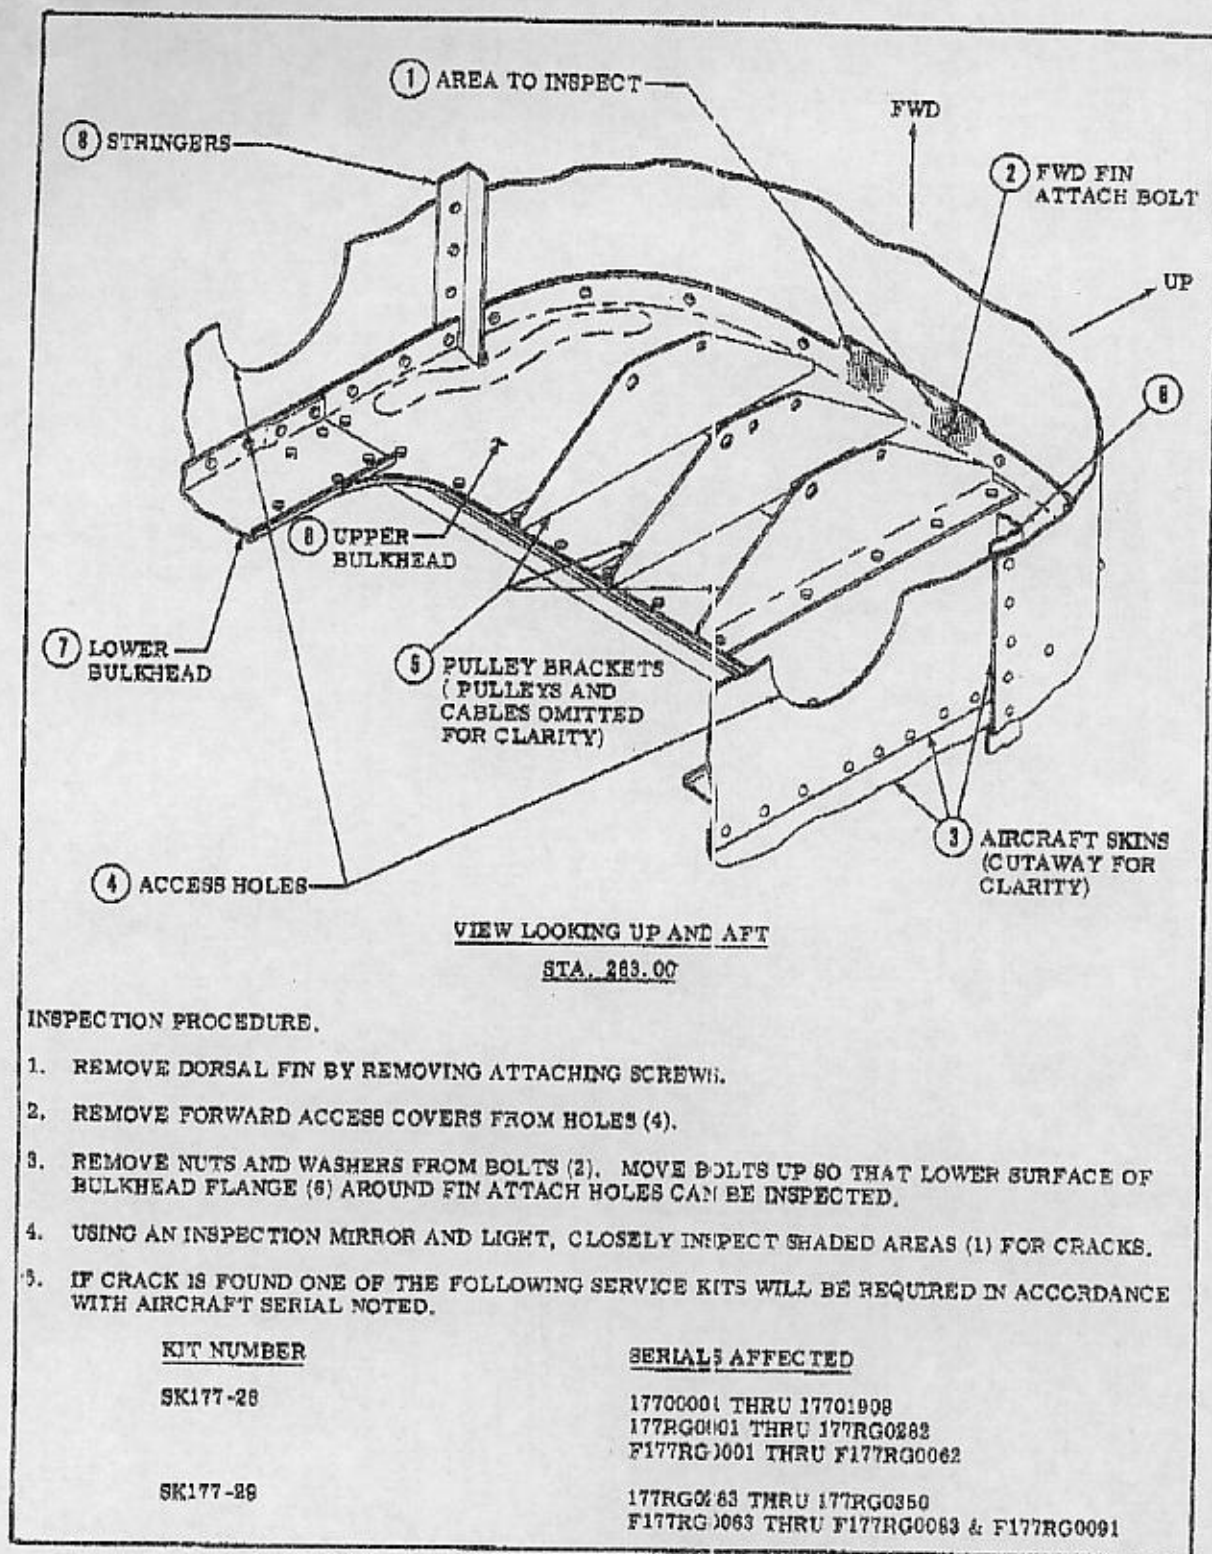
Figure 1. Vertical Fin Attachment Bulkhead Inspection.

An improved vertical fin forward attachment bulkhead (P/N 1712104-11), which incorporates a stiffener in the area shown in Figure 1, has been phased into production on Cardinal and Cardinal RG series aircraft.

It is important that a careful inspection of the forward attachment bulkhead on affected in-service aircraft be accomplished within the next 100 hours of operation and at each periodic inspection thereafter as shown in Figure 1.

Cracking around the vertical fin attachment bolt holes will require that bulkhead assembly be replaced with the improved configuration bulkhead by installing the applicable Service Kit as shown below.
