SUBJECT: Service Bulletin SEB89-1 Revision 3. Stabilator Balance Weight Arm Bracket Inspection Replacement.

SEB89-1
Revision 3

STABILATOR BALANCE WEIGHT ARM BRACKET INSPECTION/REPLACEMENT

1968 thru 1978 Cardinal and Cardinal RG Series Airplanes

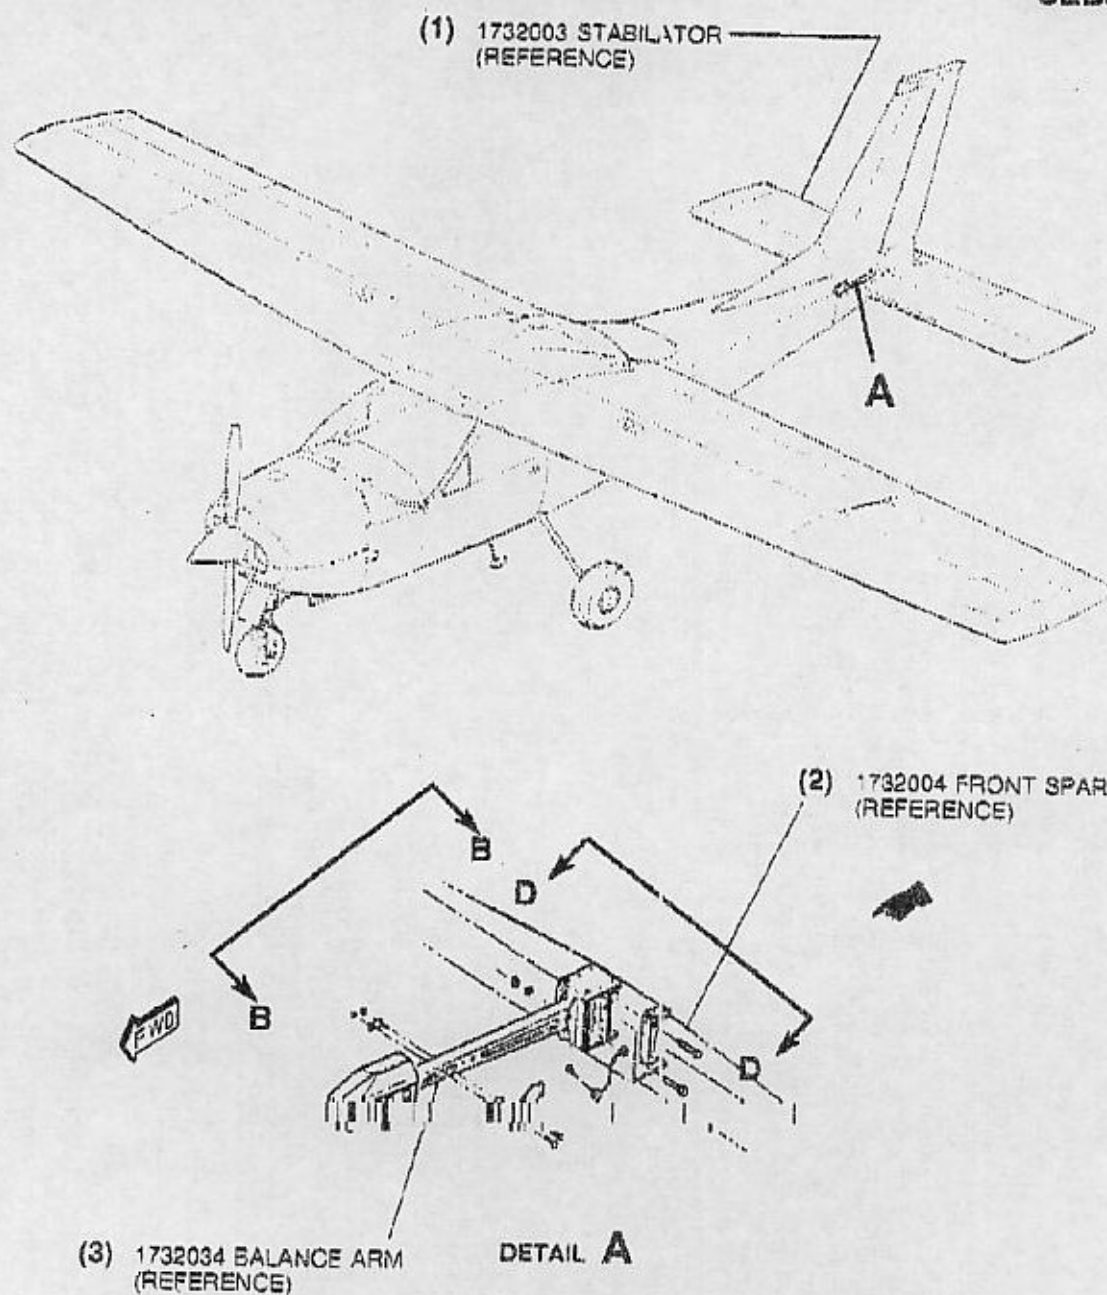
Figure 1. Stabilator Balance Weight Arm Brackets Inspection & Replacement (Sheet 1 of 4)

Service experience indicates the possibility of crack(s) developing in the aluminum stabilator balance weight arm brackets at approximately 2000 hours. To assist in preventing loss of the control surface balance weight, it is recommended the brackets be inspected and replaced with new steel brackets as detailed in this Service Bulletin.

1. Remove stabilator (1) from airplane per appropriate Service Manual (refer to Figure 1, Sheet 1).
2. Remove balance arm (3) from stabilator by removing bolts, washers and nuts (4 & 10). retain balance arm, bolts and washers. discard nuts (refer to Figure 1, Sheets 2 & 3).

5. If a crack or cracks are detected, proceed as follows.
6. (Refer to Figure 1, Detail A, View B-B, C-C & D-D, Sheets 1 thru 4) With the balance arm removed, drill out existing rivets in location (7 & 12) on both RH & LH brackets (5). Remove and discard brackets.

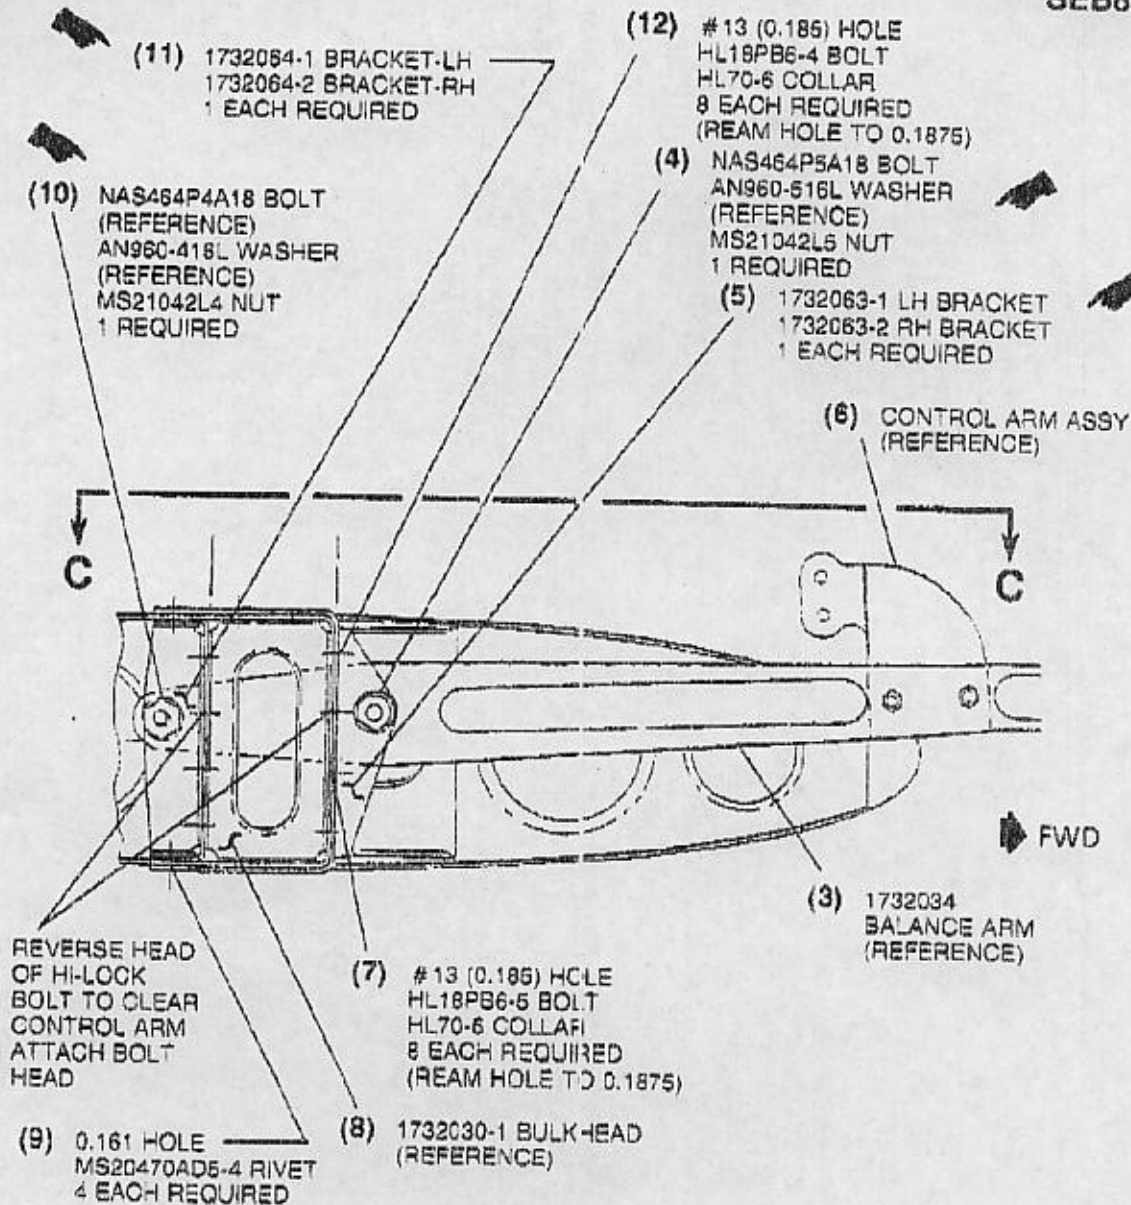
Figure 1. Stabilator Balance Weight Arm Brackets Inspection & Replacement (Sheet 2)

3. Visually inspect RH & LH brackets (5 & 11) for cracks, especially near the radius under the bolt hole. If no cracks are visible, use Eddy Current inspection to verify no small cracks have started.
