Inspection Report

Property Address:
2711 Claypool-Alvaton Rd
Bowling Green KY 42103

Foremost RV Inspections

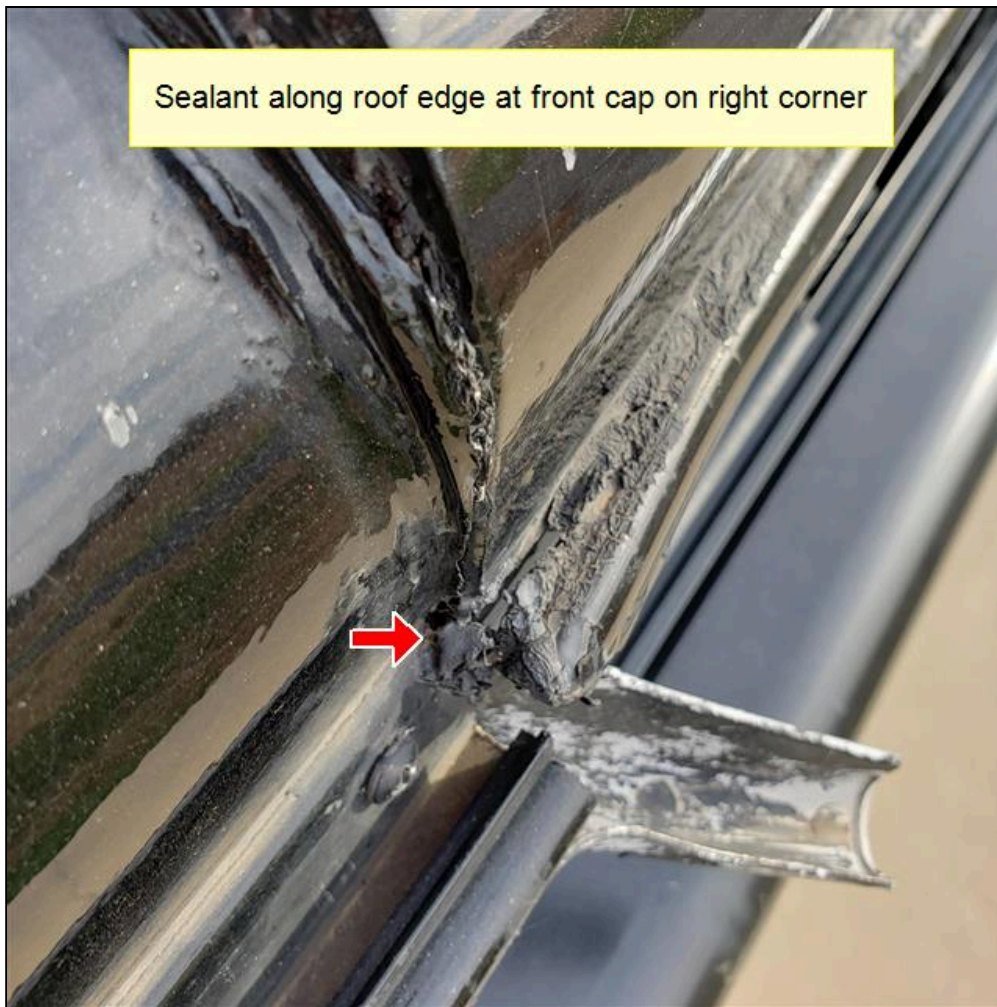
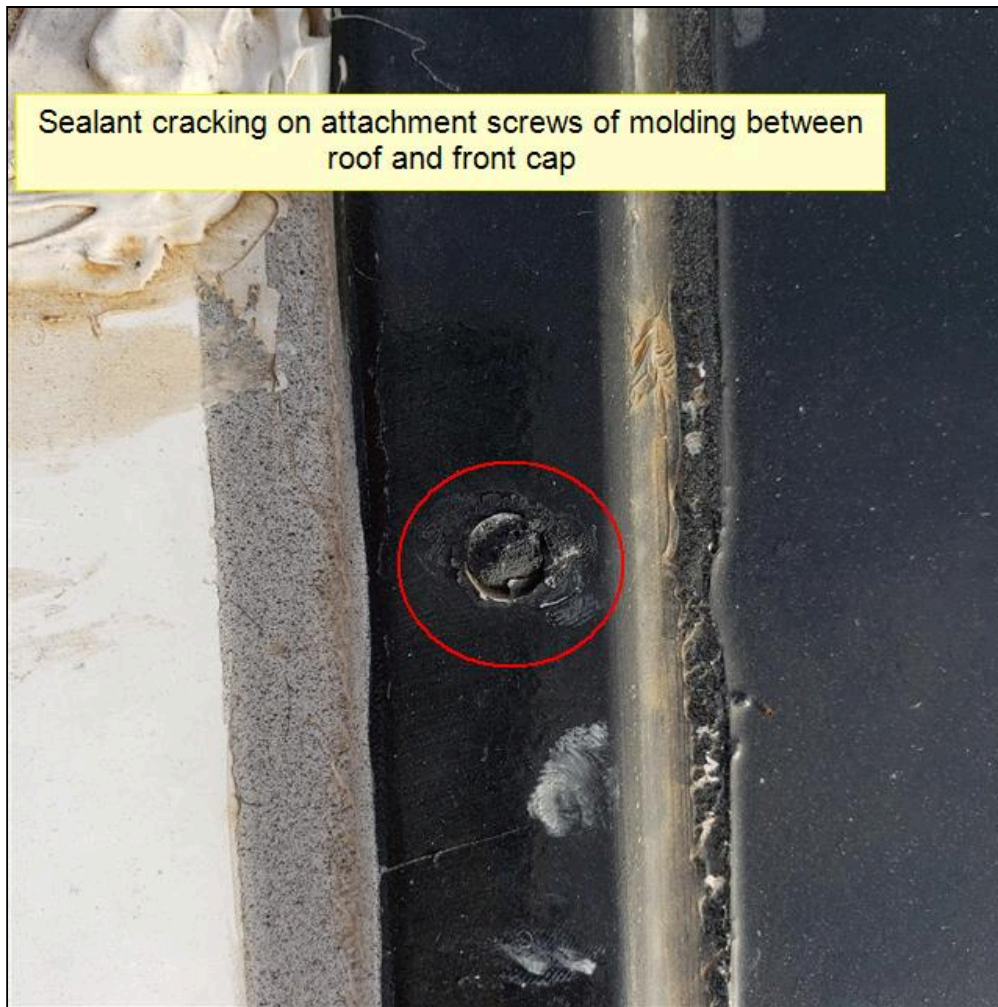
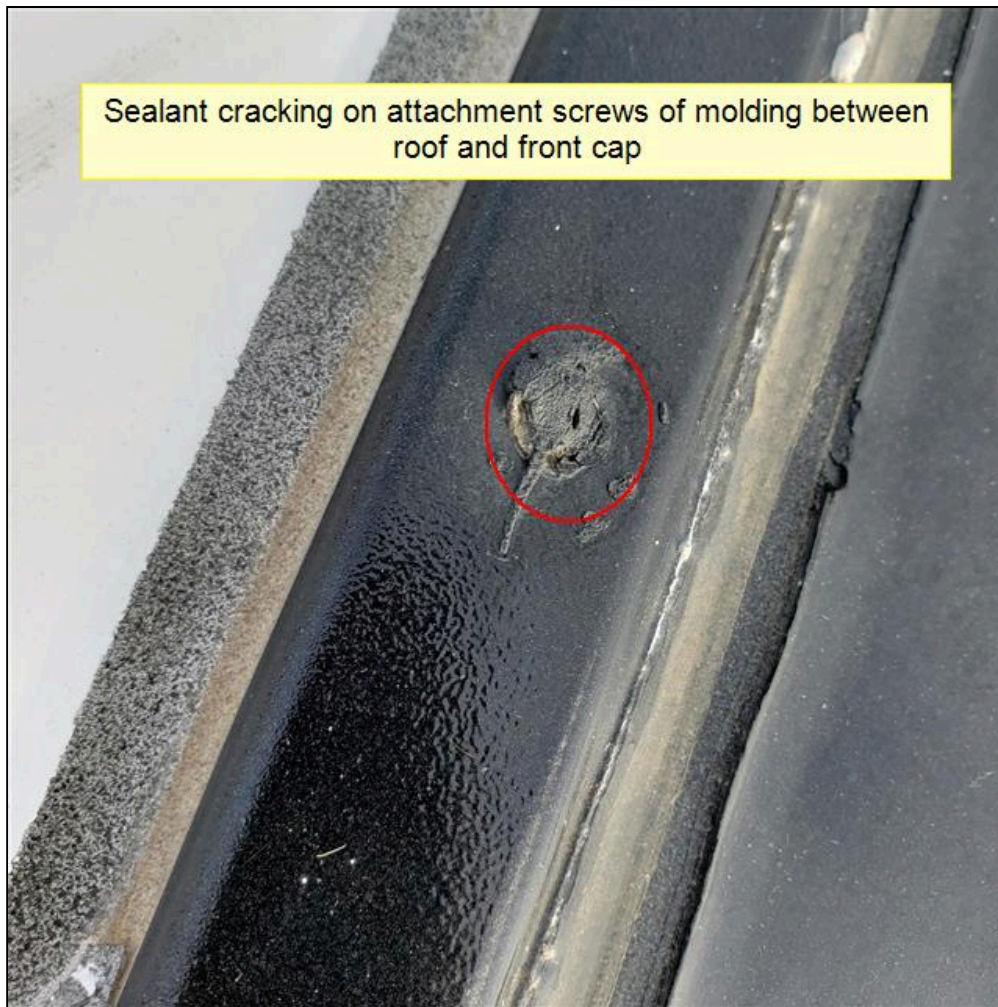
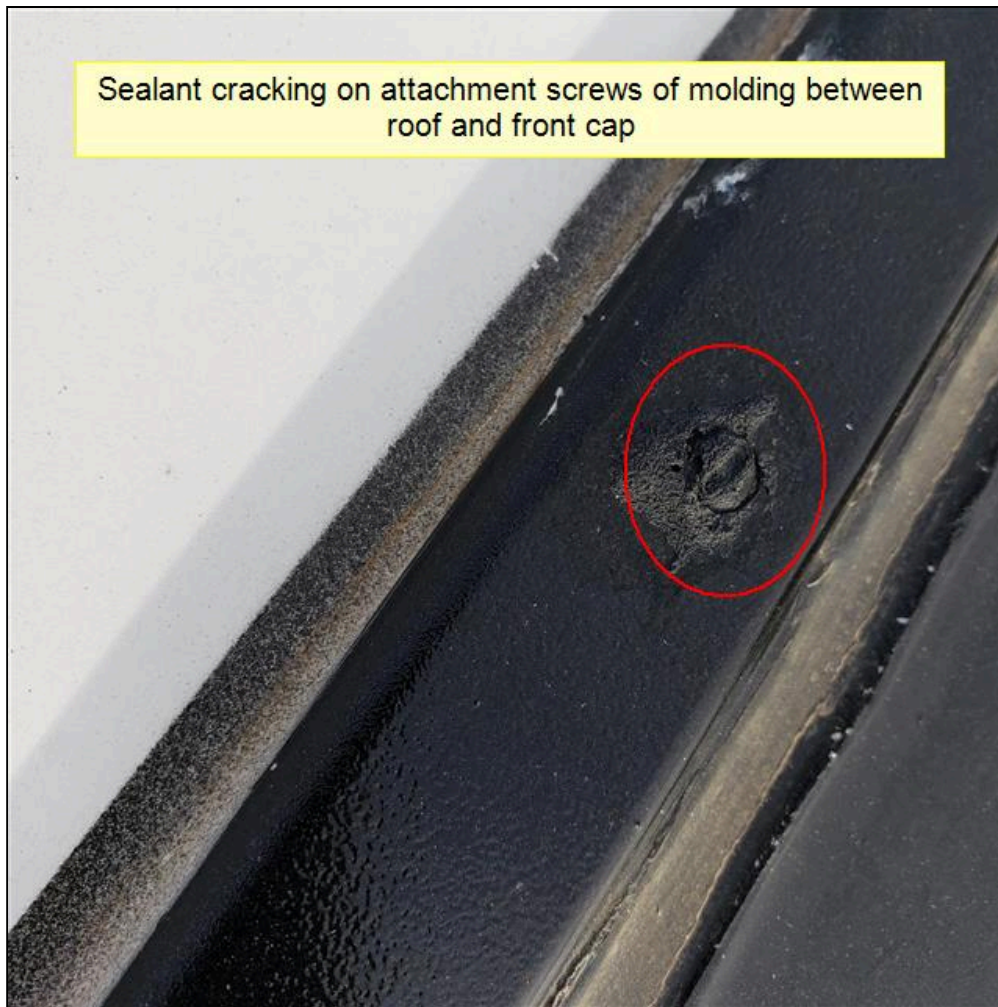
Sealant along left and right corners and joint molding screws is cracking. Reseal areas to prevent water intrusion.

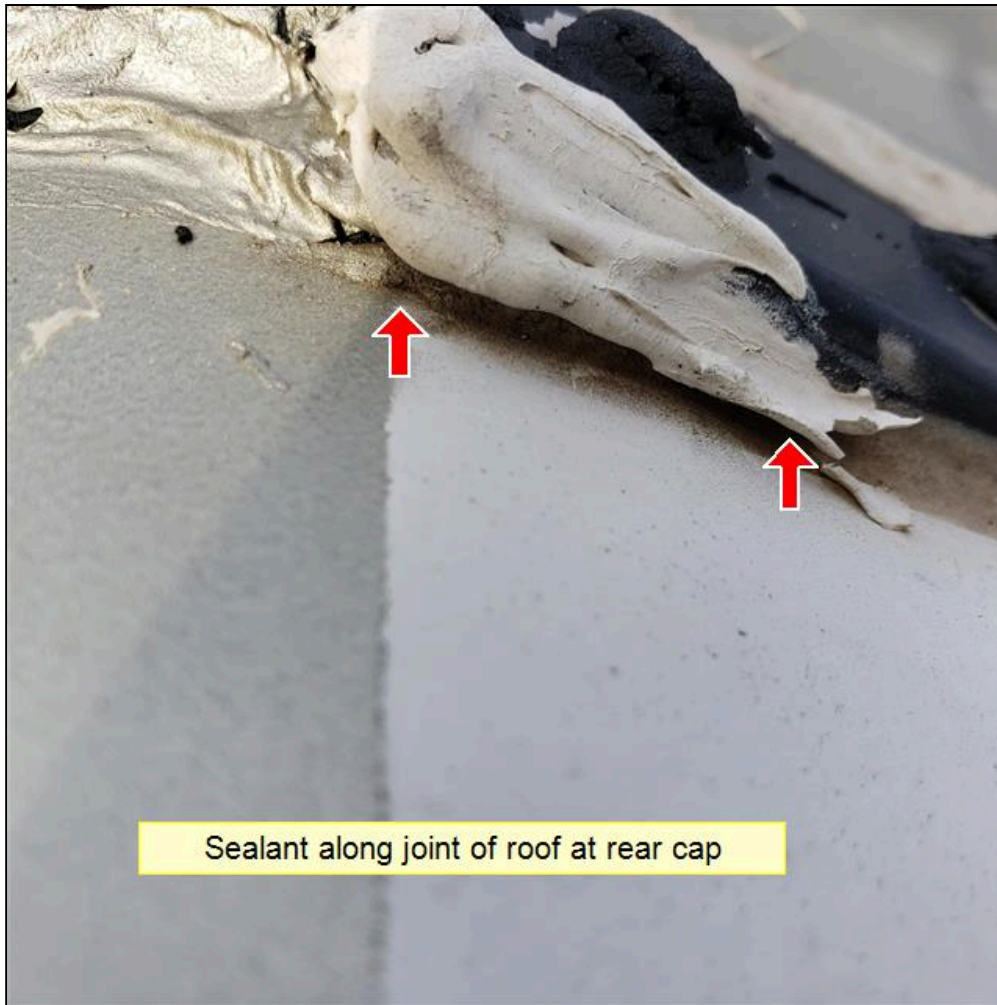
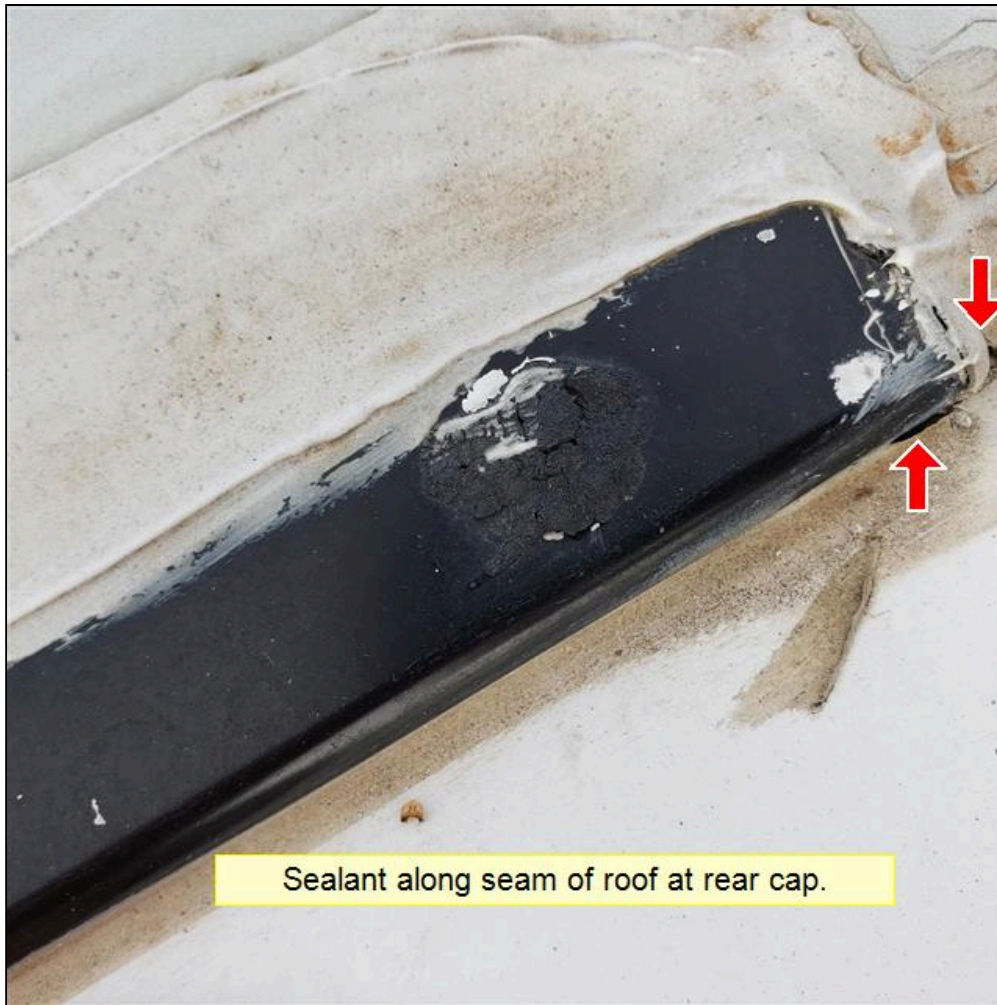
Sealant cracking at roof seam along rear cap at corners and along edge

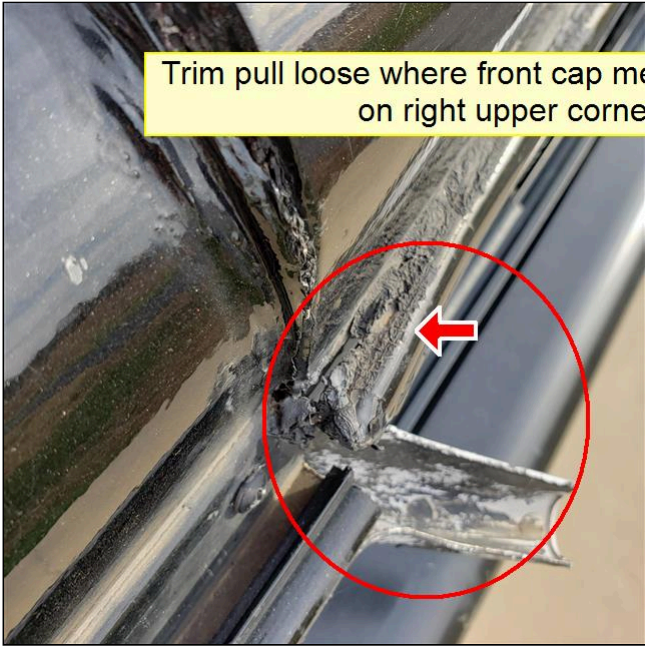
Trim along right front upper corner pulling loose. Reattach trim and reseal.

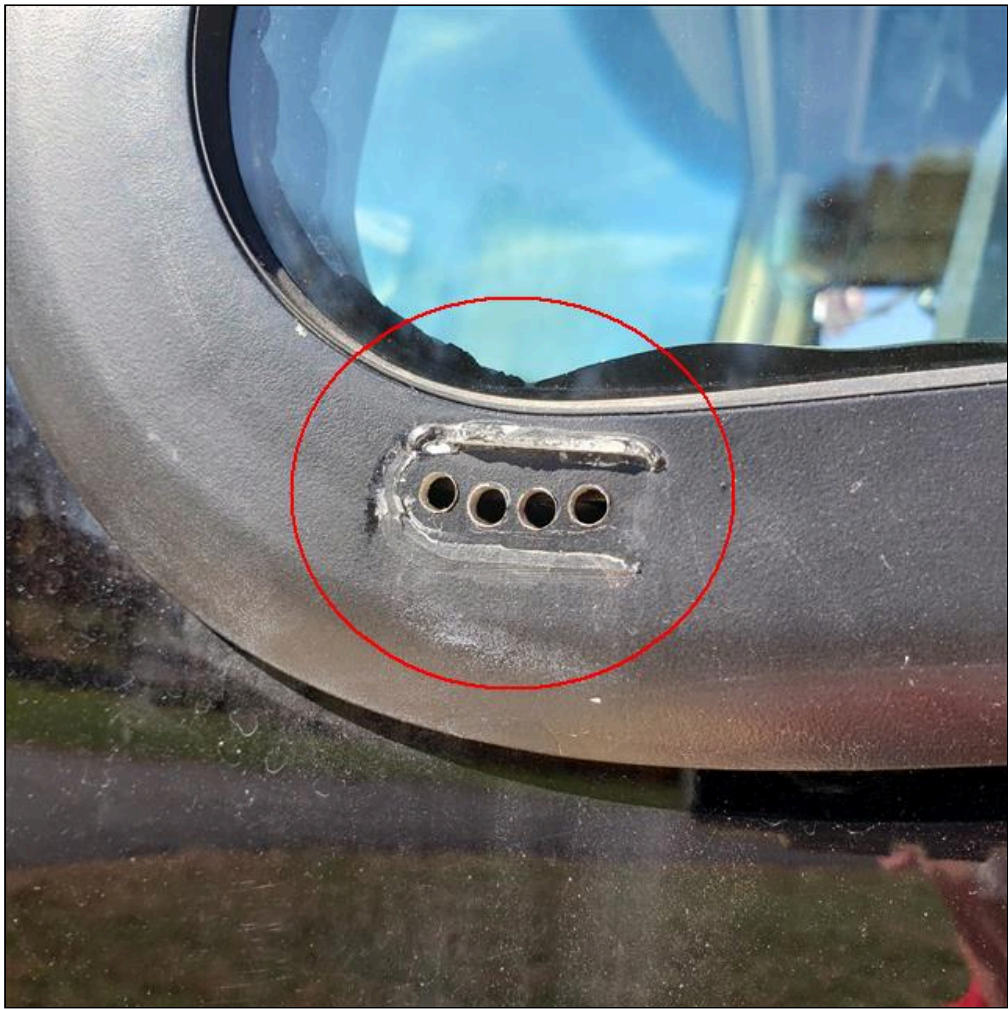
Driver side window has holes that should be sealed to prevent water/air intrusion

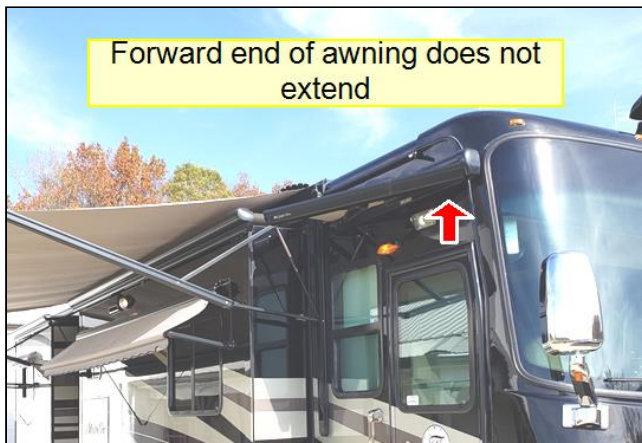
Door awning does not extend properly.

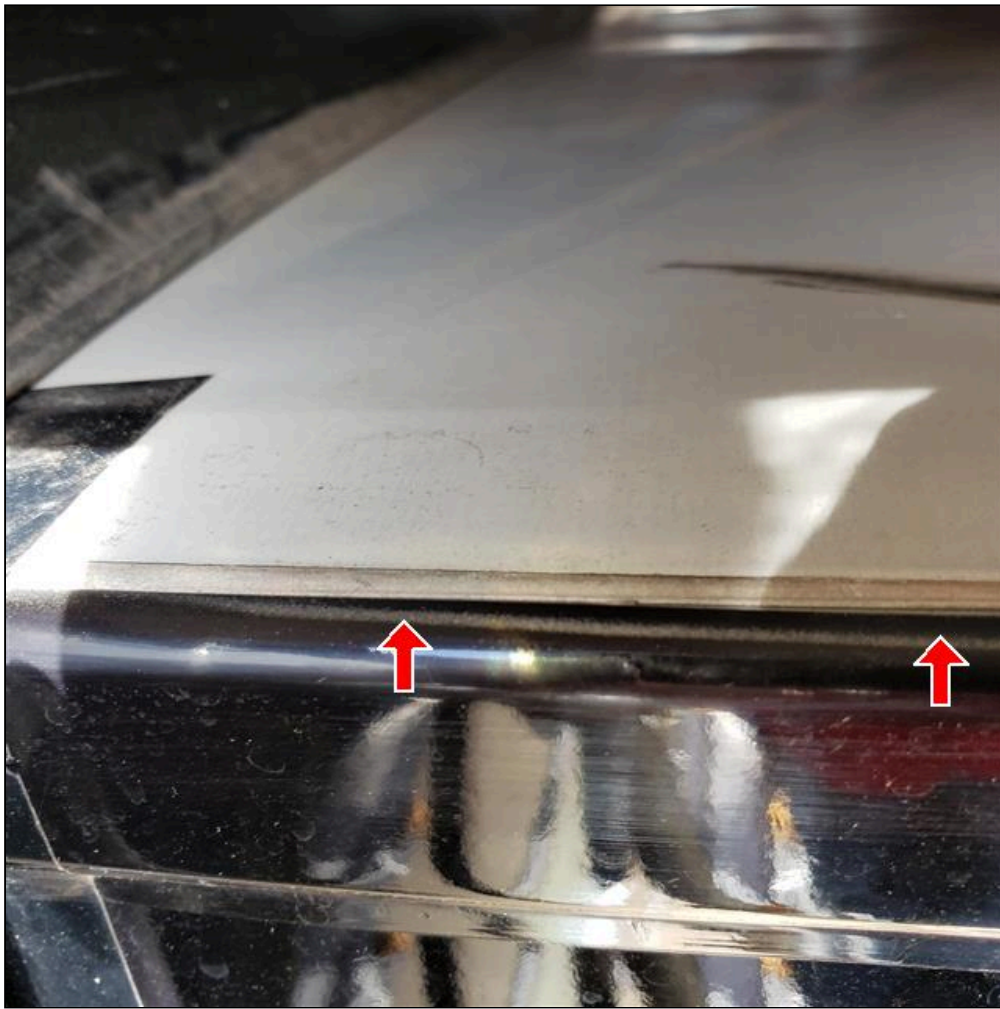
7.0.B Slideout Roof
Acceptable

Small gap in sealant on forward edge of roof.

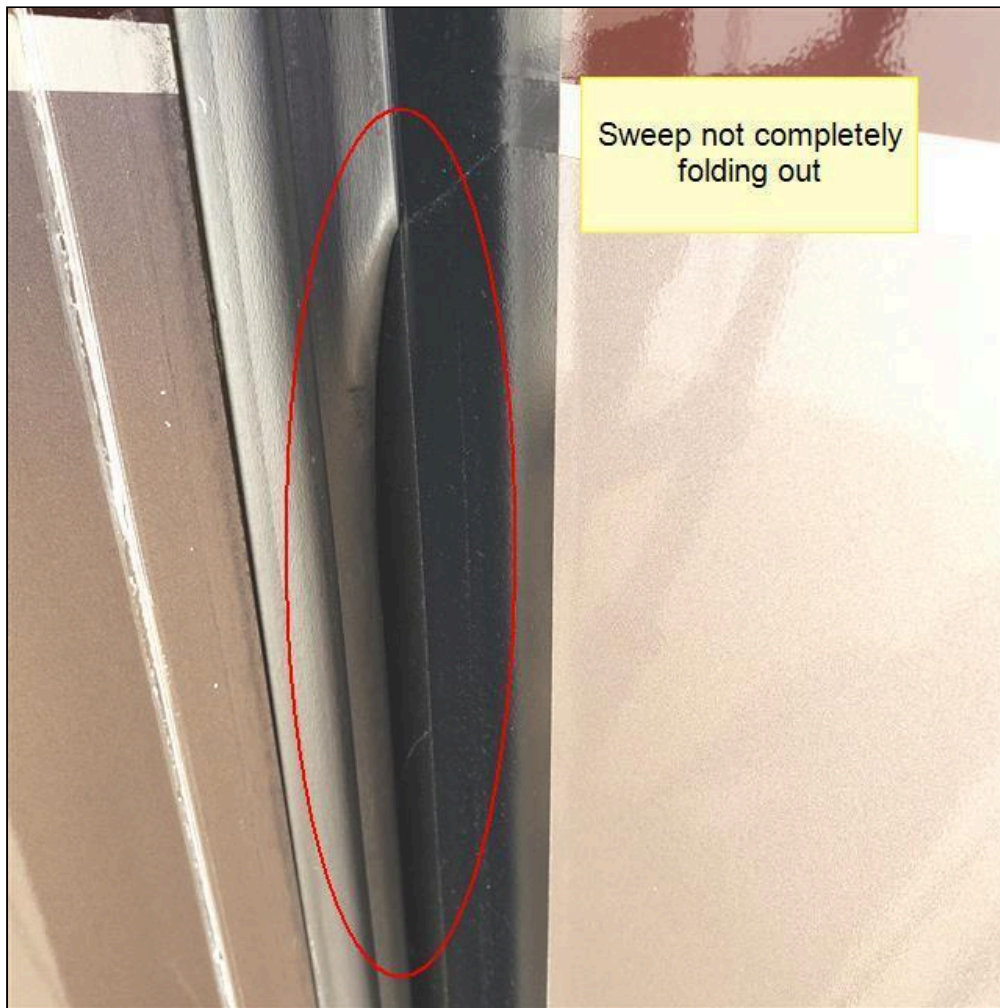
- 7.0.C Slideout Roof**
Acceptable
- 7.1.C Slideout T-Molding Trim**
Acceptable
- 7.2.C Seals, Sweeps and Gaskets**
Acceptable

Clean and lubricate sweeps to fold in and out easily

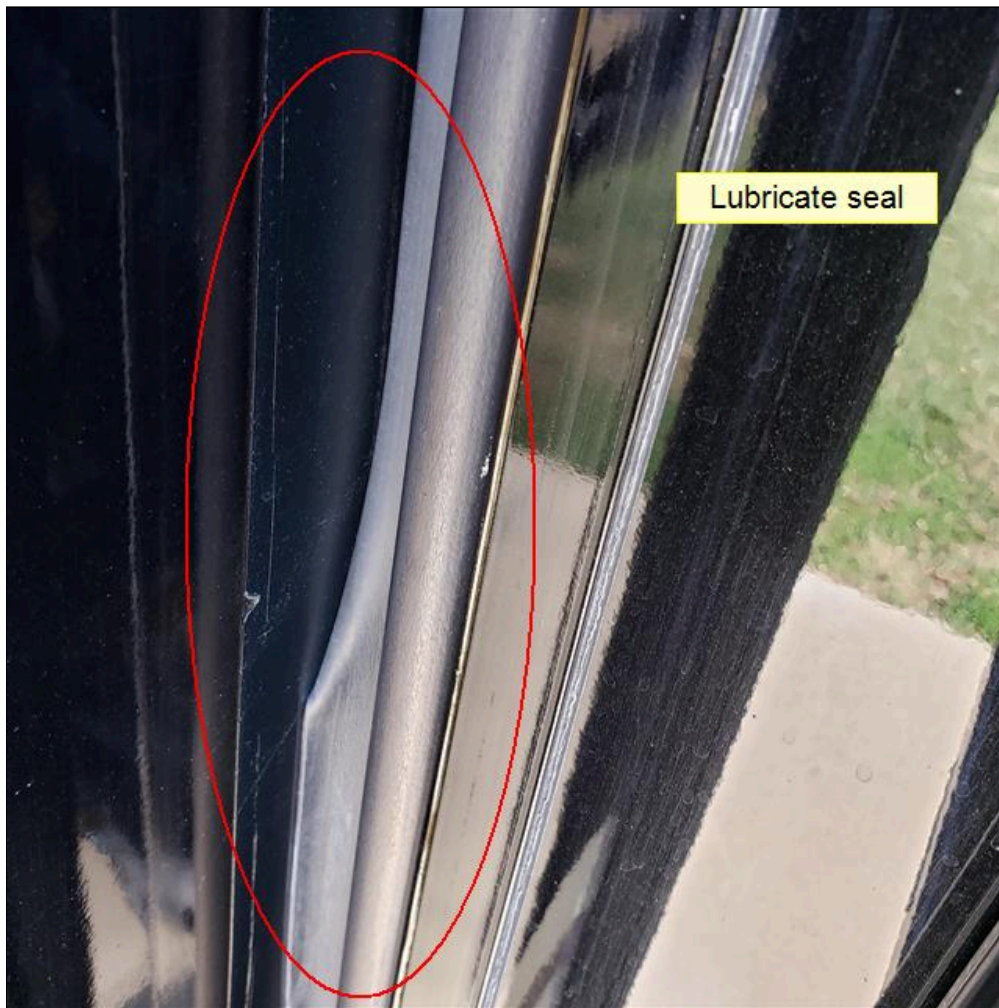
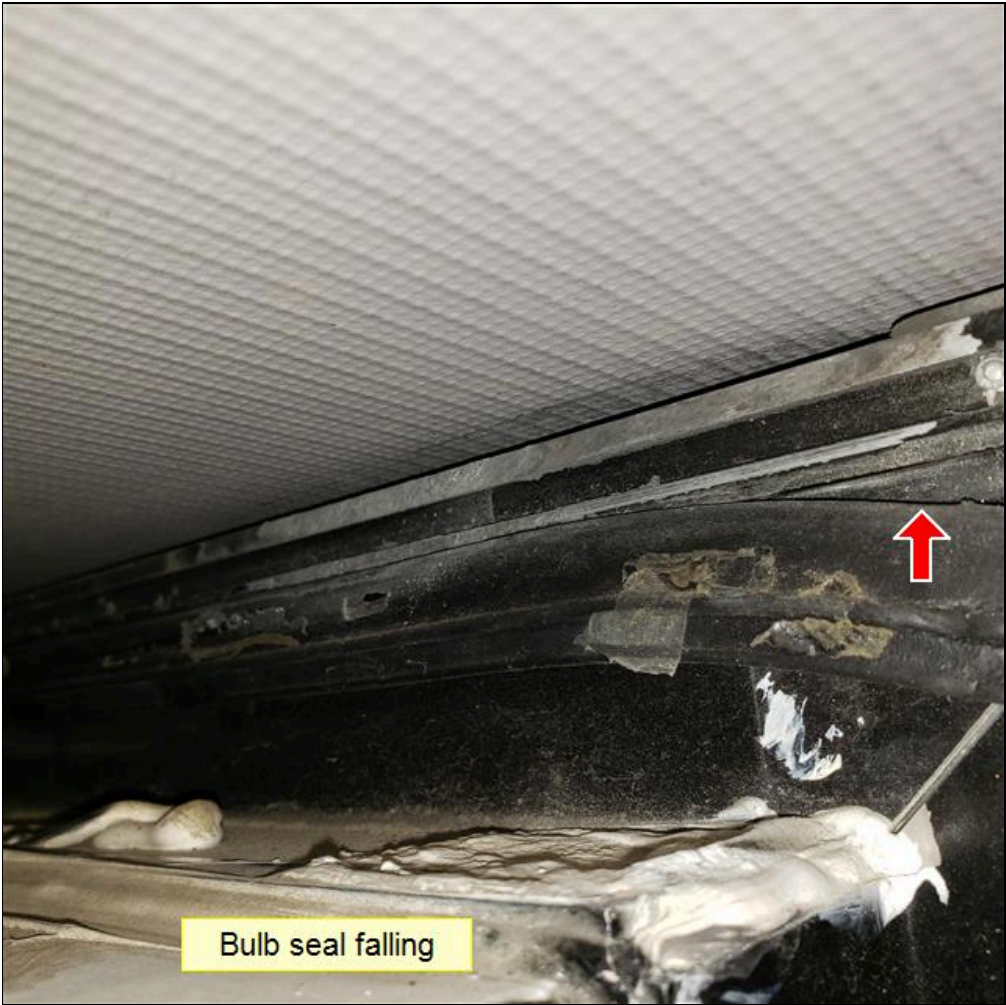
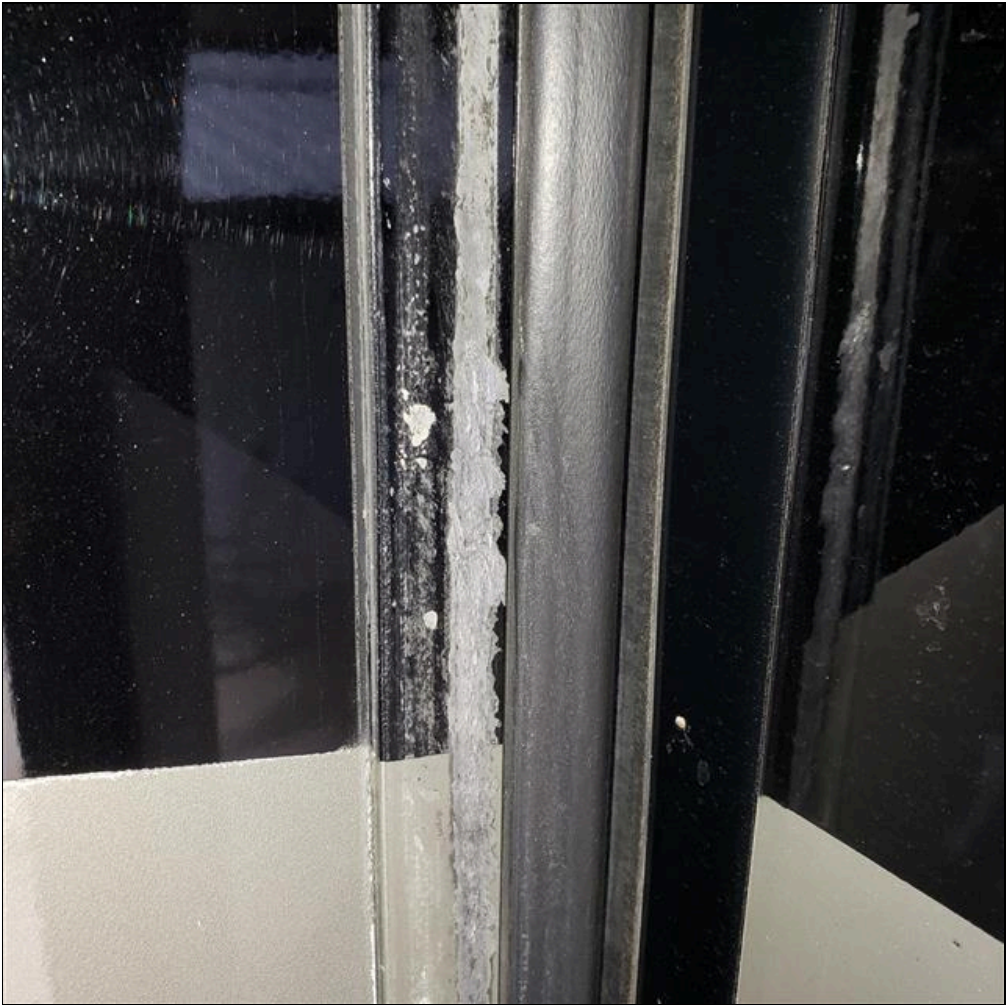
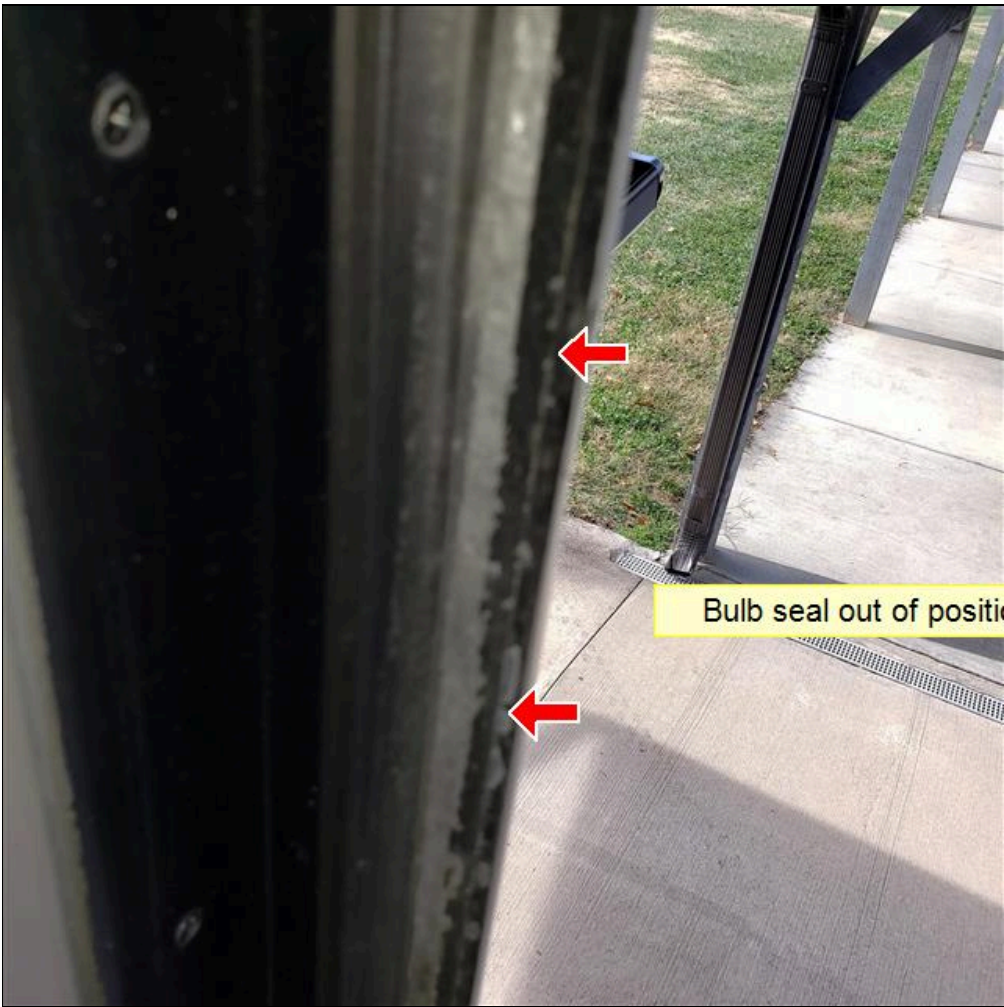
- 7.0.D Slideout Roof
Acceptable
- 7.1.D Slideout T-Molding Trim
Acceptable
- 7.2.D Seals, Sweeps and Gaskets
Fair

Bulb seal out of position along rear edge and roof. Lubricate sweep to properly fold in and out

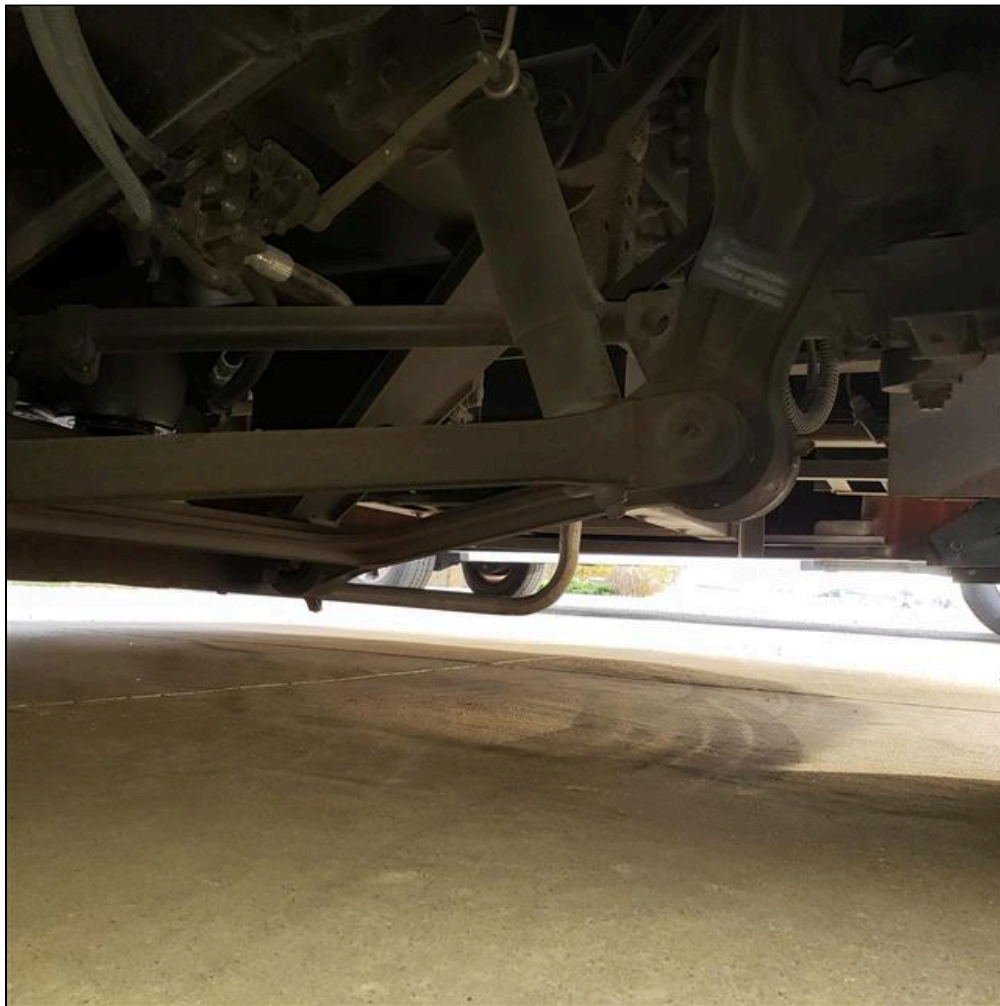
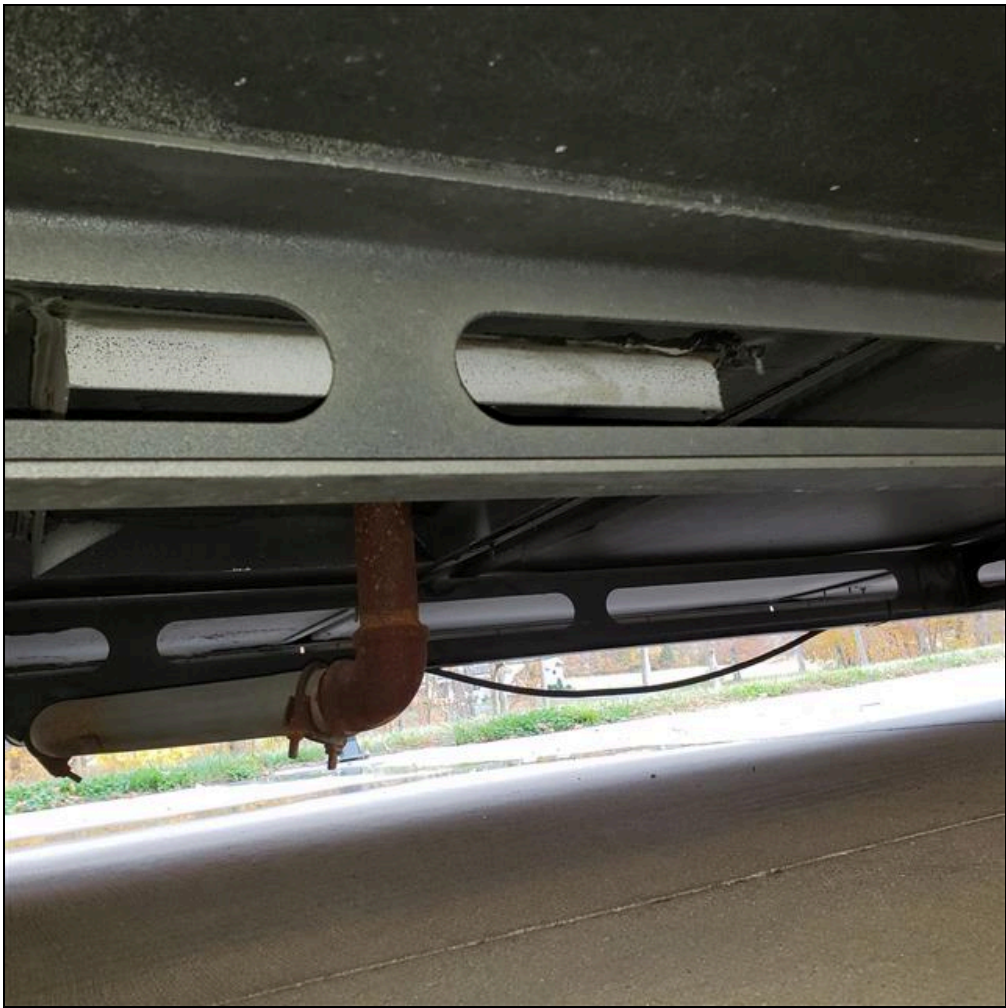
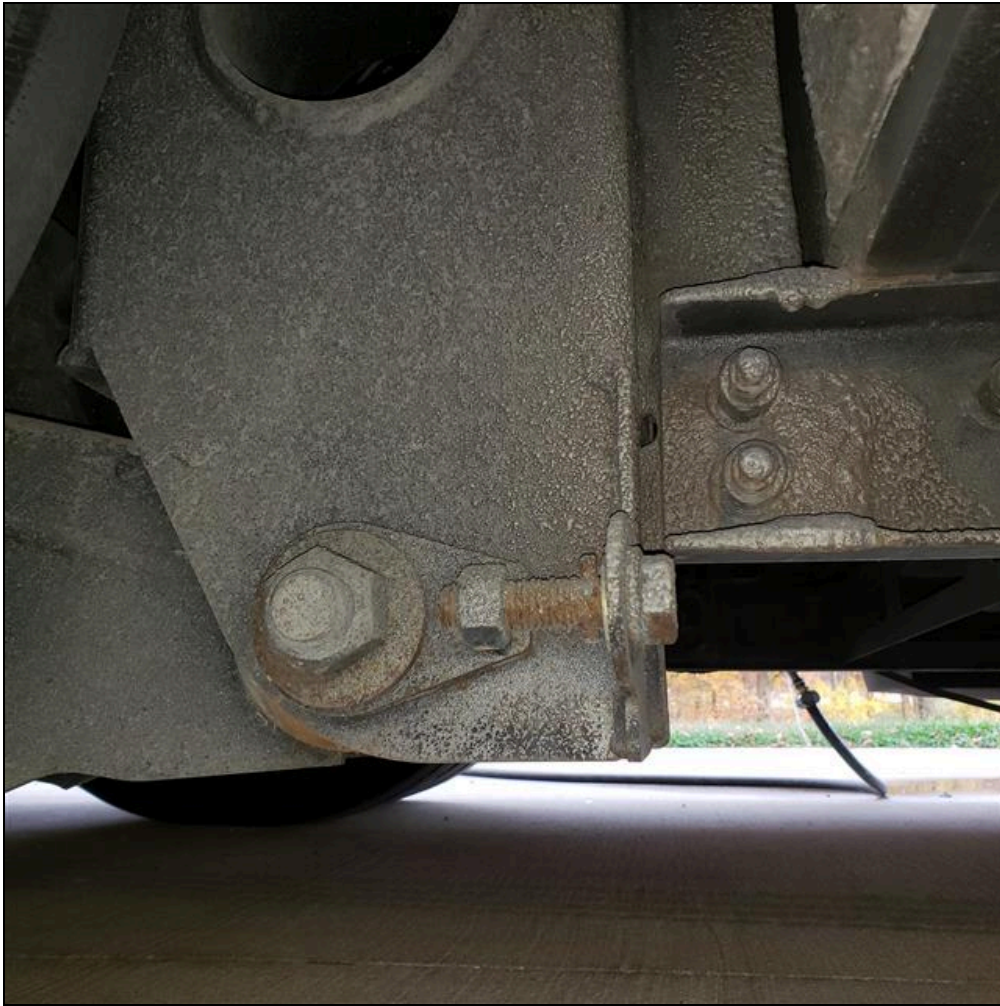
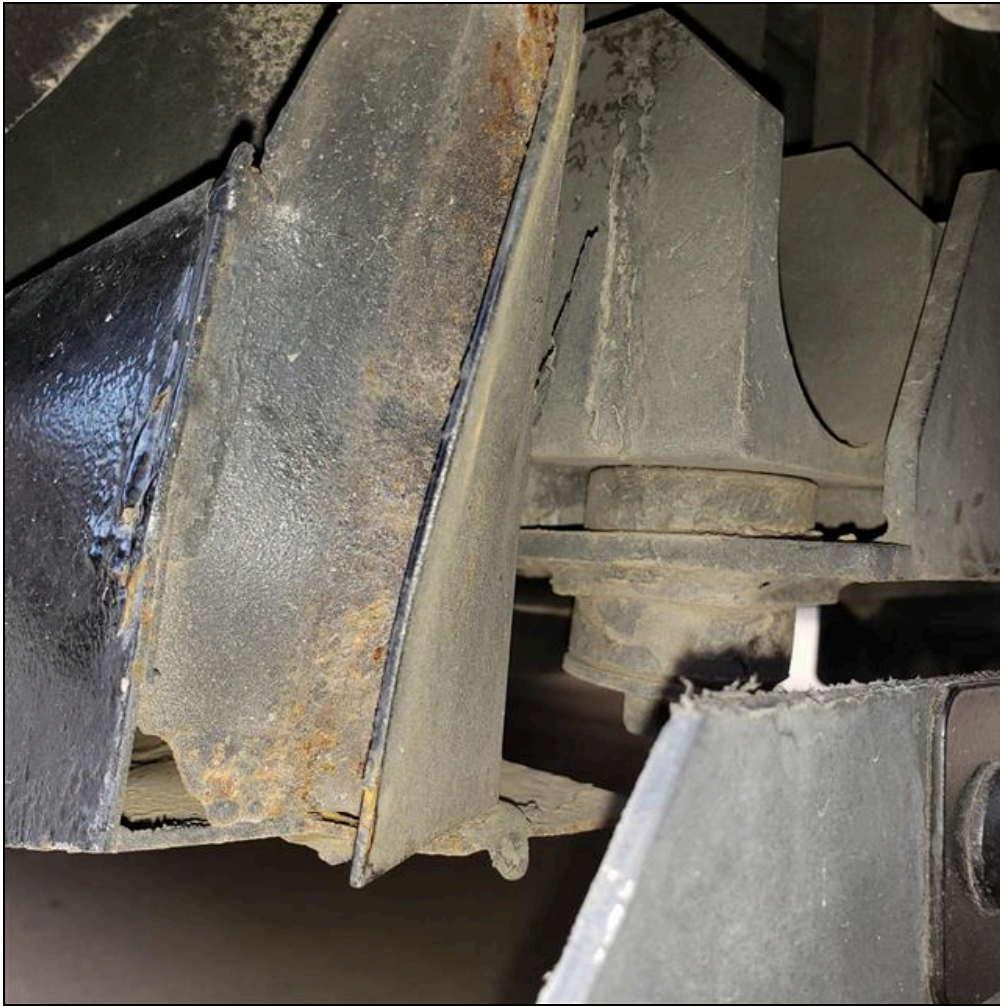
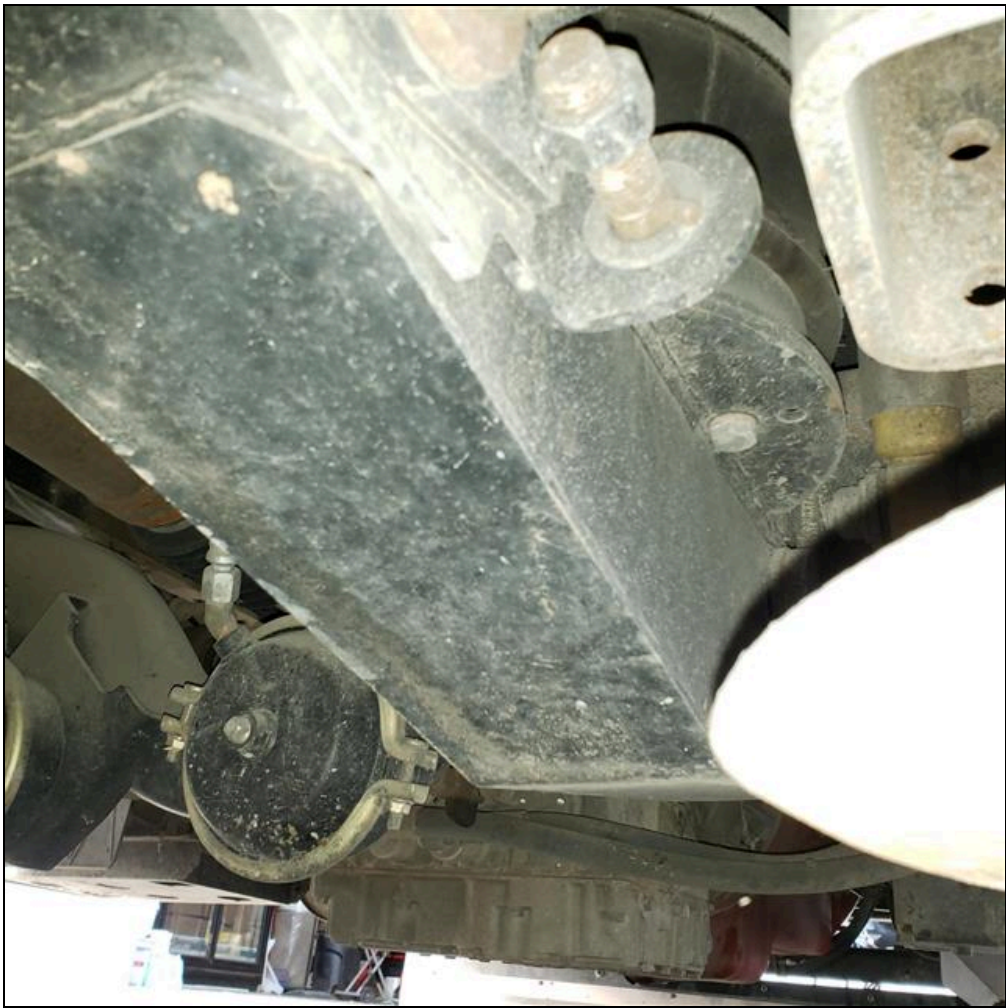
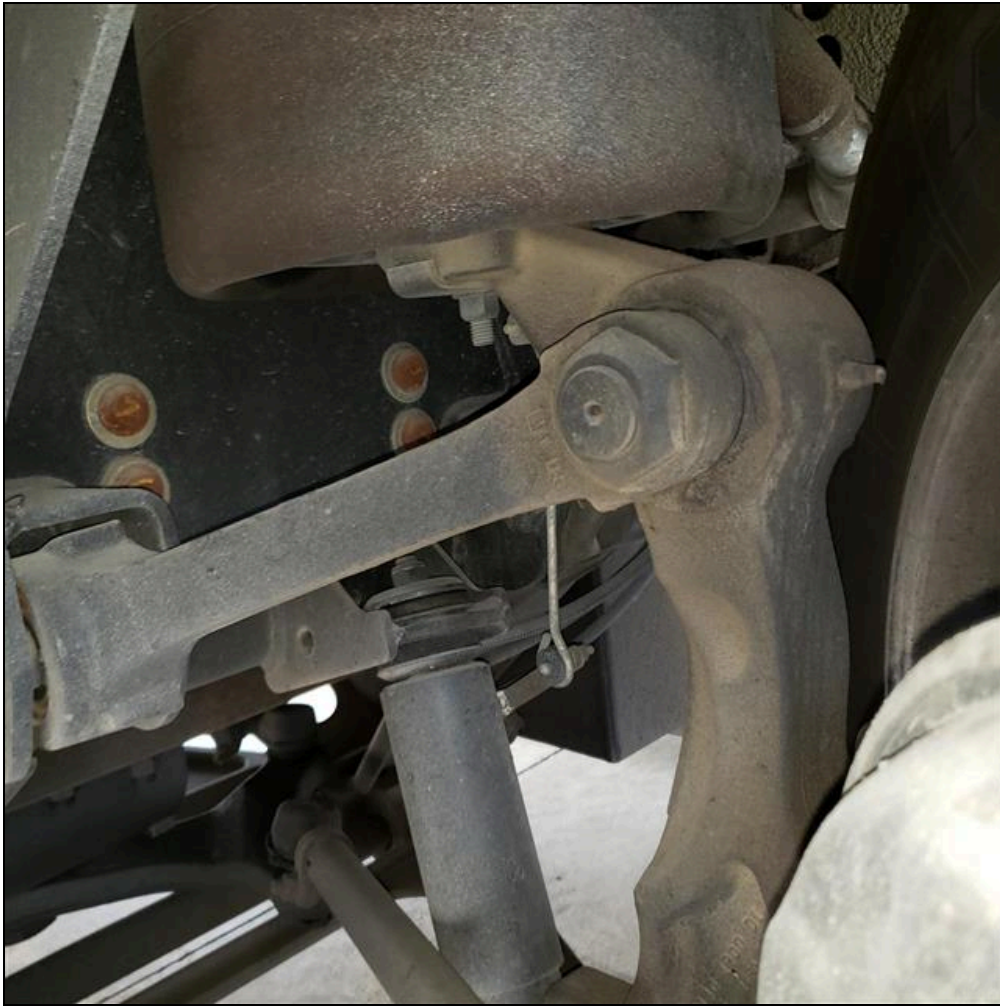
Chassis and undercarriage are in good condition. No damage or previous repairs were noted. Minor surface rust noted on rear engine sub-frame. Front tie rods show excessive wear, see inspection items

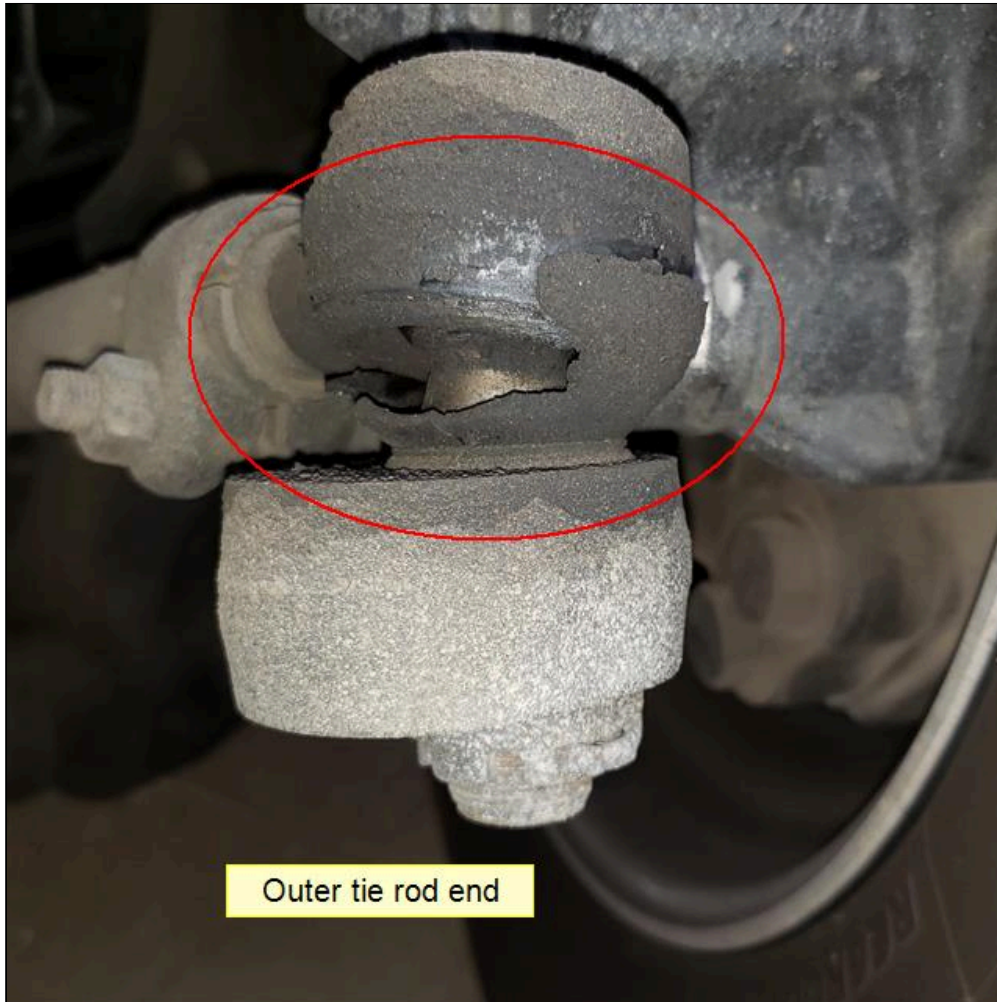
Fair

Front inner and outer tie-rod end boots dry rotted and broken require replacement
