Inspection Report

Property Address:
2711 Claypool-Alvaton Rd
Bowling Green KY 42103

Foremost RV Inspections

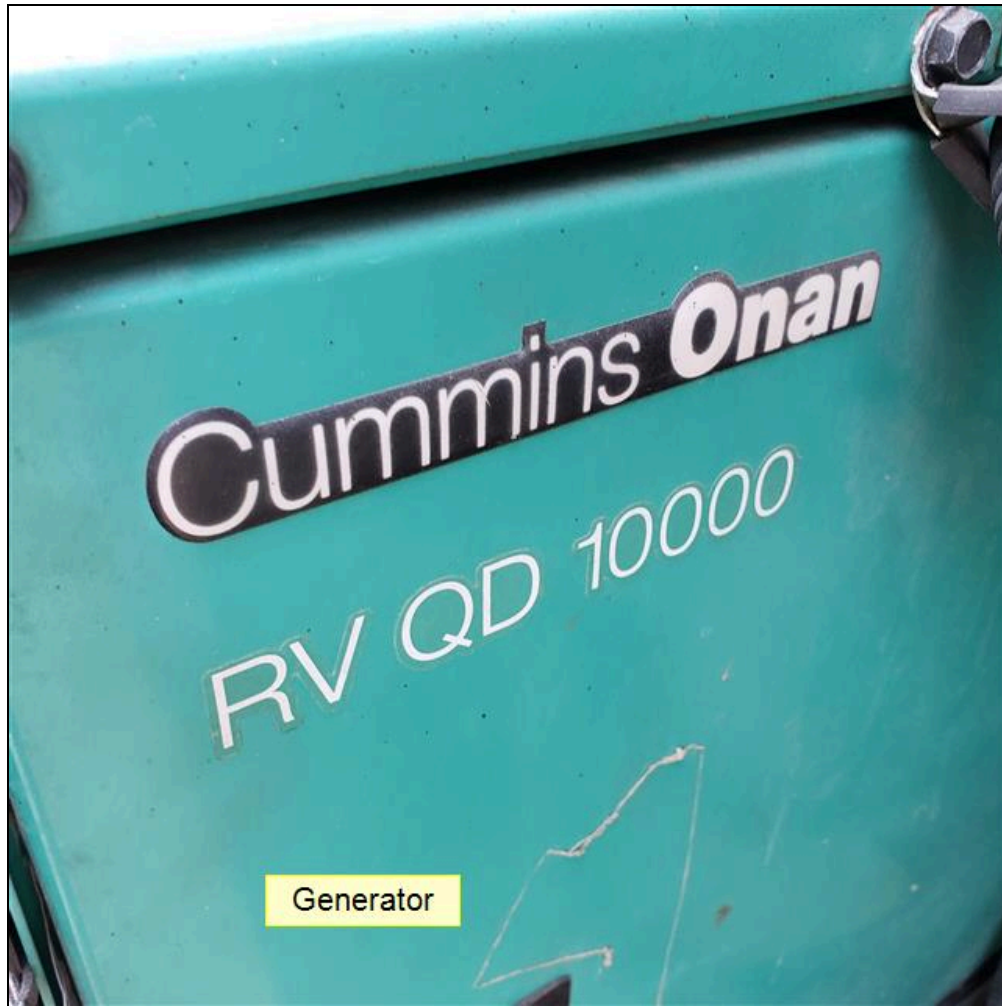
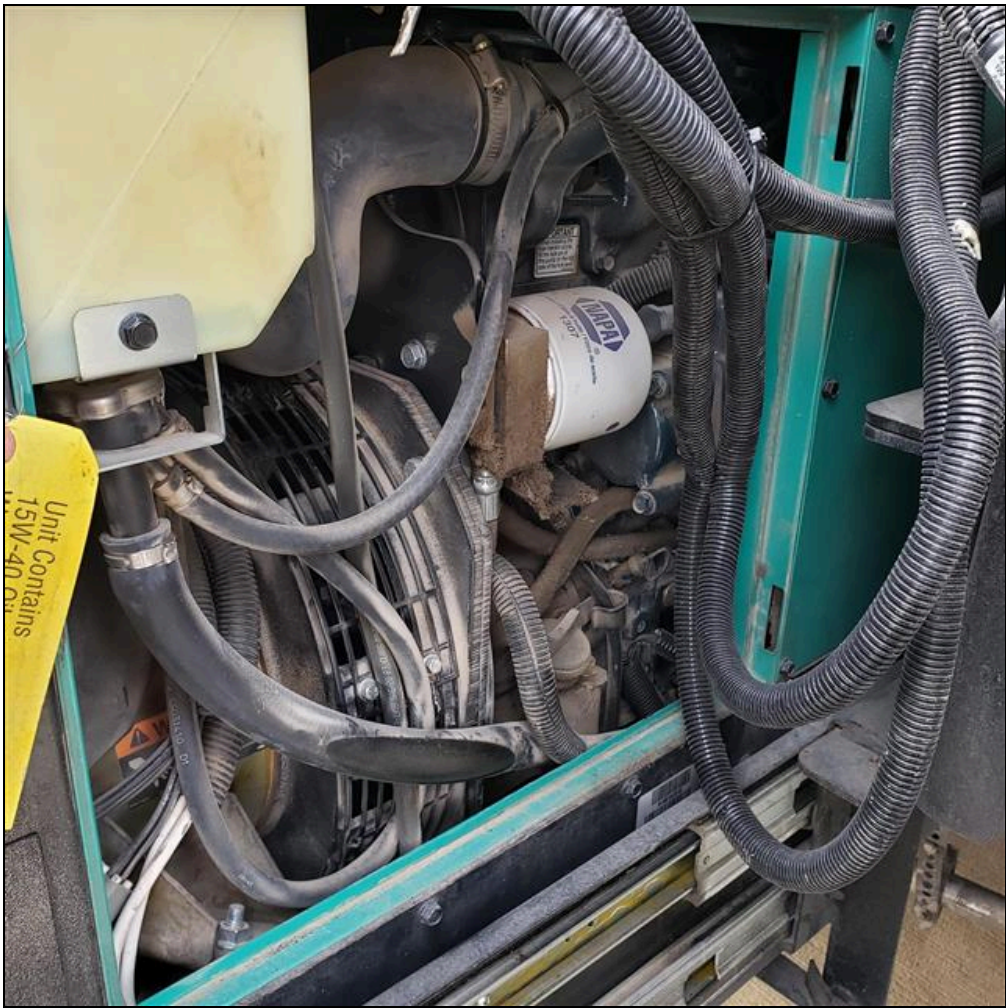
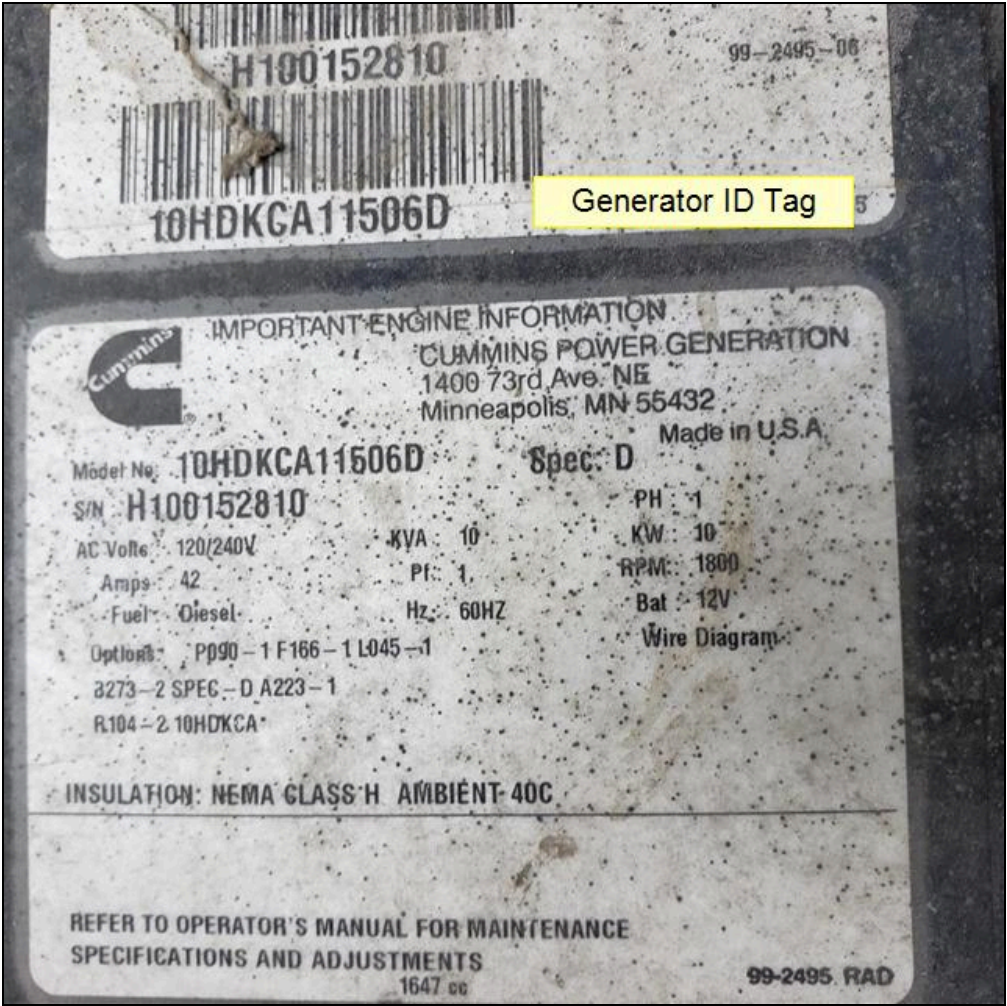
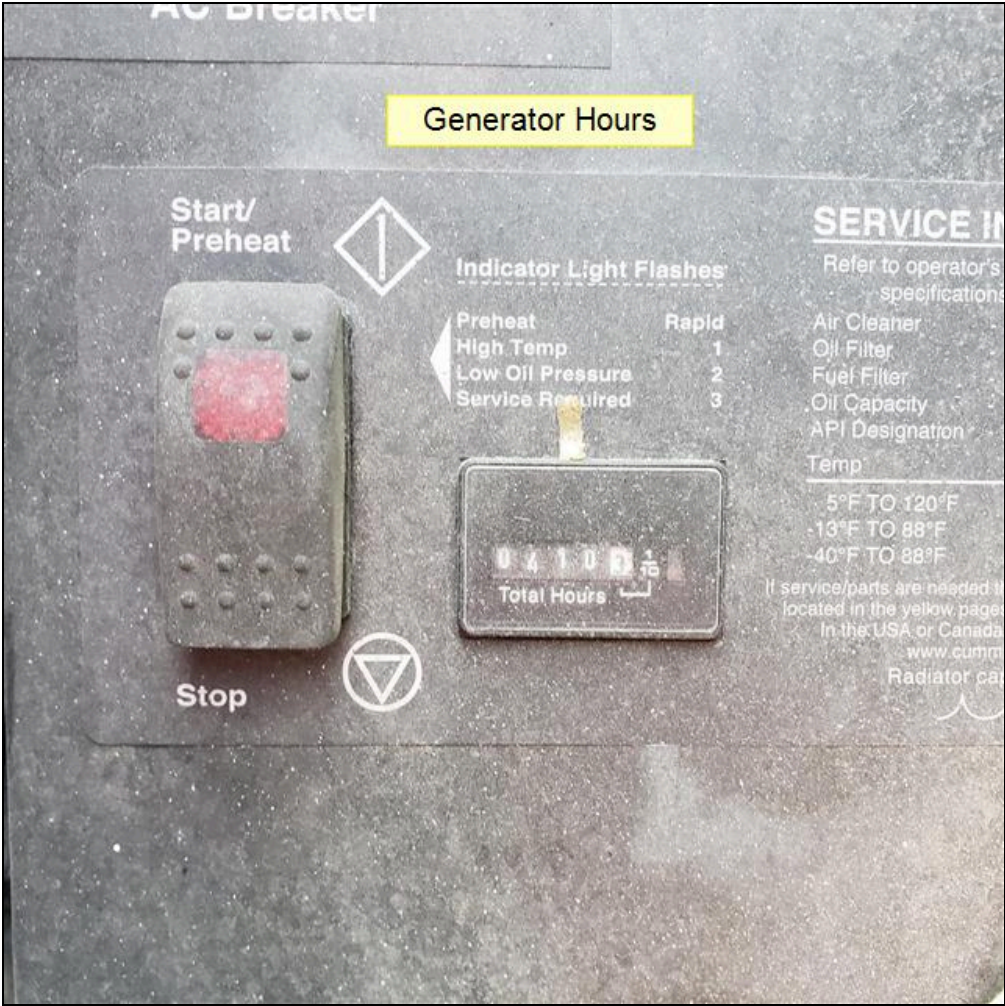
All 12-volt systems operated appropriately. 120-volt electrical systems were checked under shore power and generator in both static condition and under load. All operated appropriately.

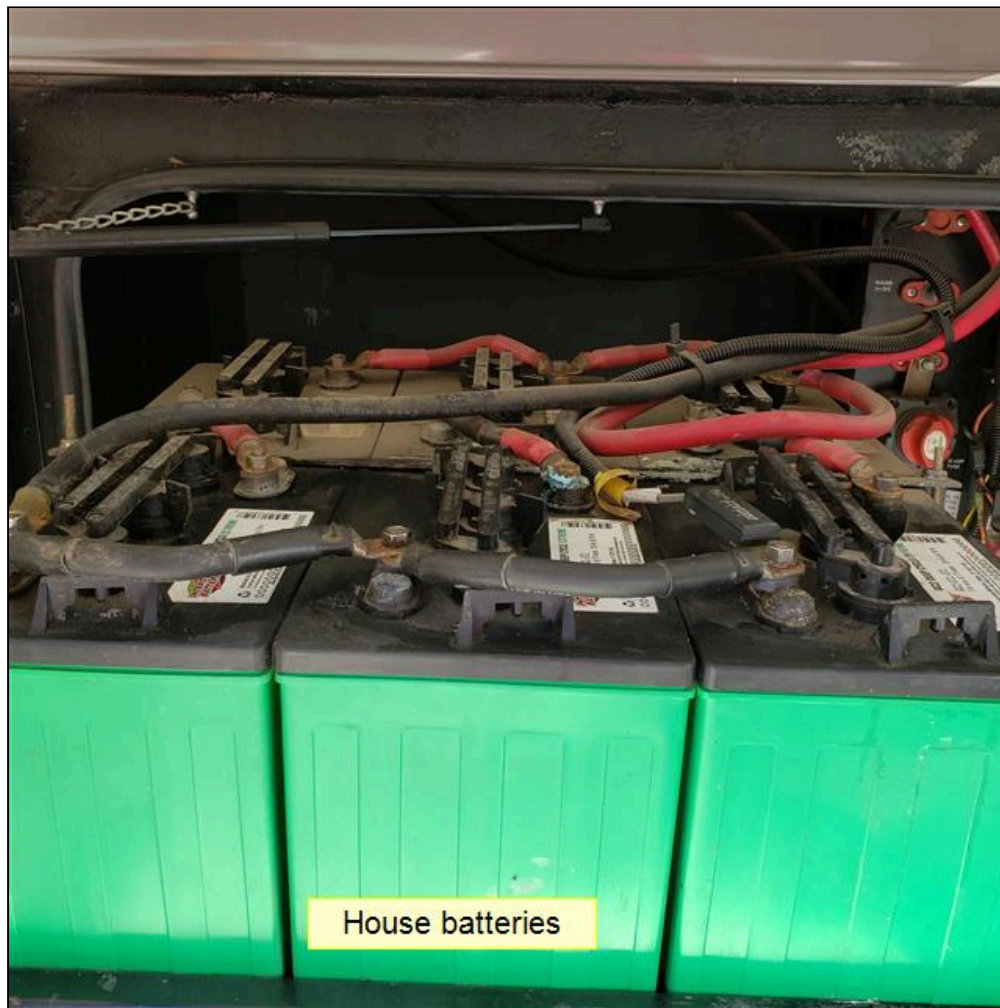
House batteries are 6-volt wired in parallel to obtain 12-volts,

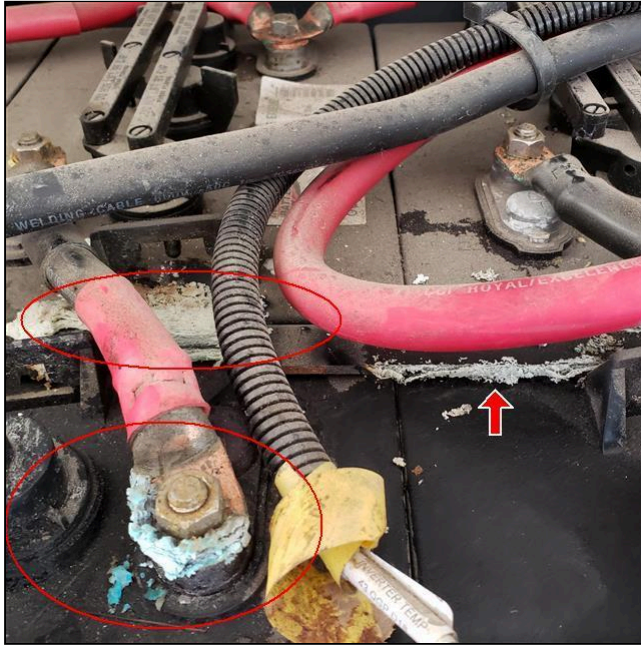
Some corrosion build up on cables. Clean and maintain for maximum performance. Bolt locking battery tray in place is loose and should be tightened.

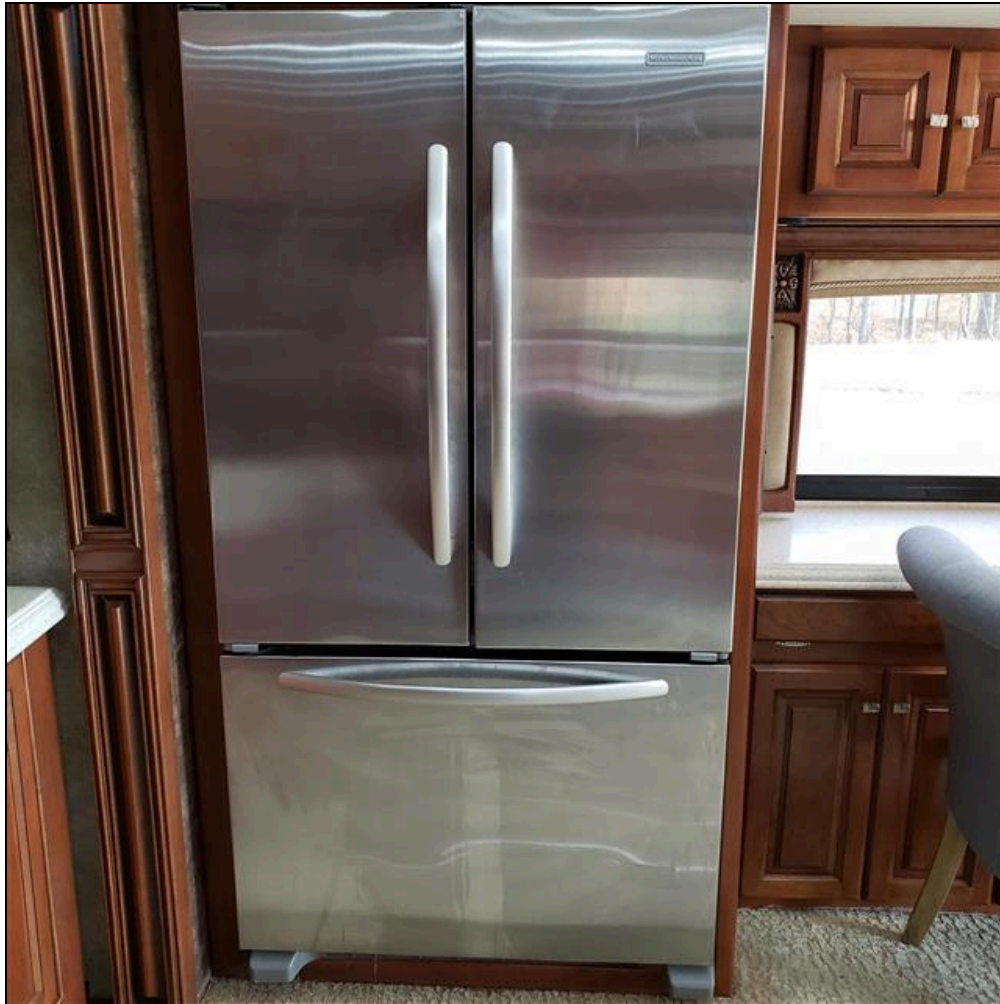
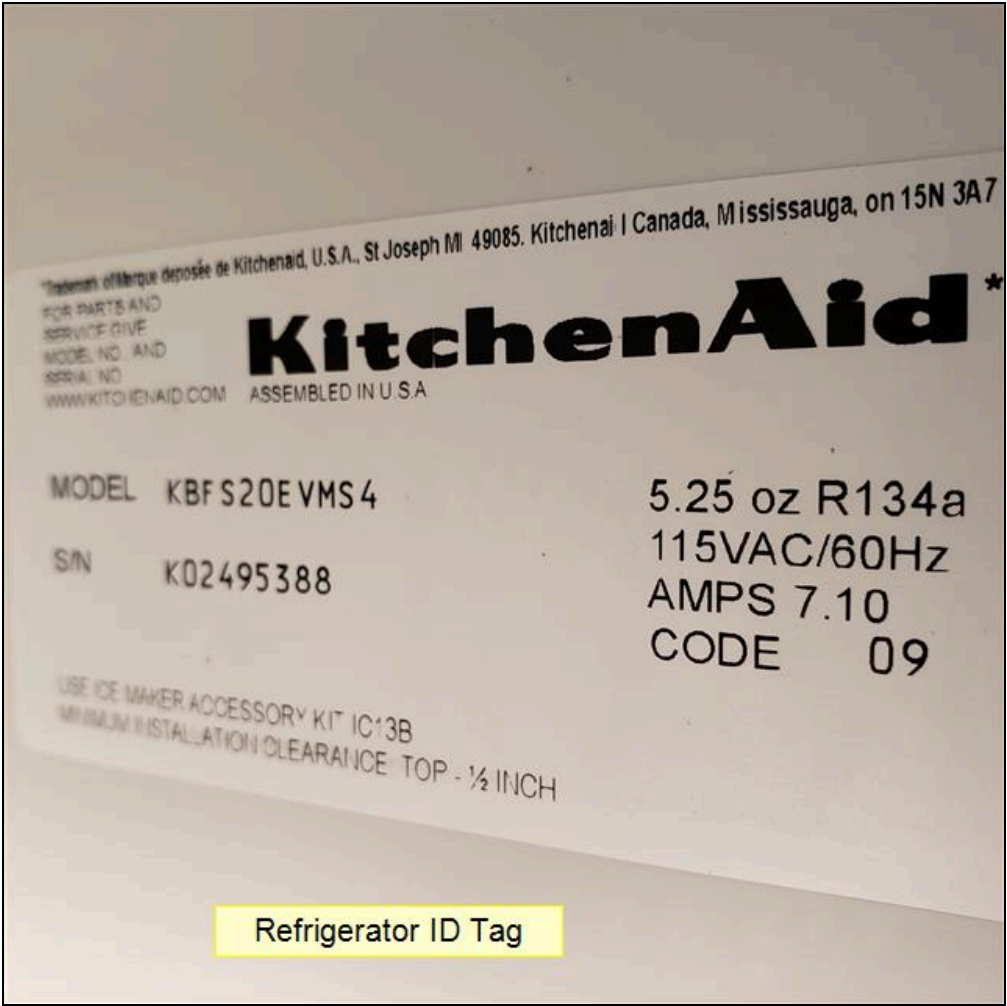
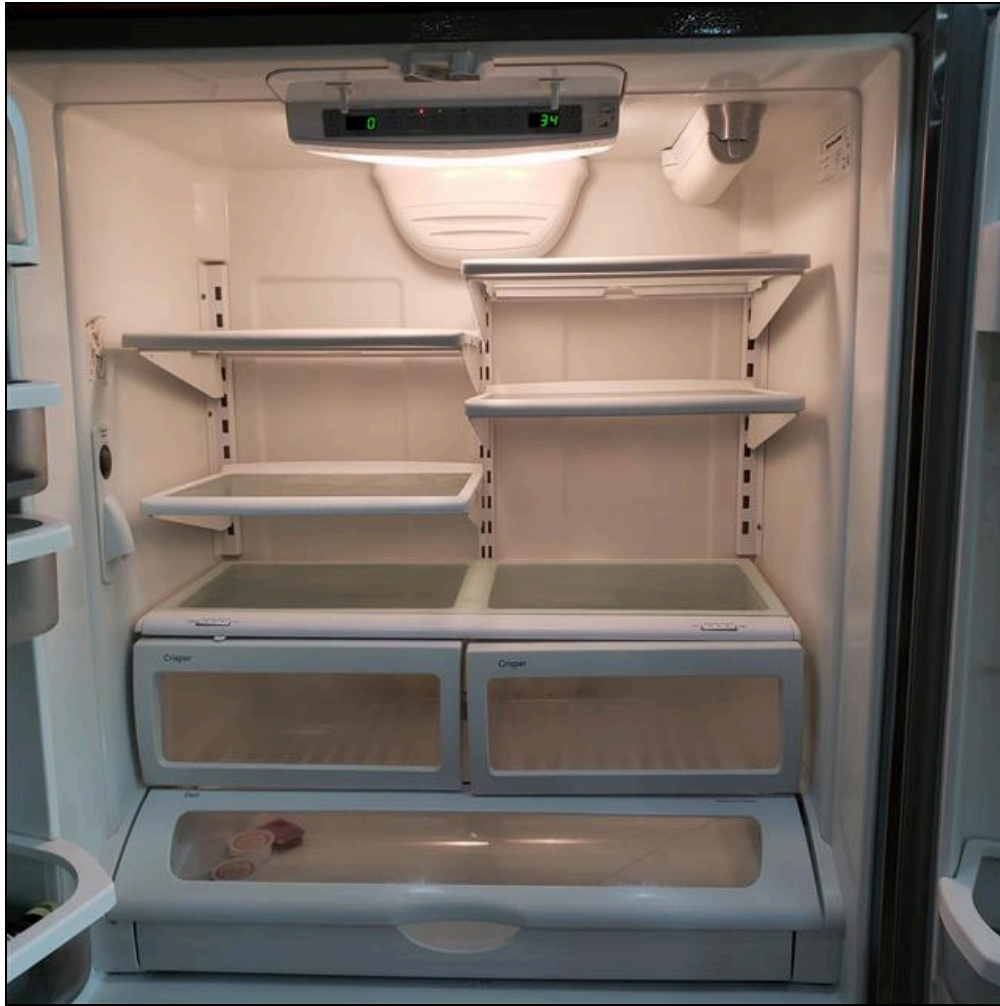
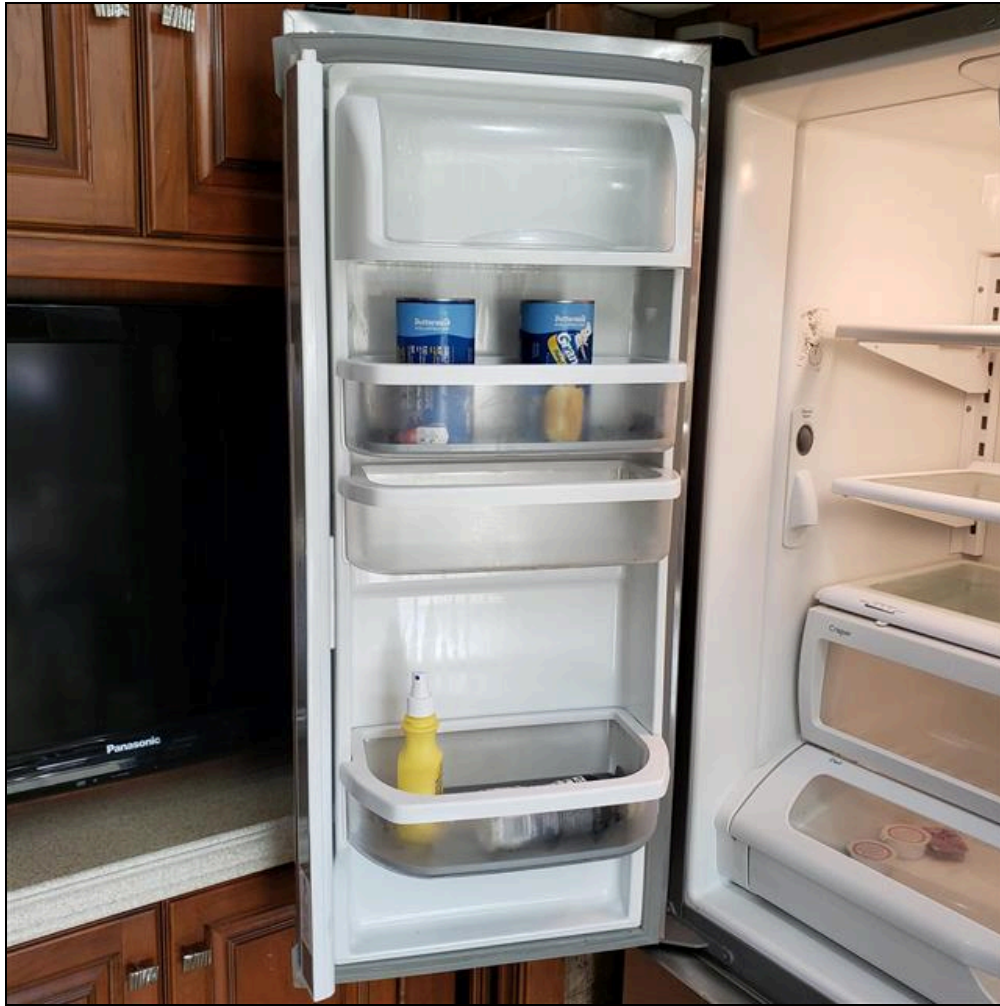
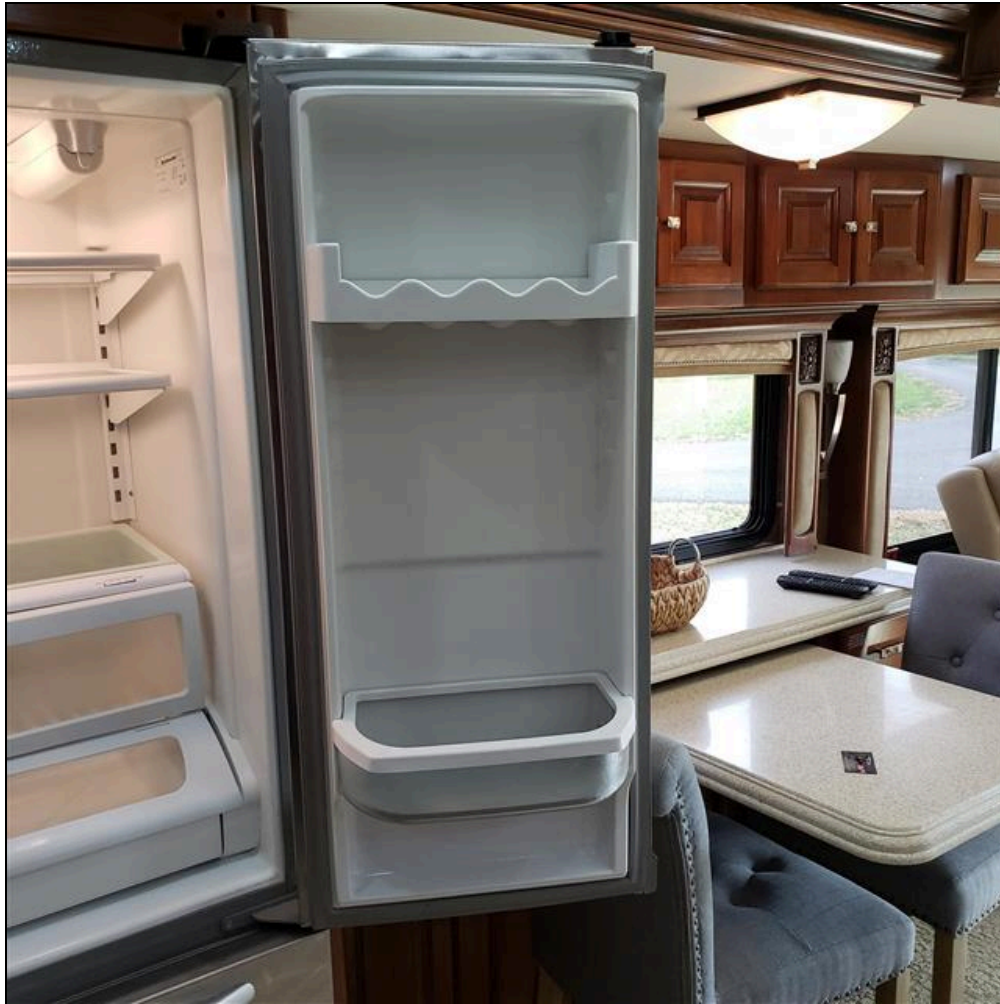
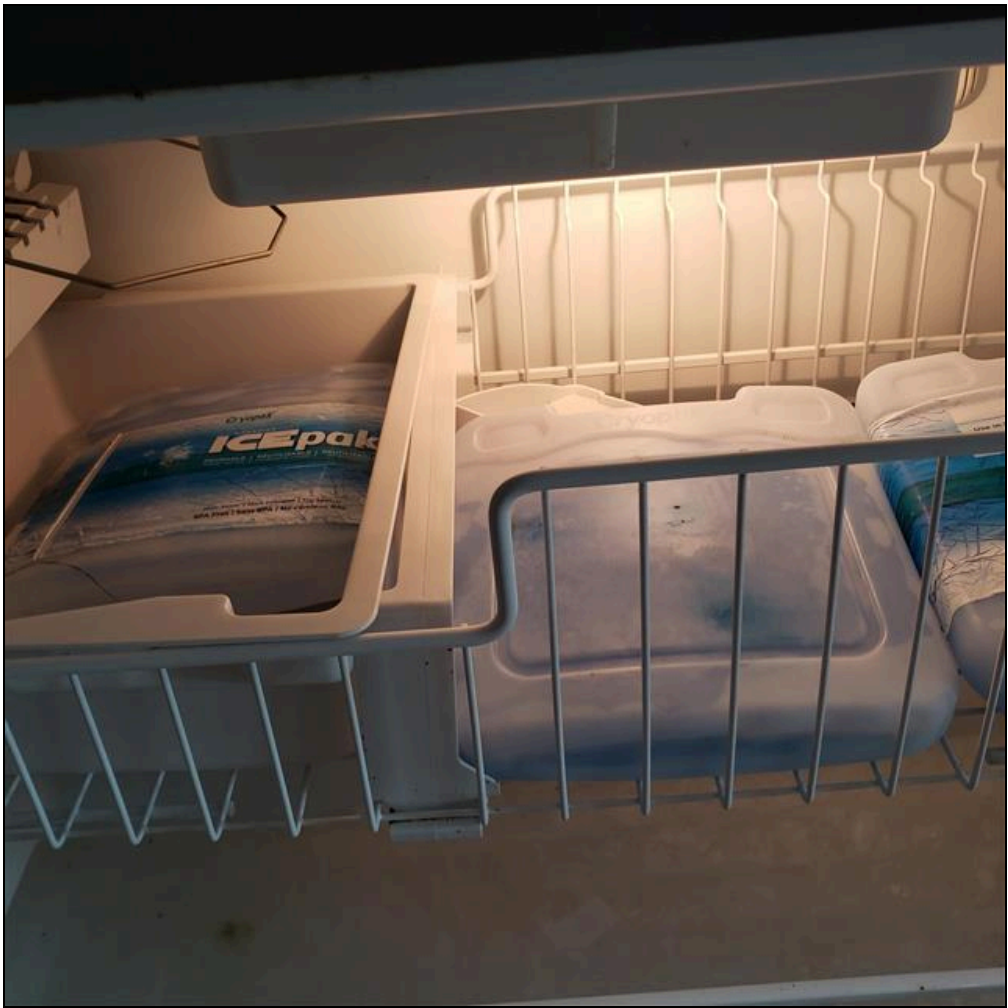
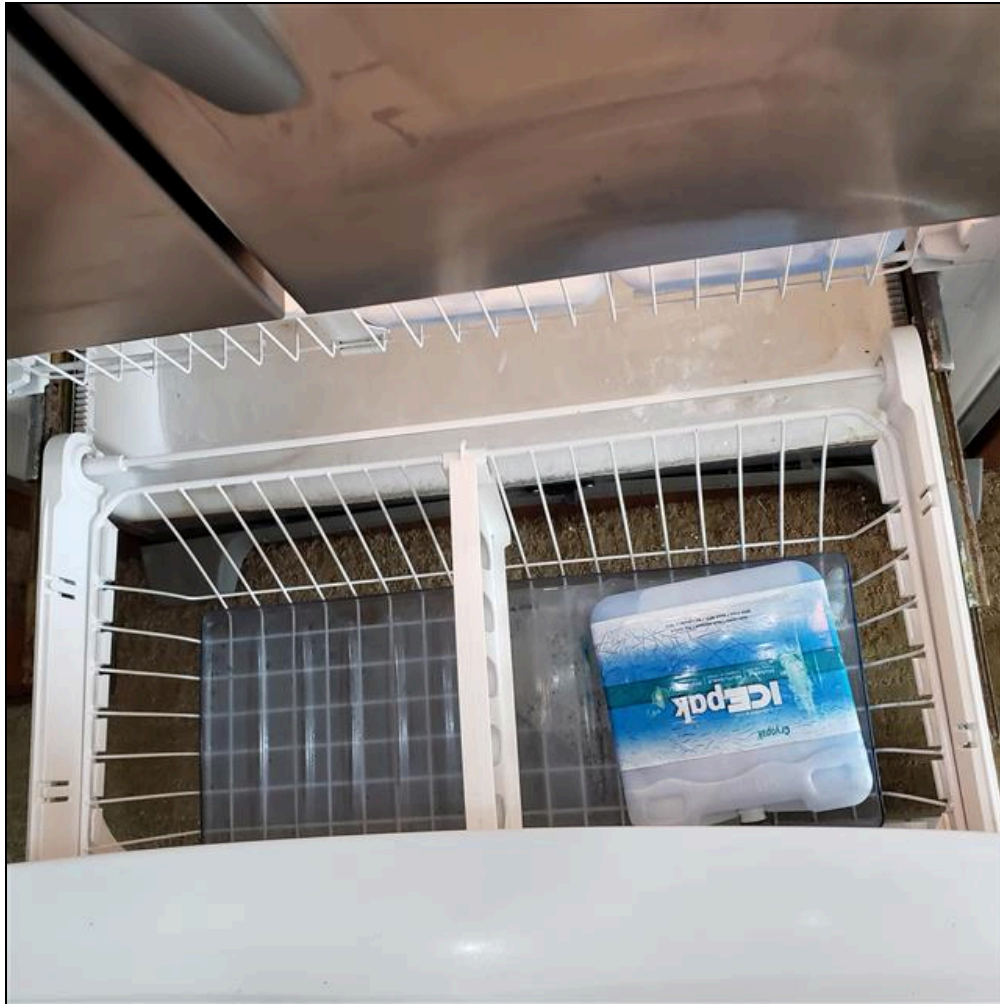
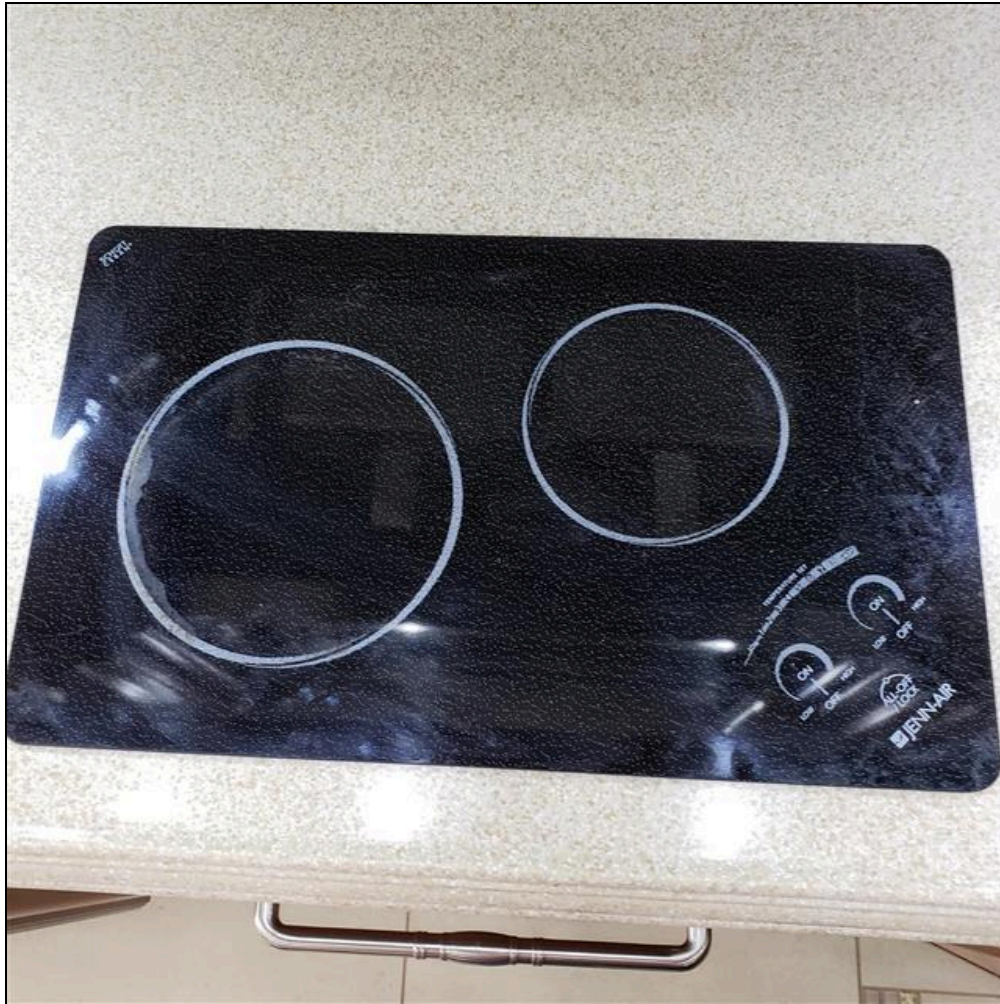
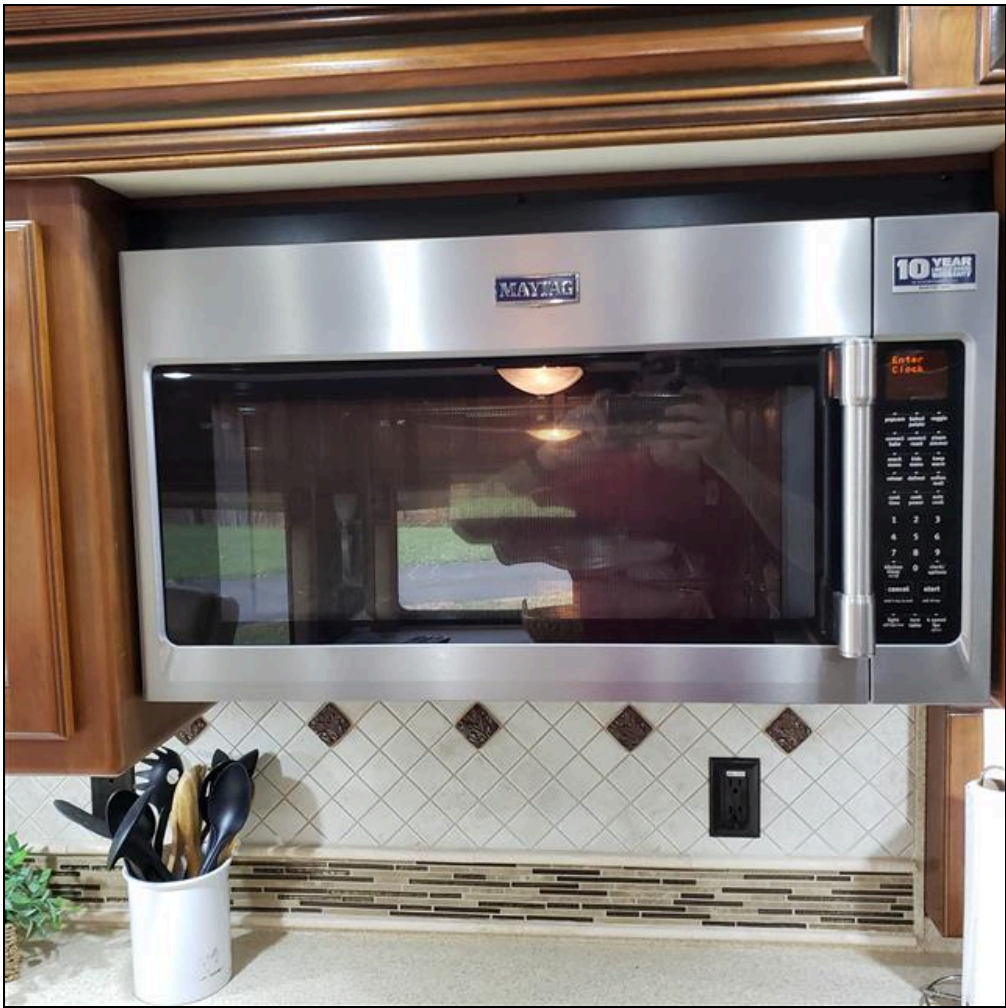
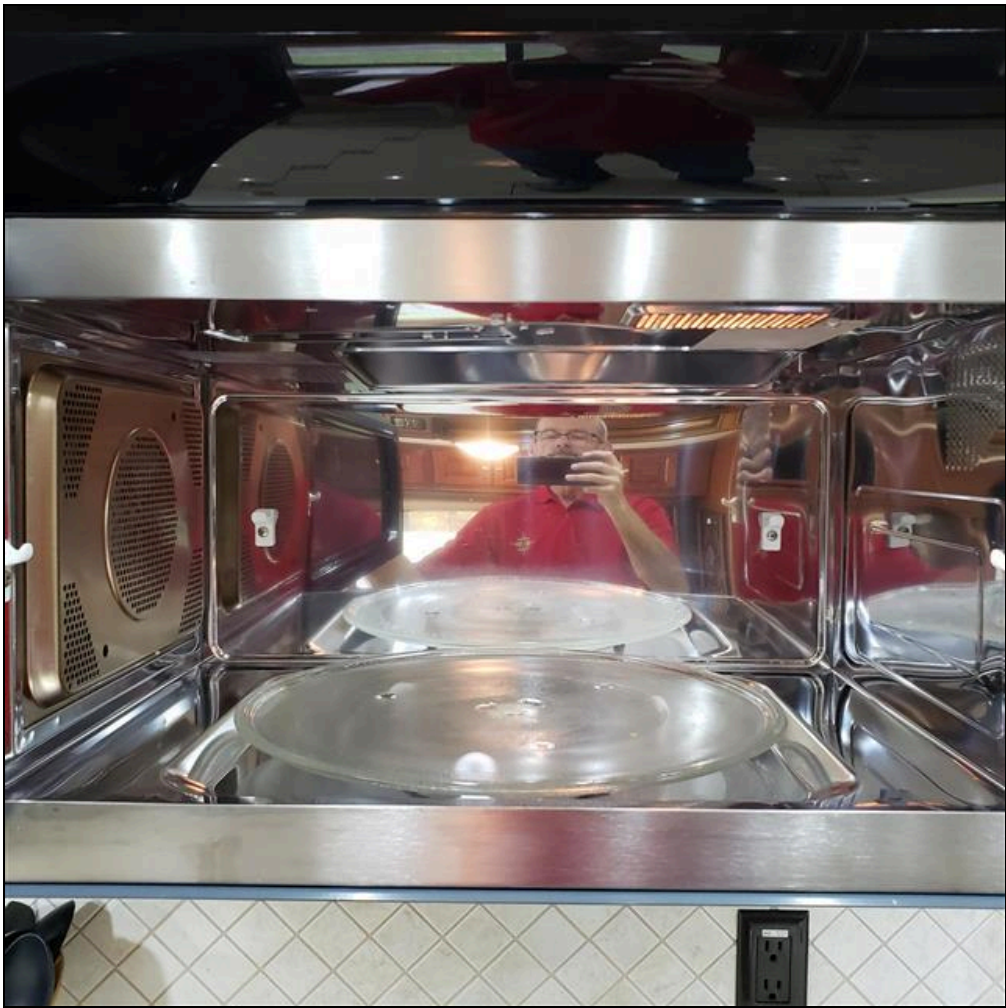
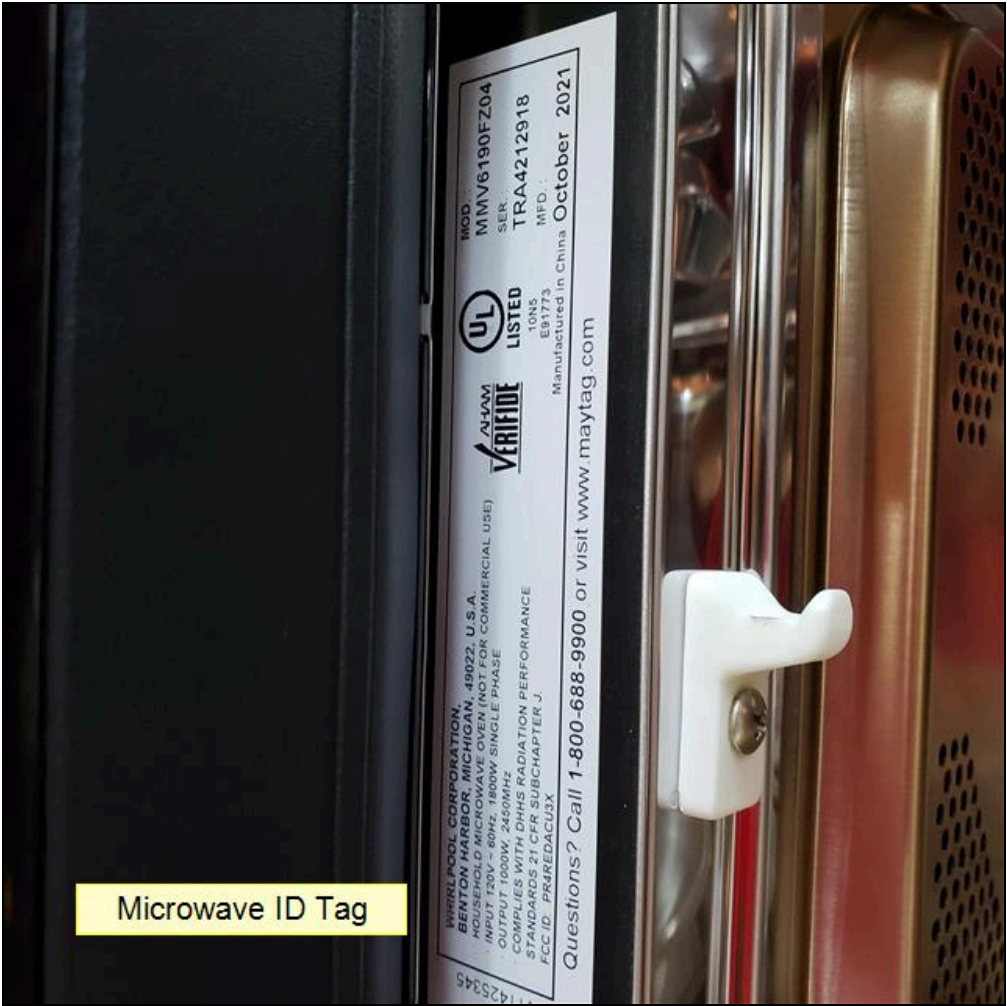
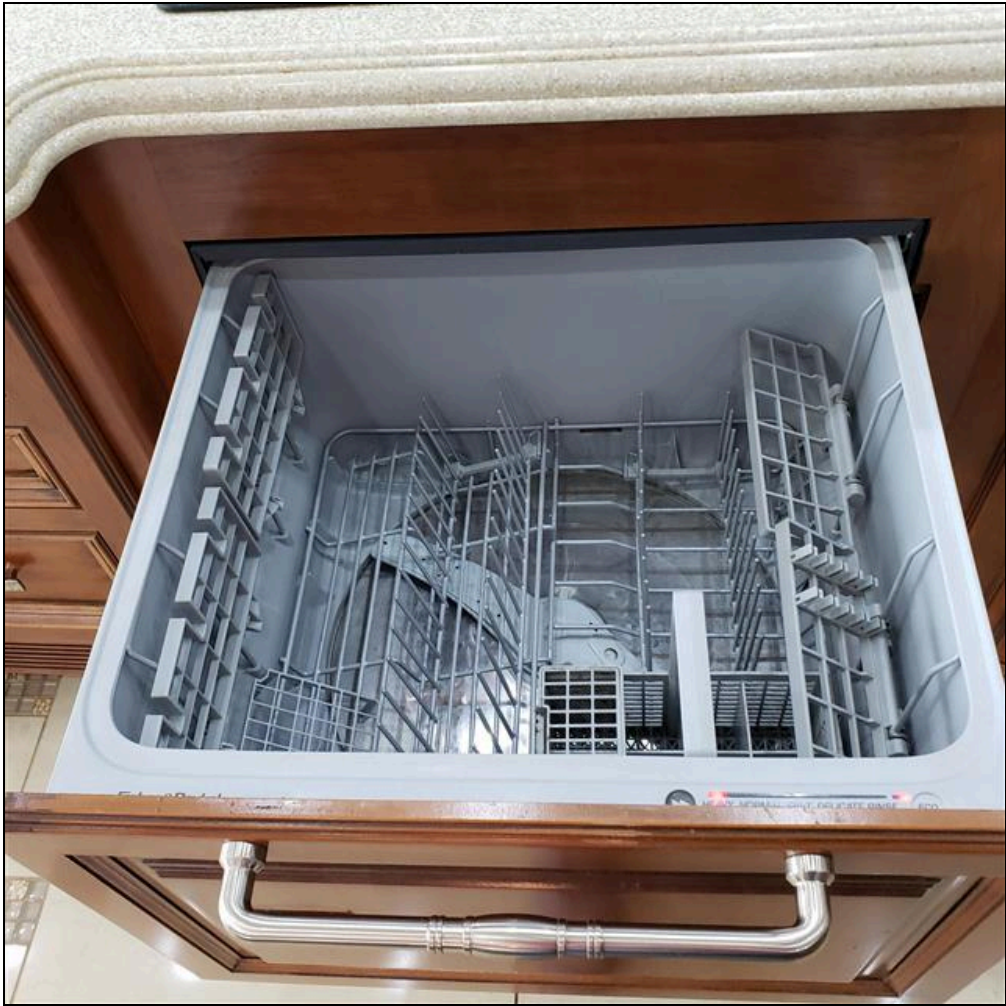
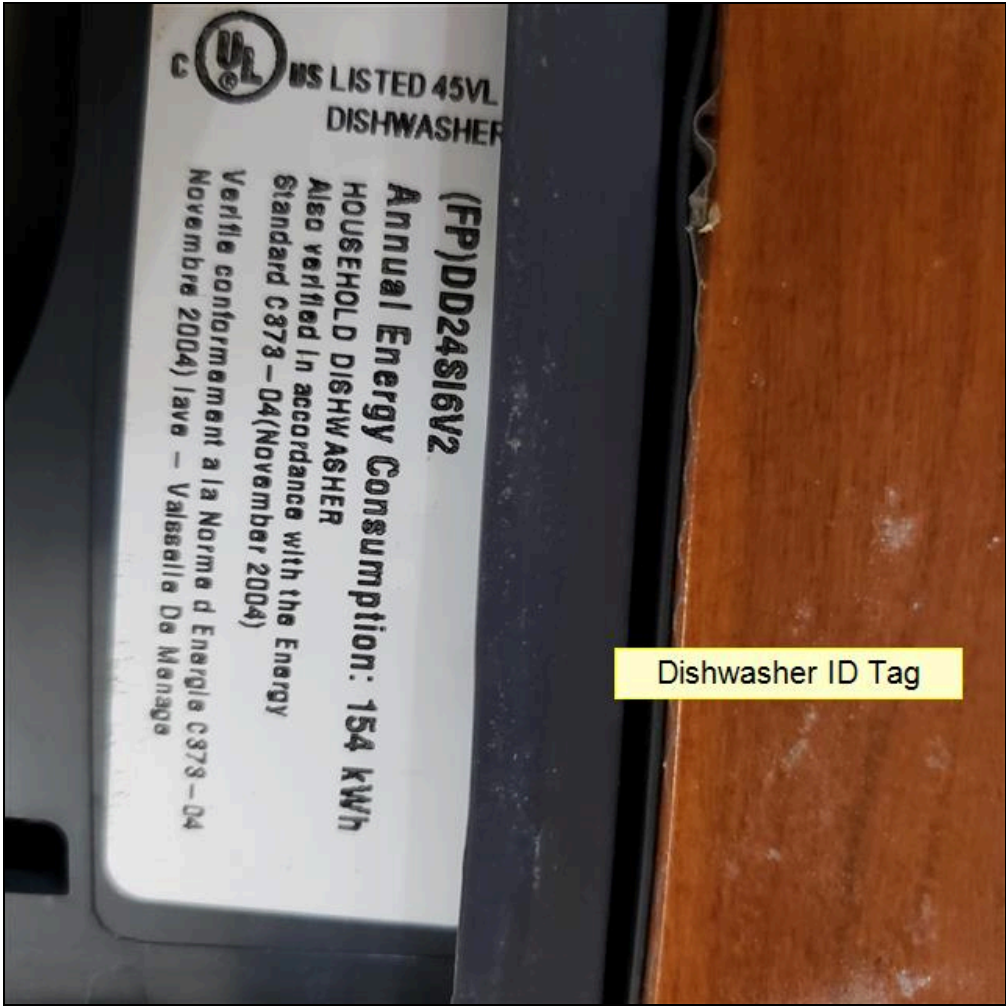
Refrigerator, Microwave/Convection Oven, Dishwasher and Cooktop all operated appropriately. Photos attached for reference

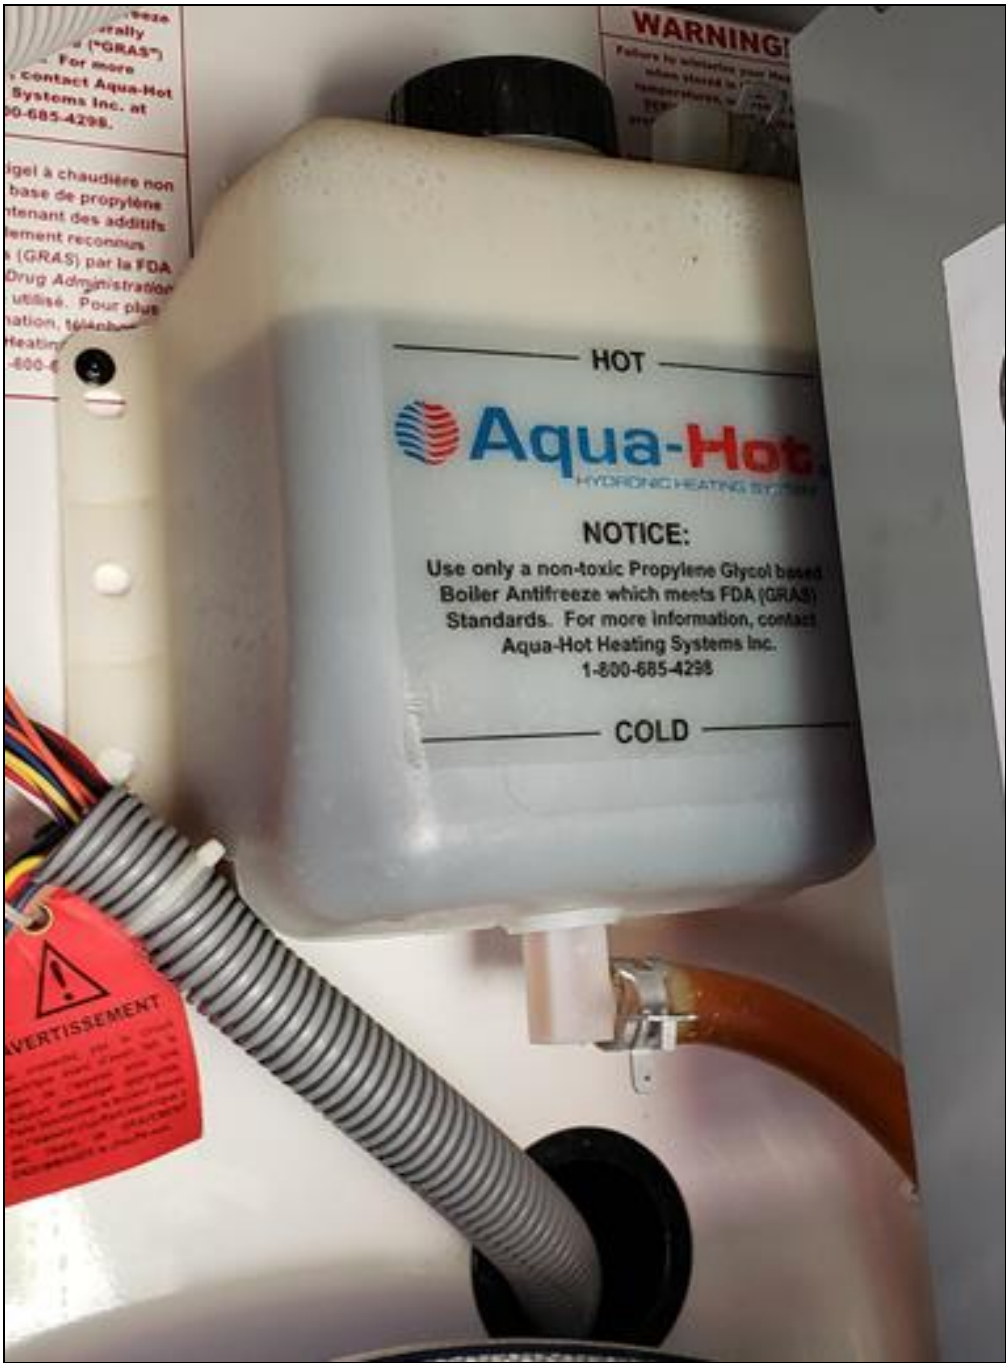
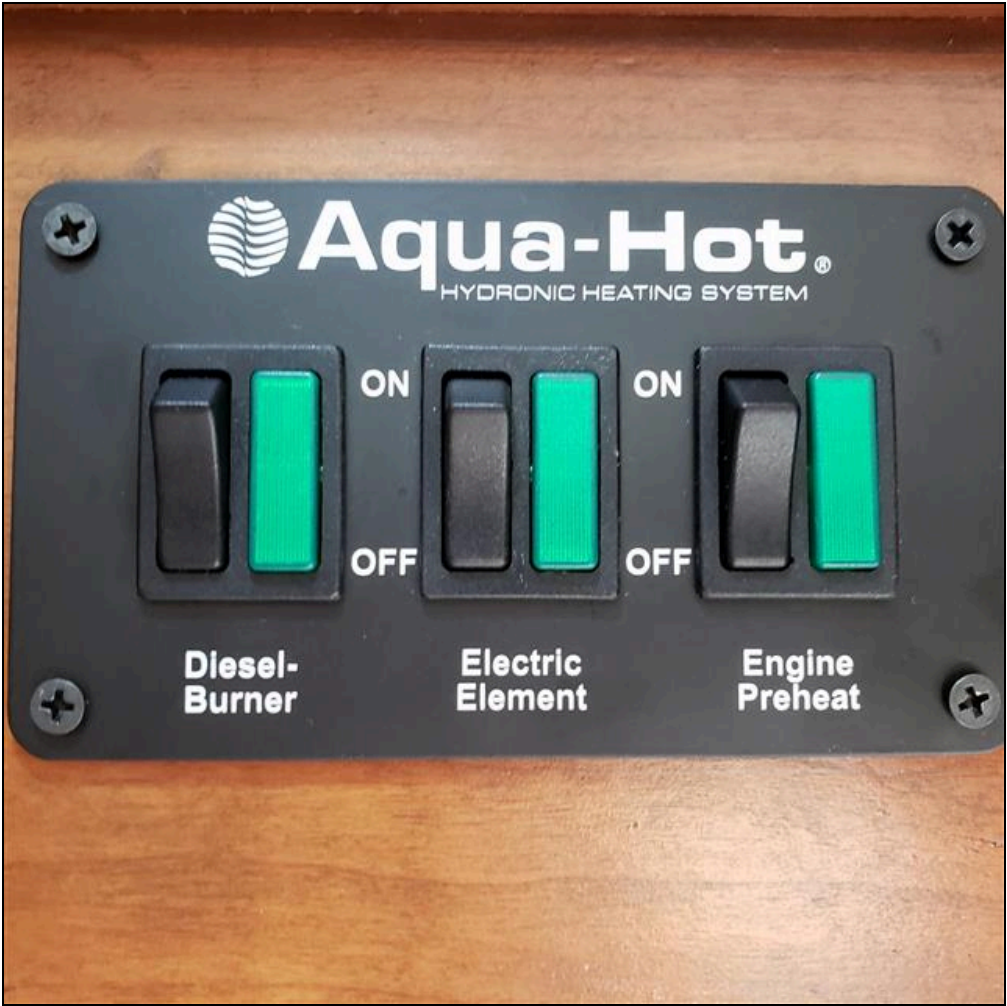
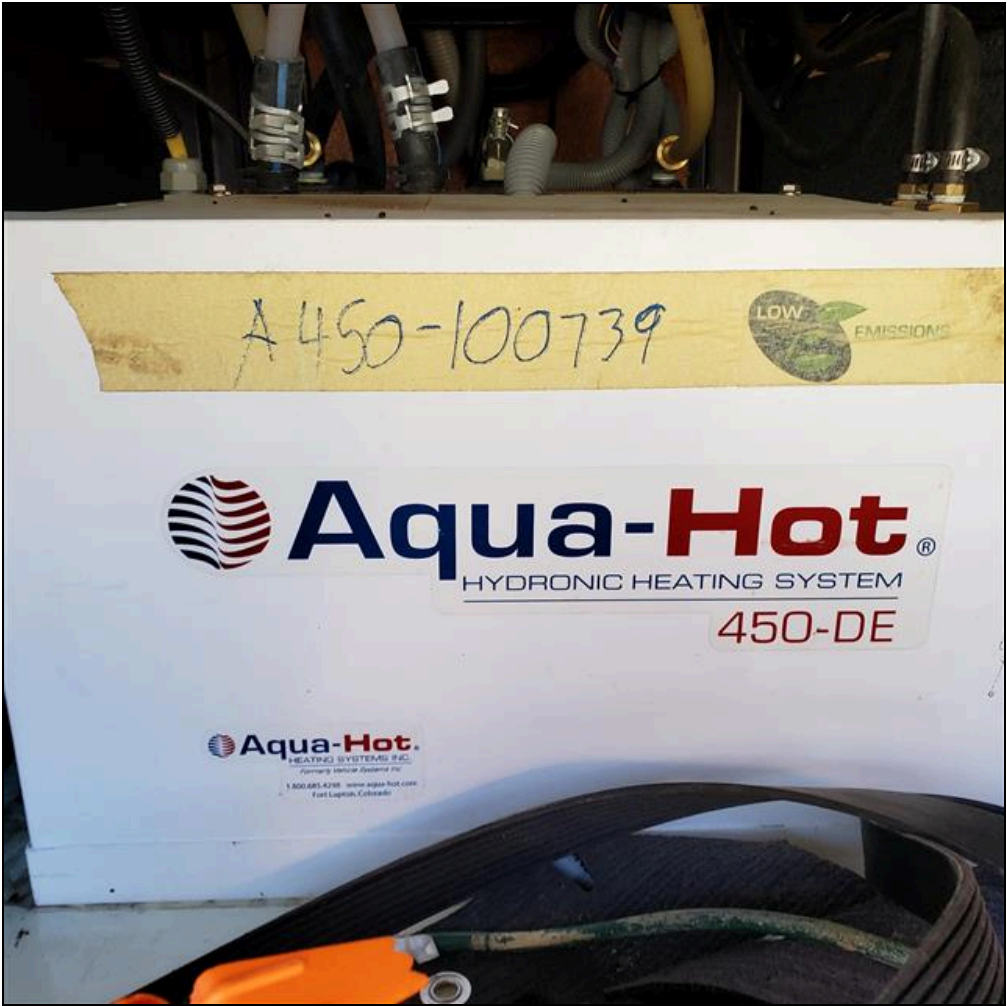
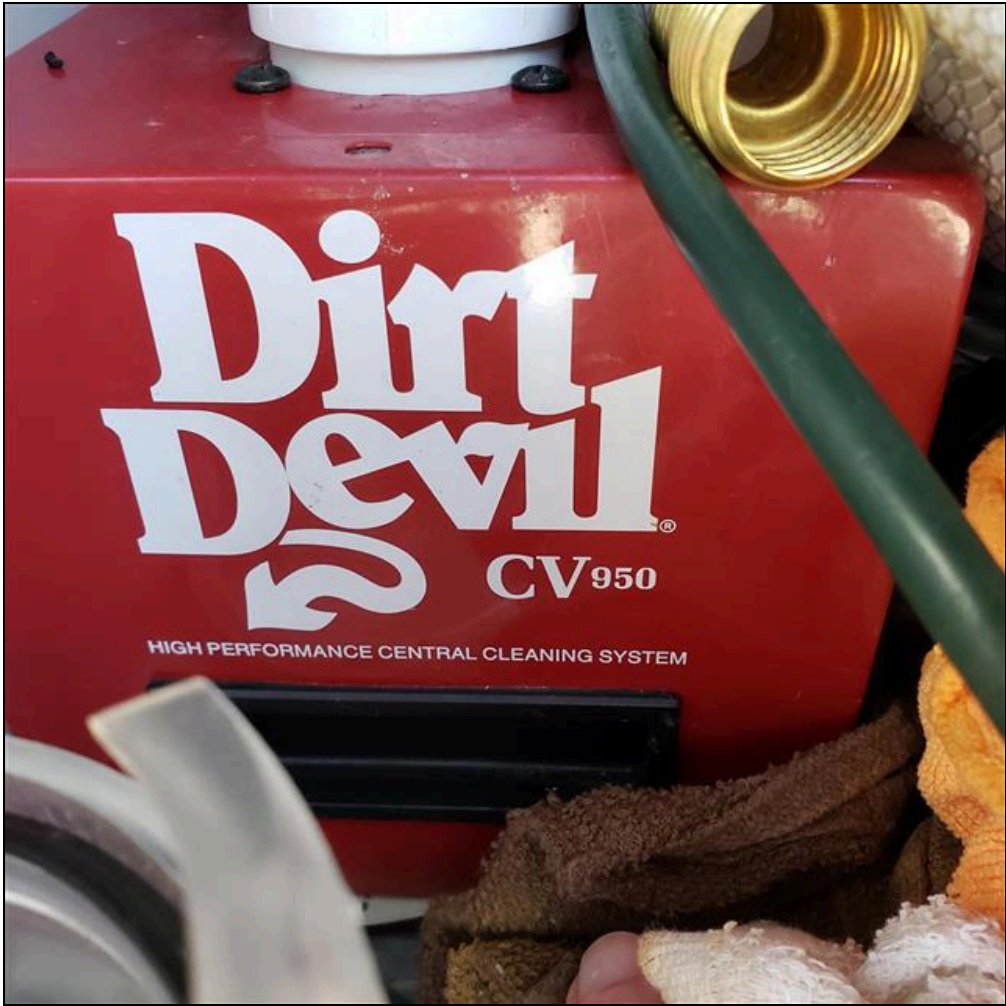
Aqua Hot system check in electric and diesel mode for water heating and heater. All operated appropriately. When burner fired in diesel mode some soot was noted on startup and is likely from not being used for a period of time. After initial start up unit ran clean.
