Inspection Report

Property Address:
2711 Claypool-Alvaton Rd
Bowling Green KY 42103

Foremost RV Inspections

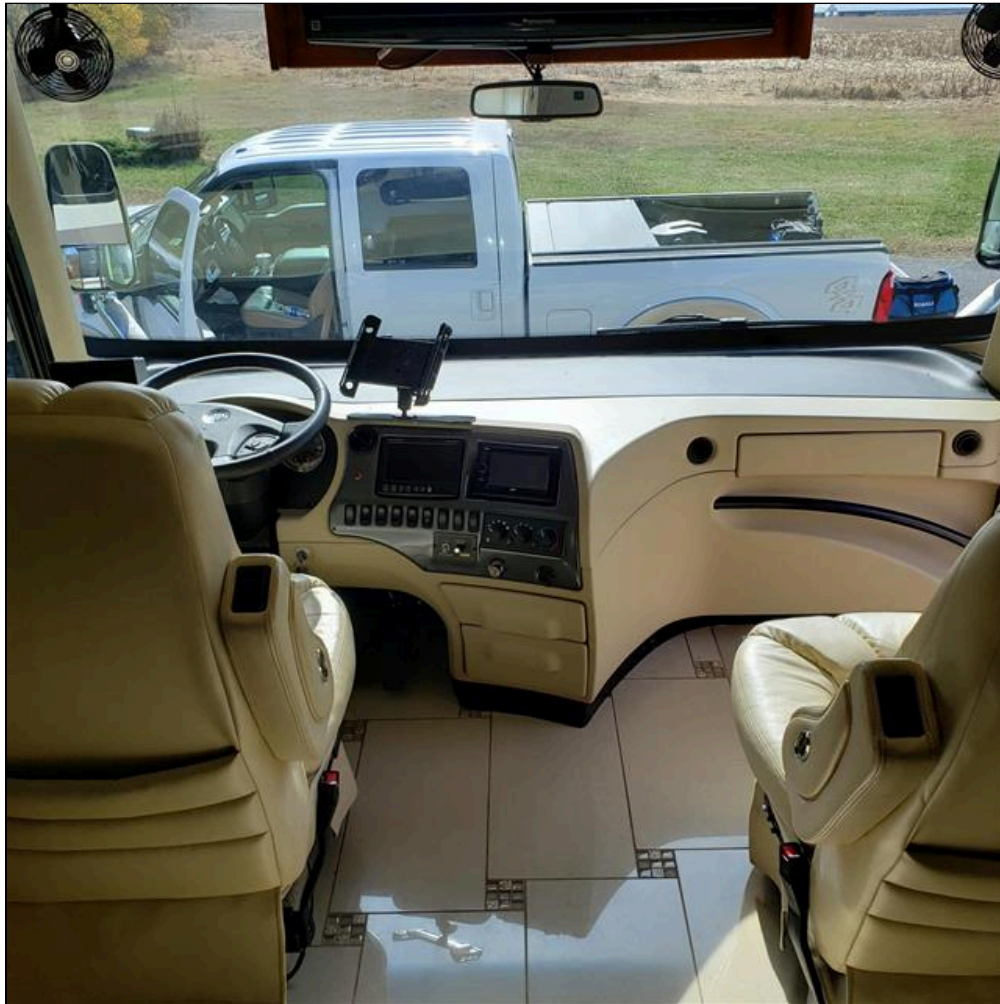
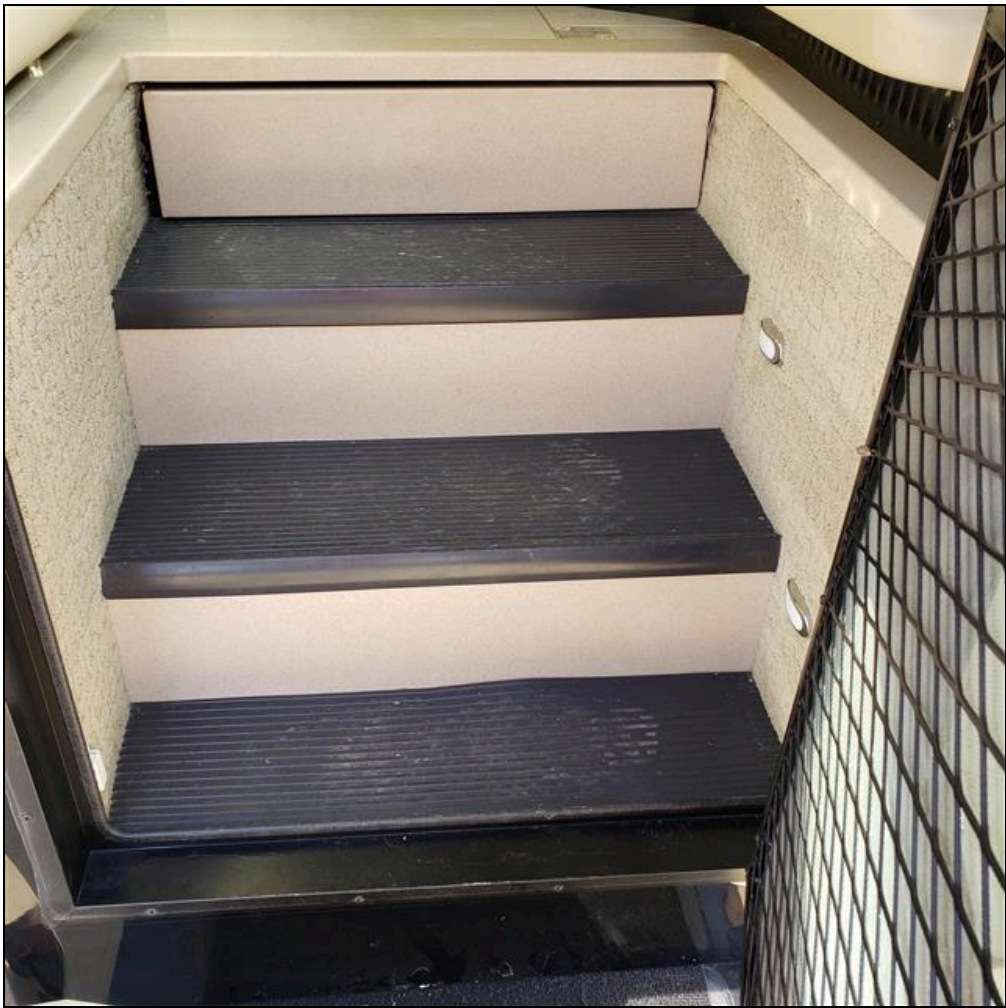
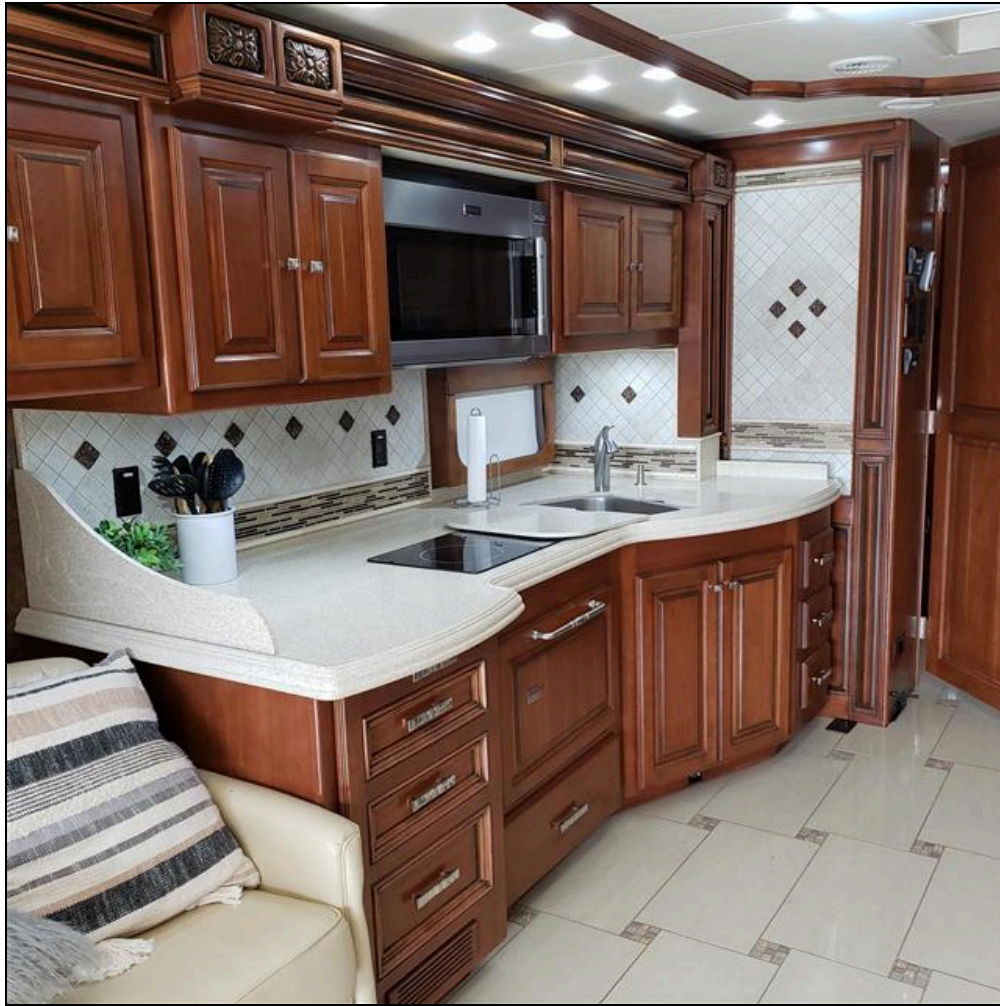
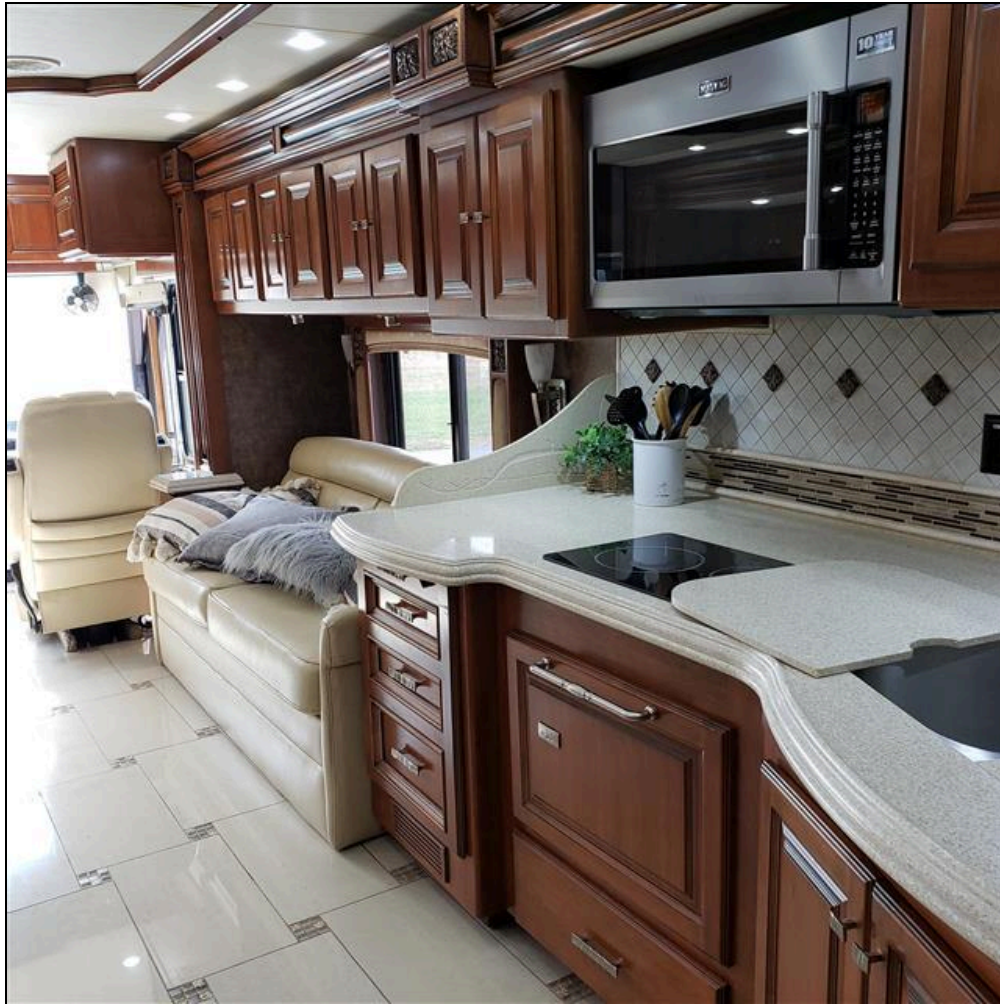
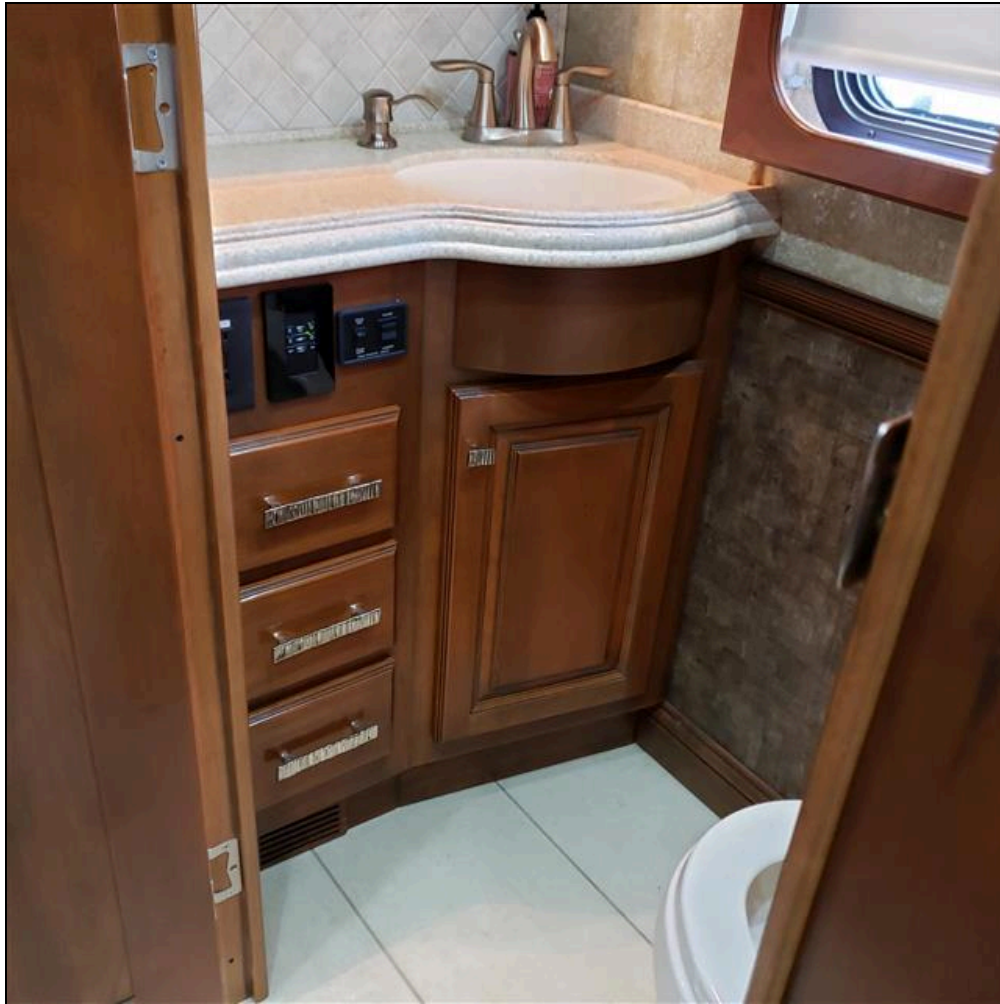
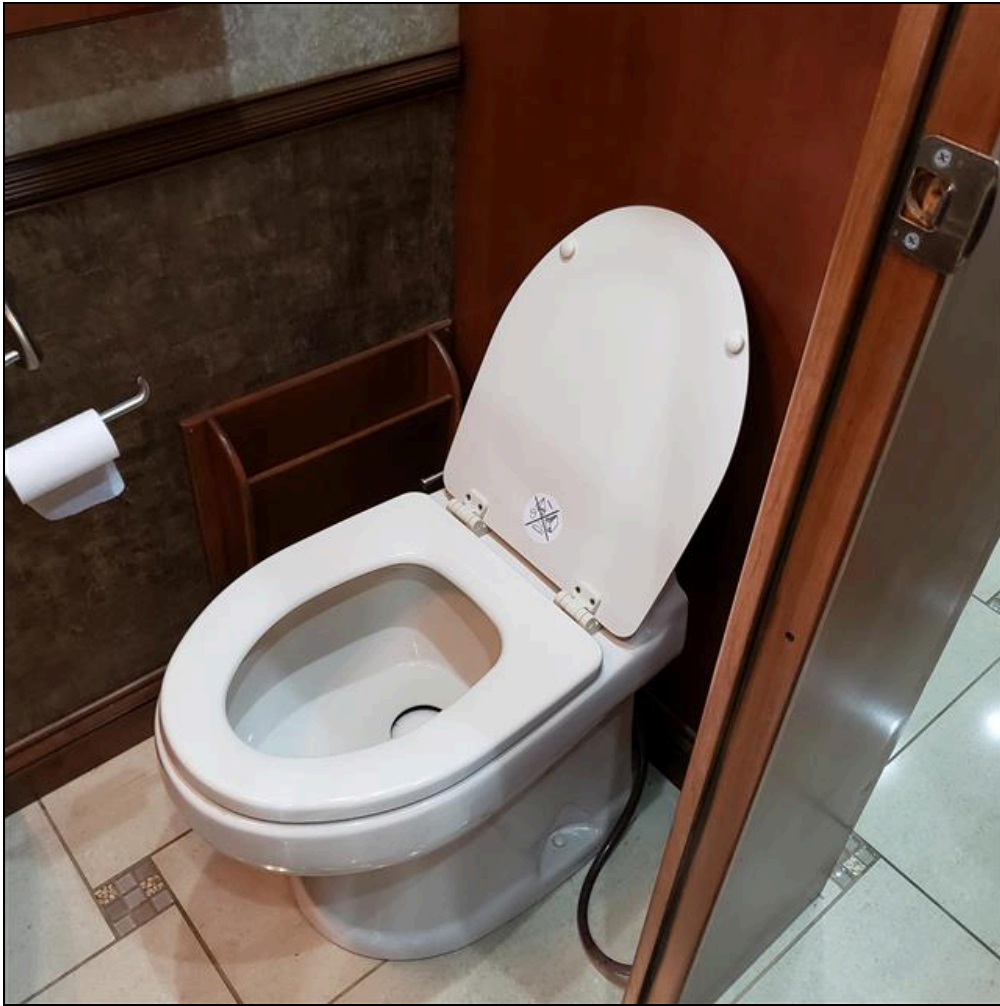
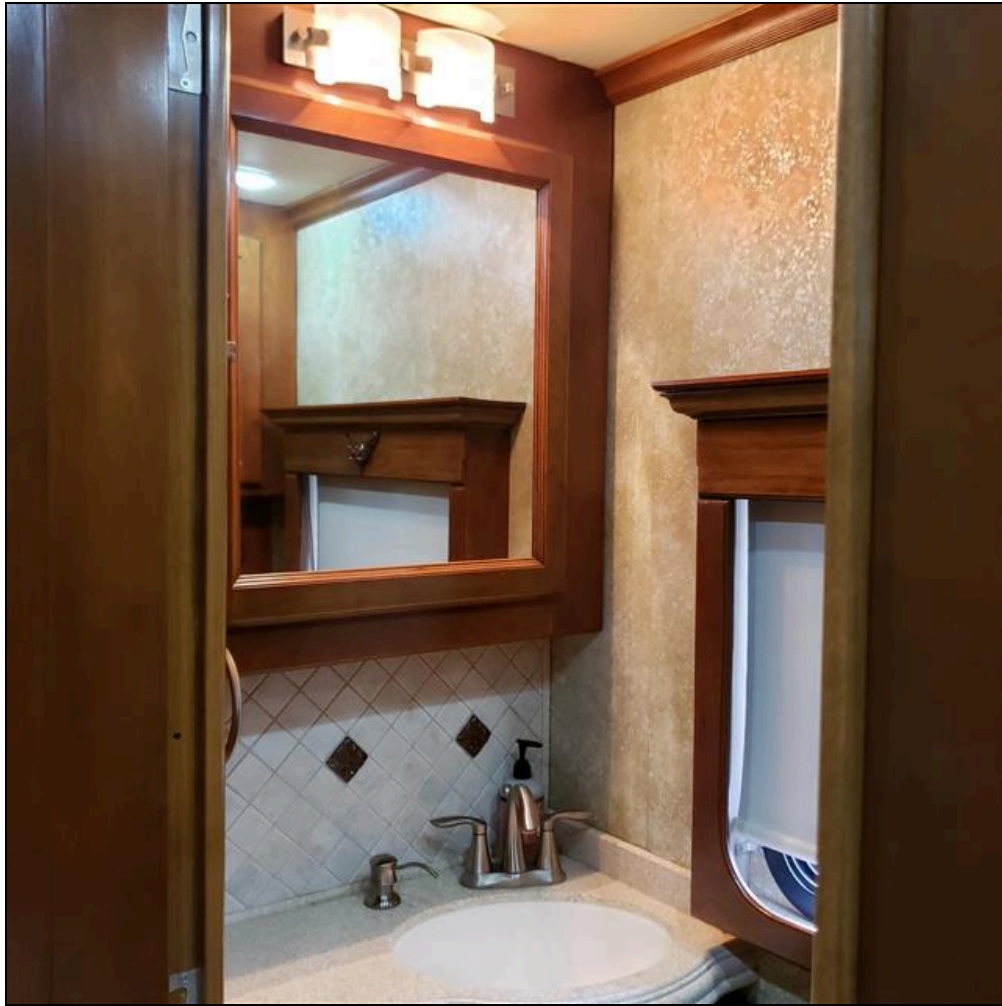
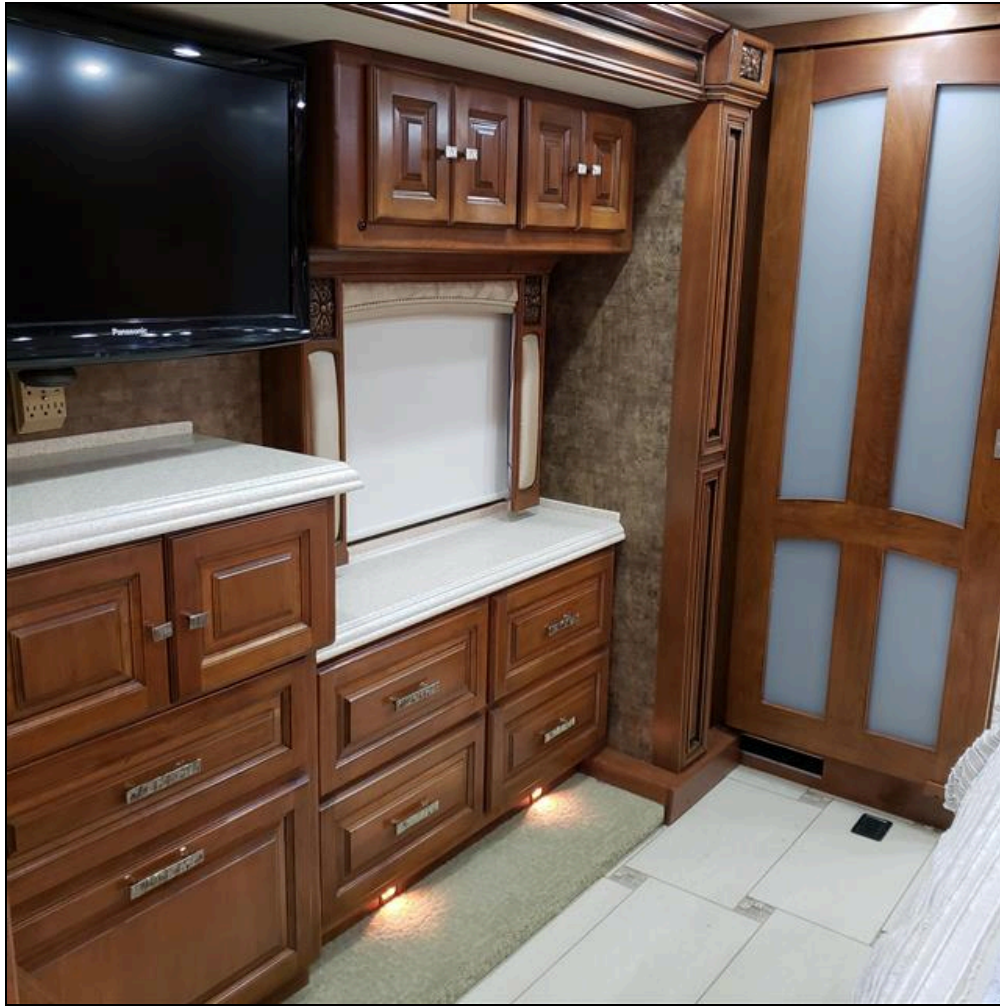
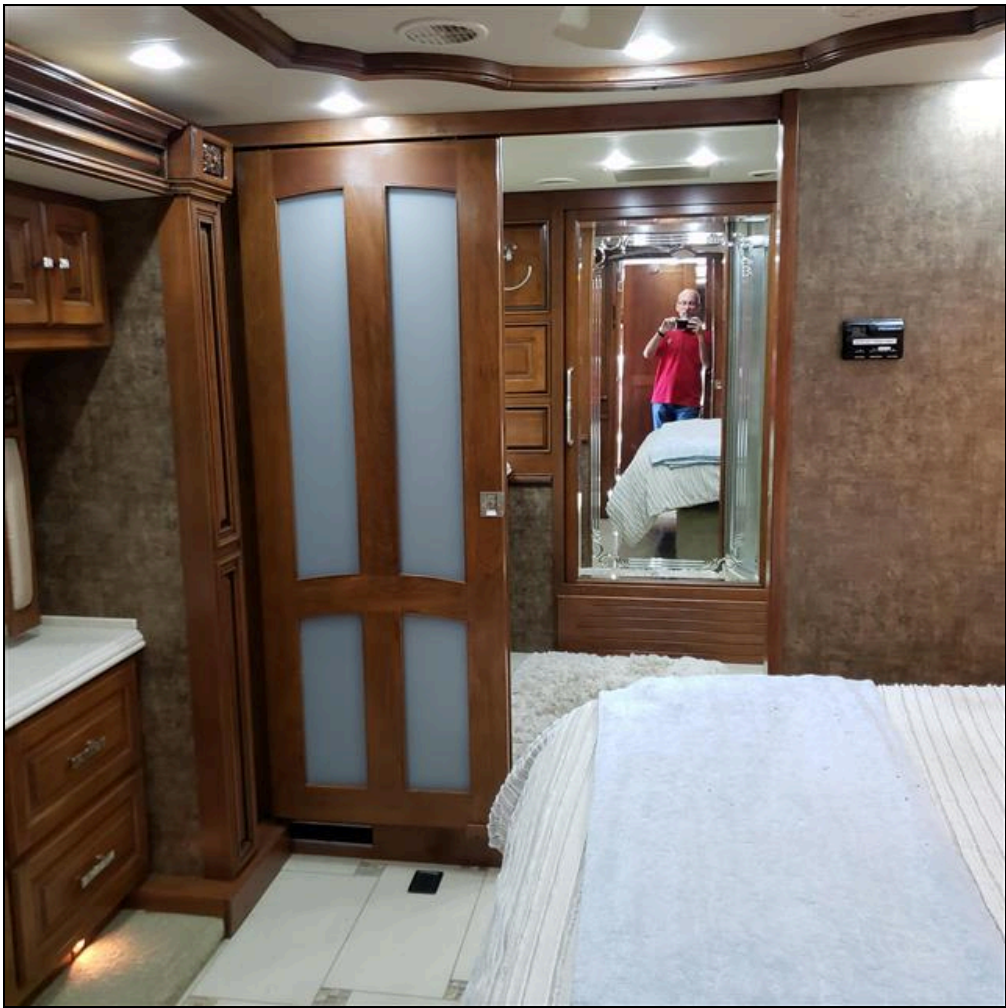
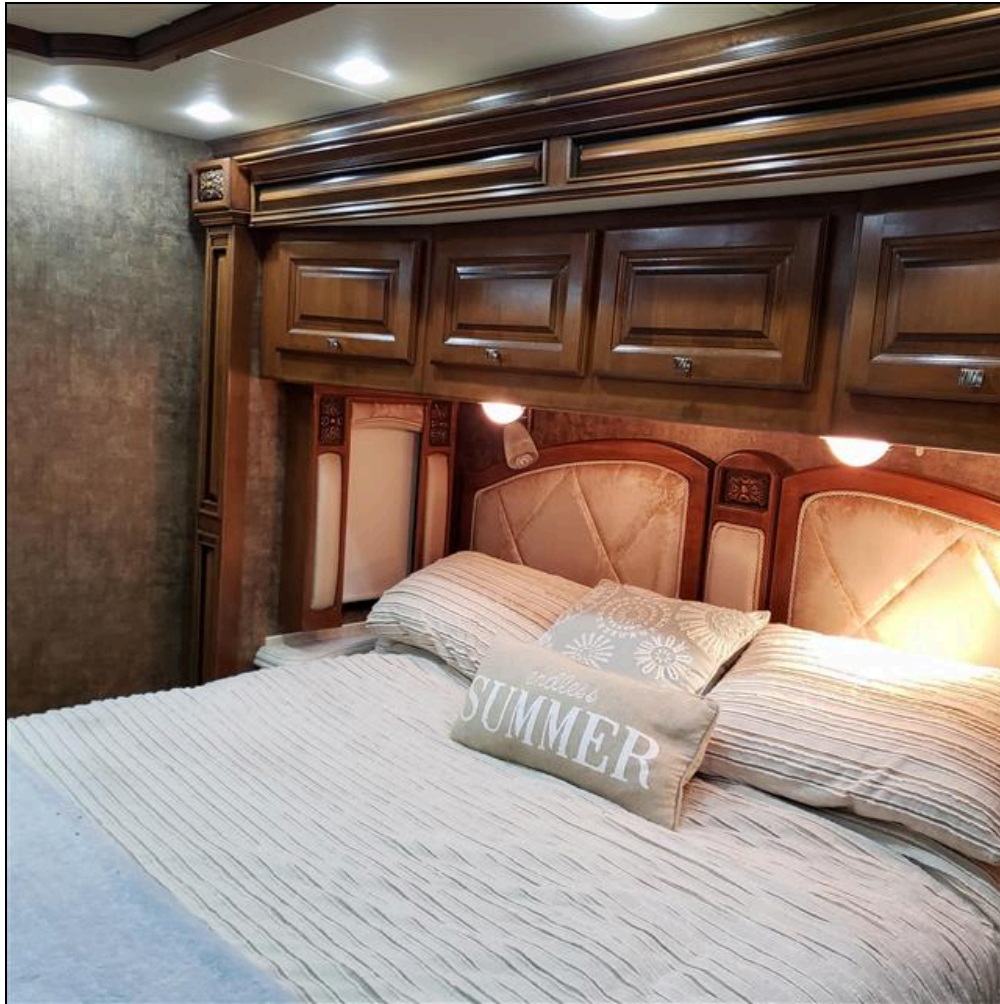
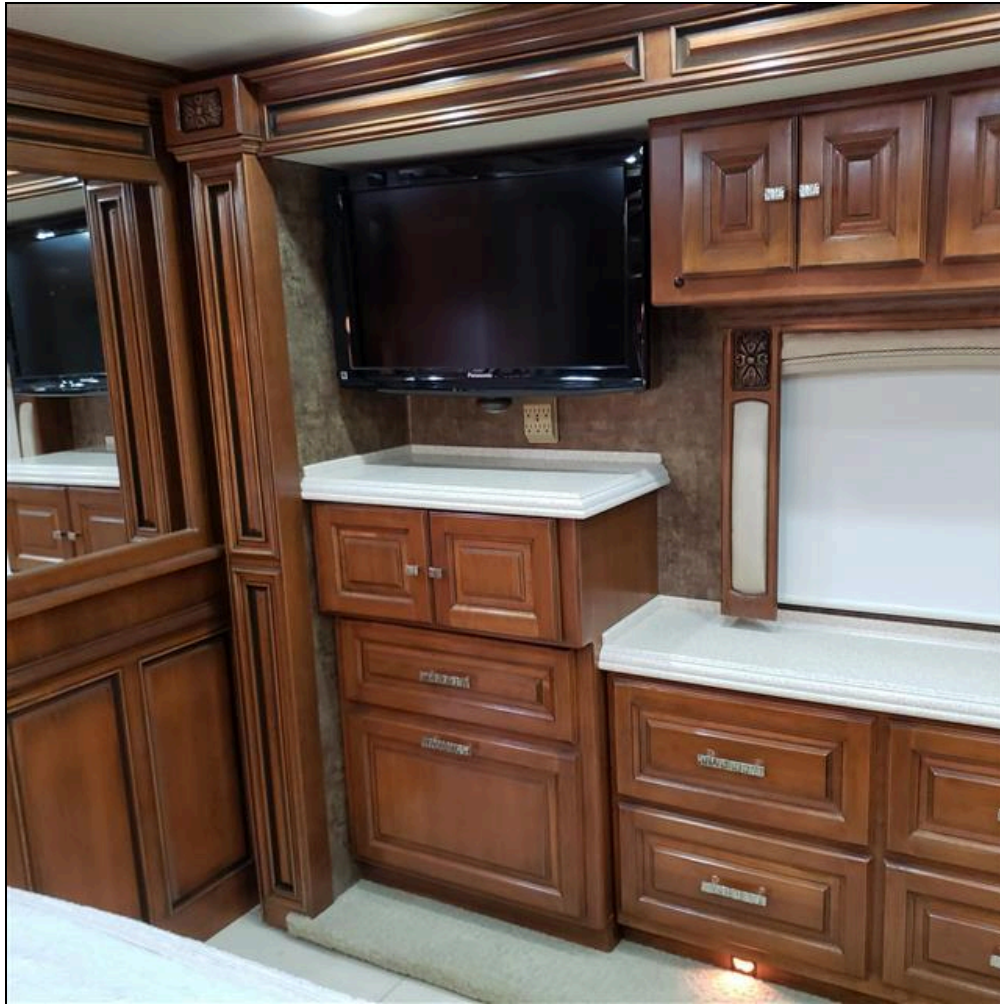
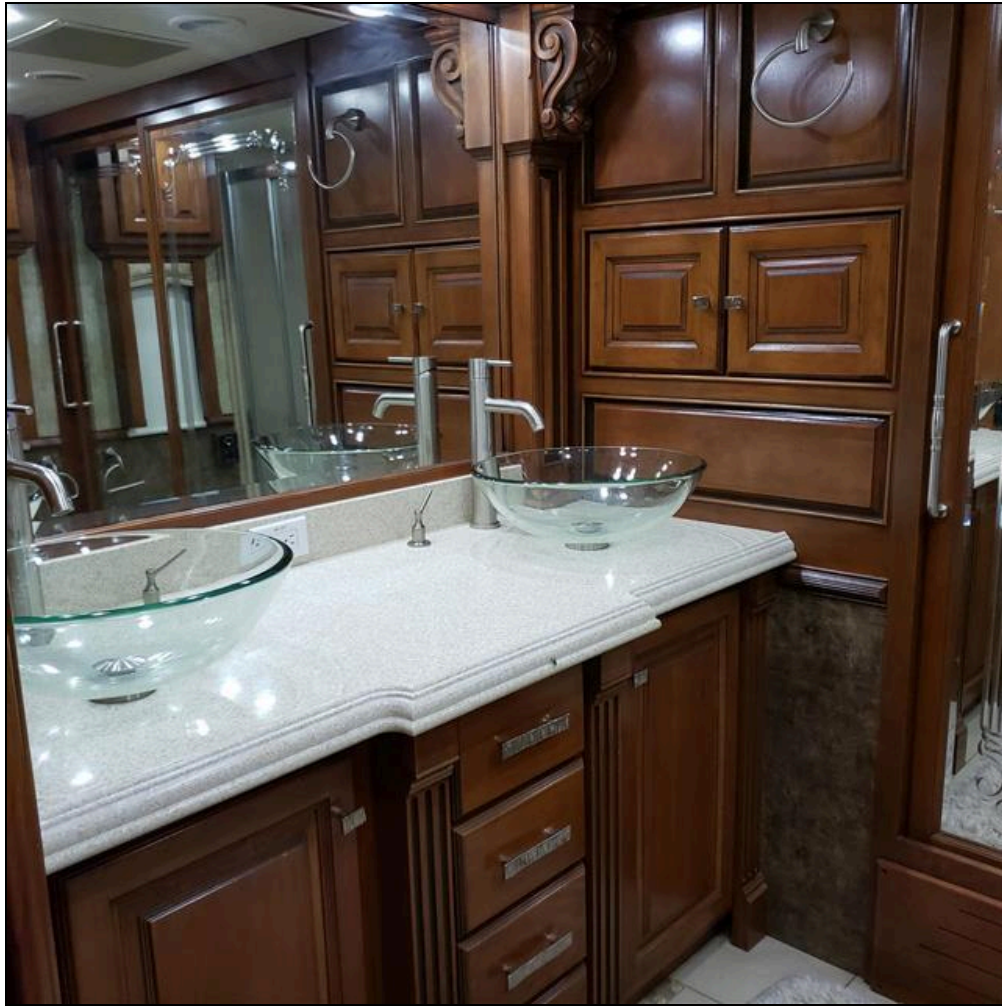
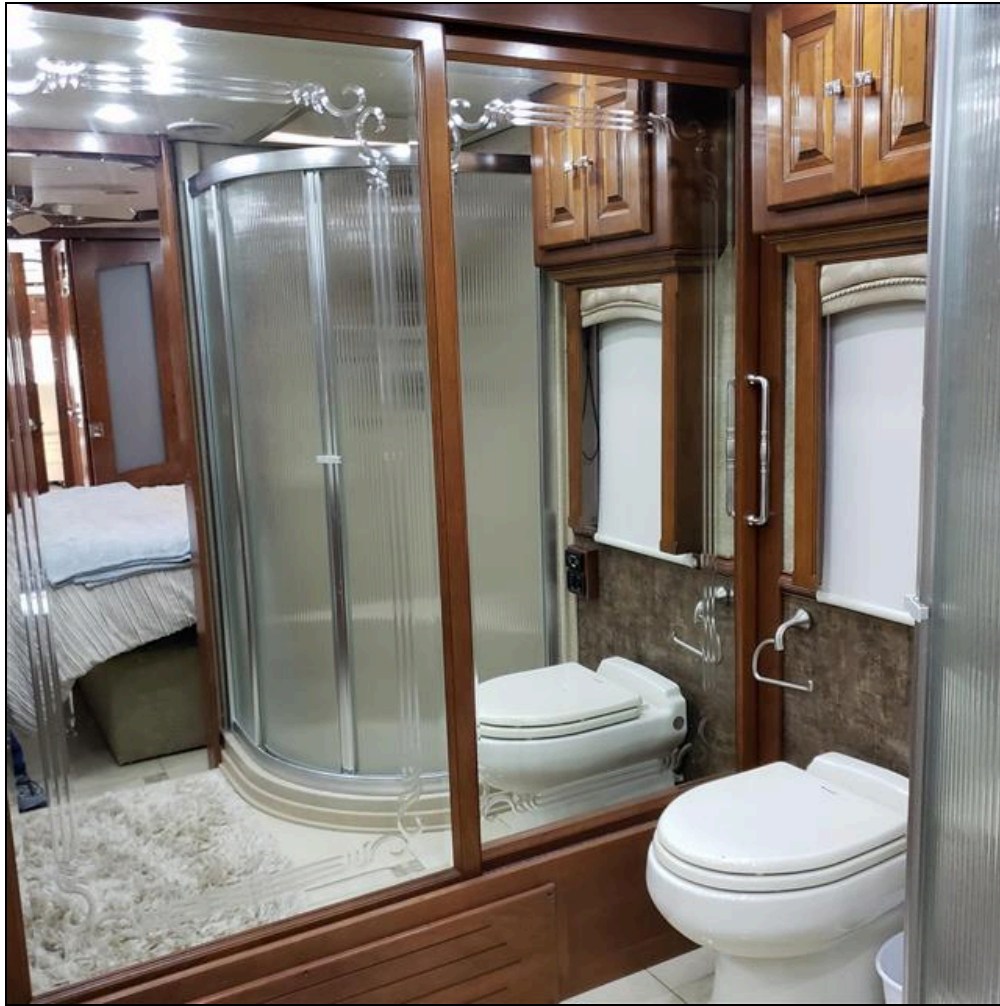
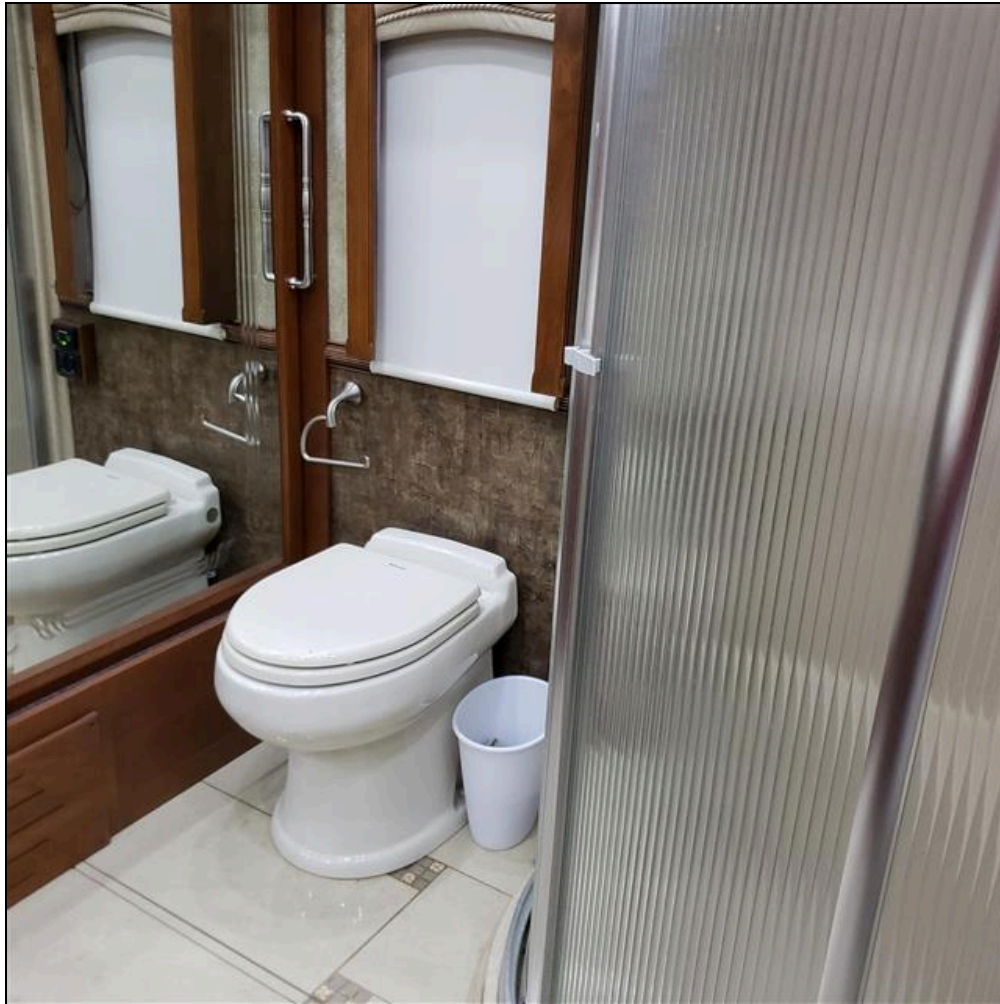
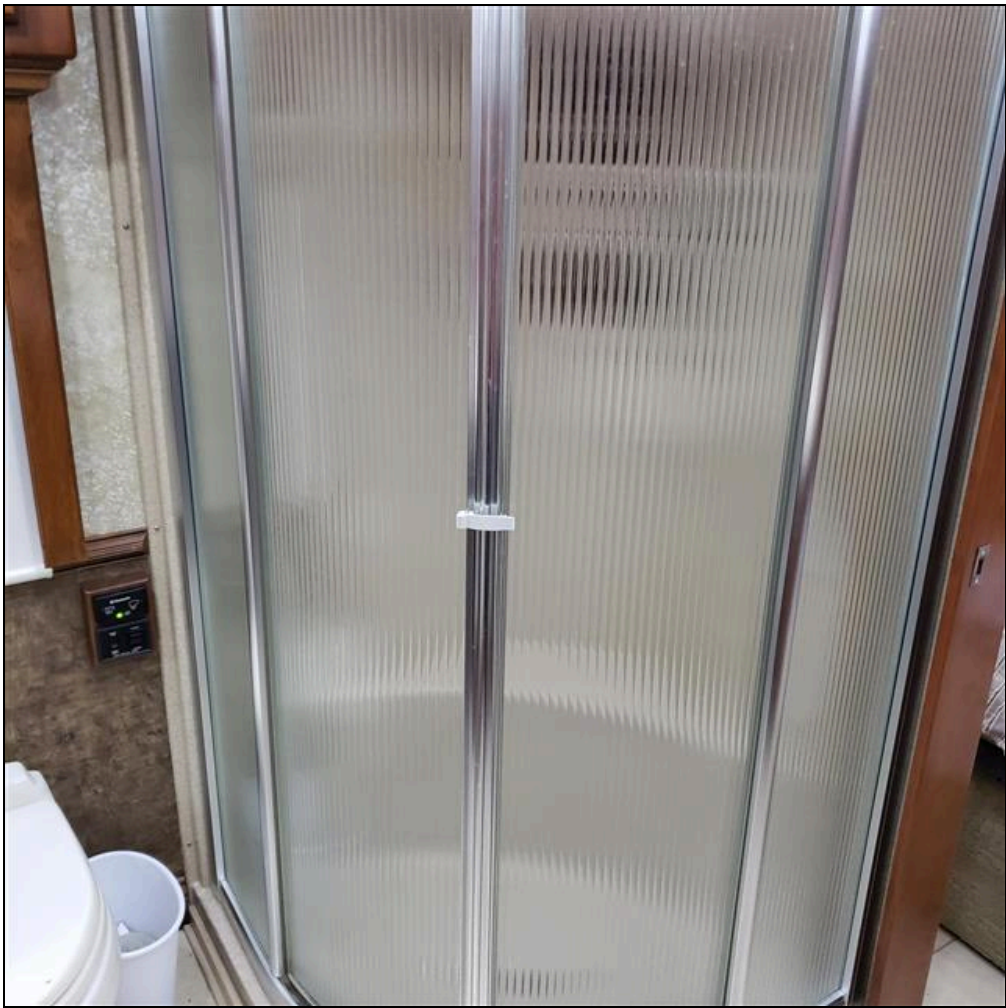
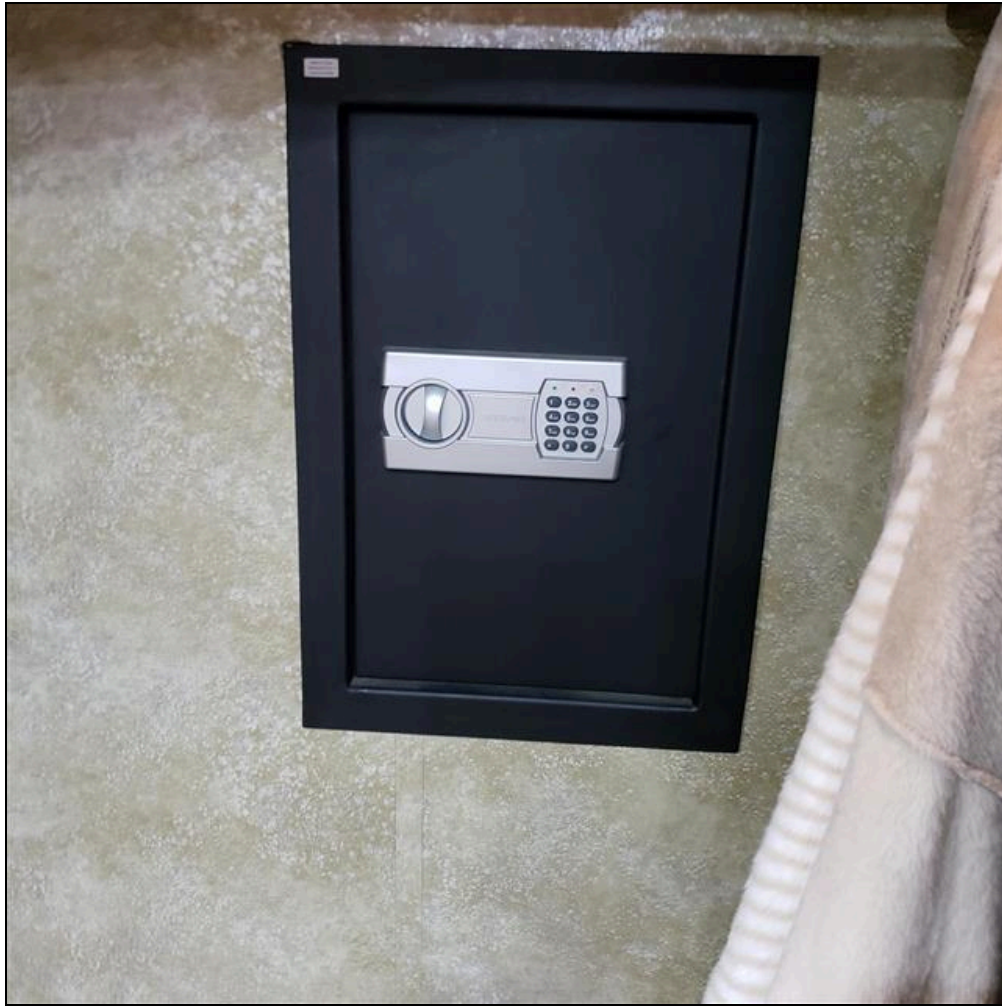
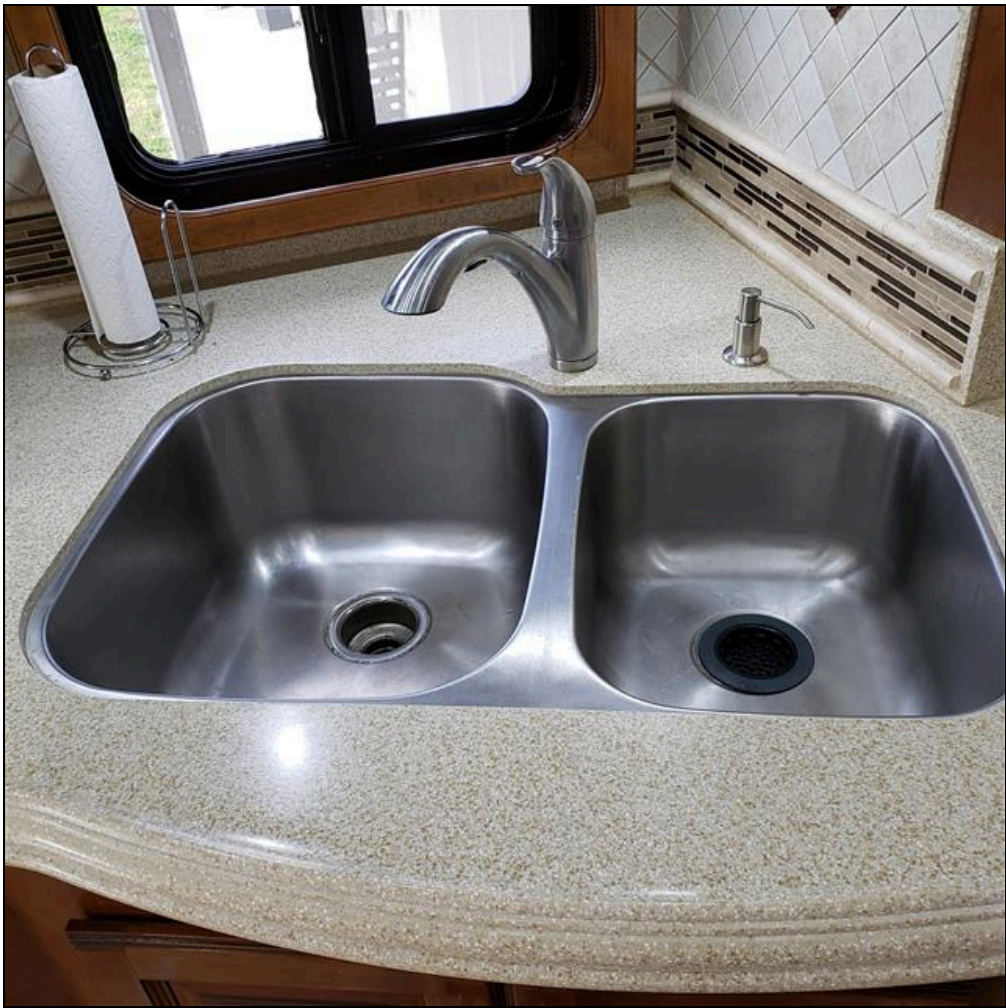
Interior is in overall good condition with only minimal wear noted that is consistent with the age. One area was noted by refrigerator with minor damage (see inspection items). Wall and floors were solid with no soft spots or delamination. All doors and drawers operated appropriately.

All faucets operated appropriately with hot and cold water. No leaks were noted at faucets or under sinks.

Toilets flushed properly and bowls held water.
