Inspection Report

Property Address:
2711 Claypool-Alvaton Rd
Bowling Green KY 42103

Foremost RV Inspections

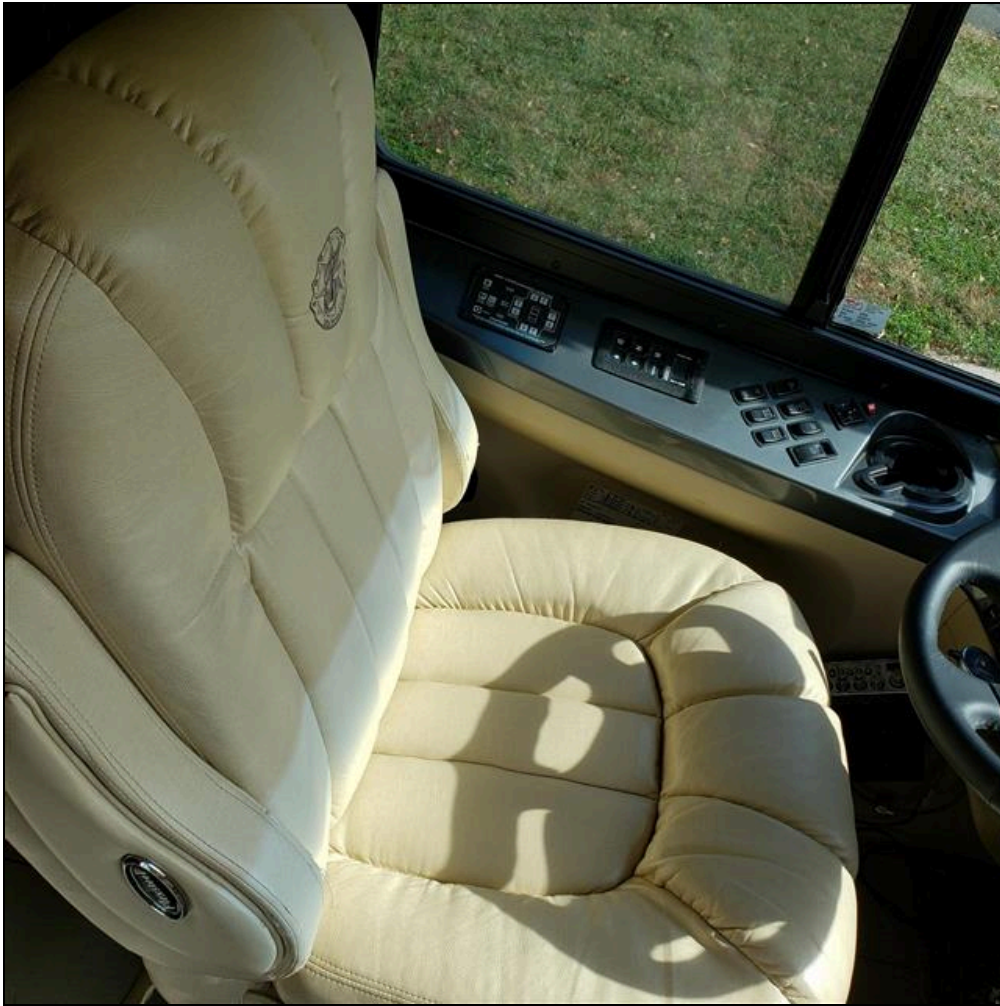
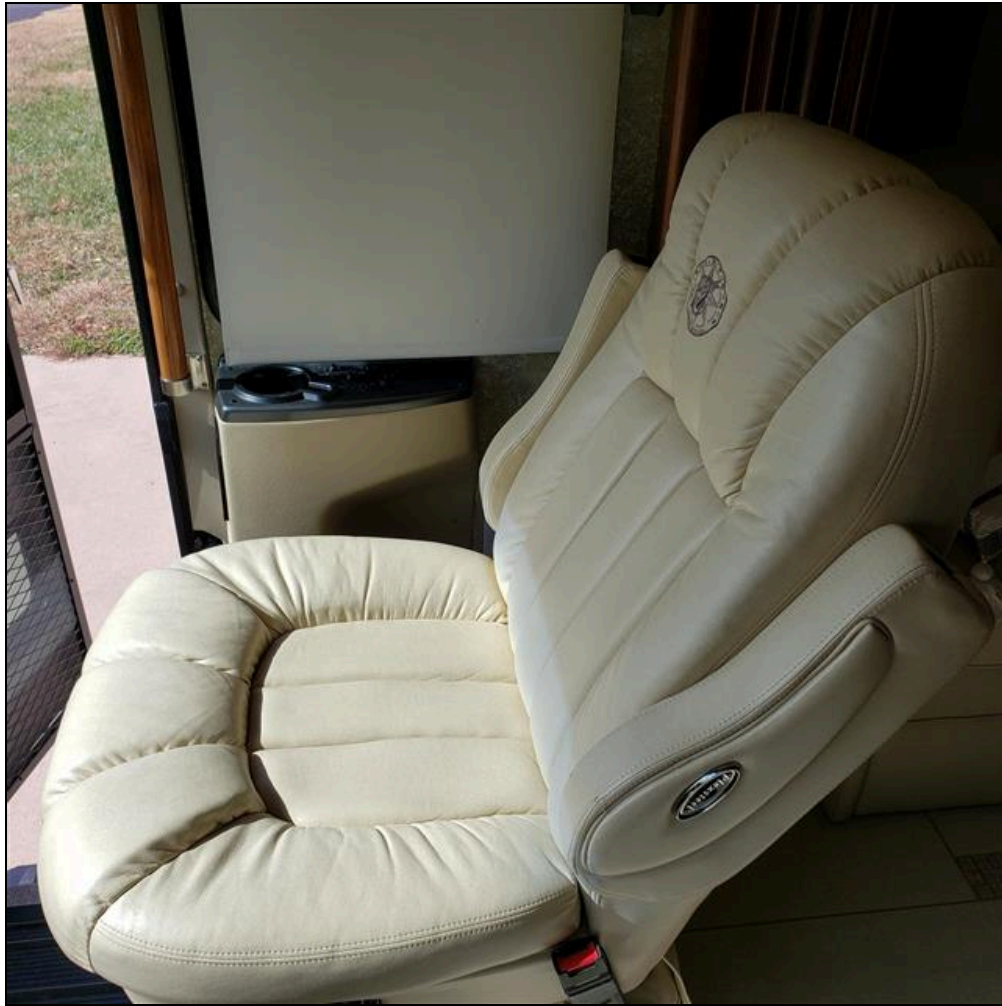
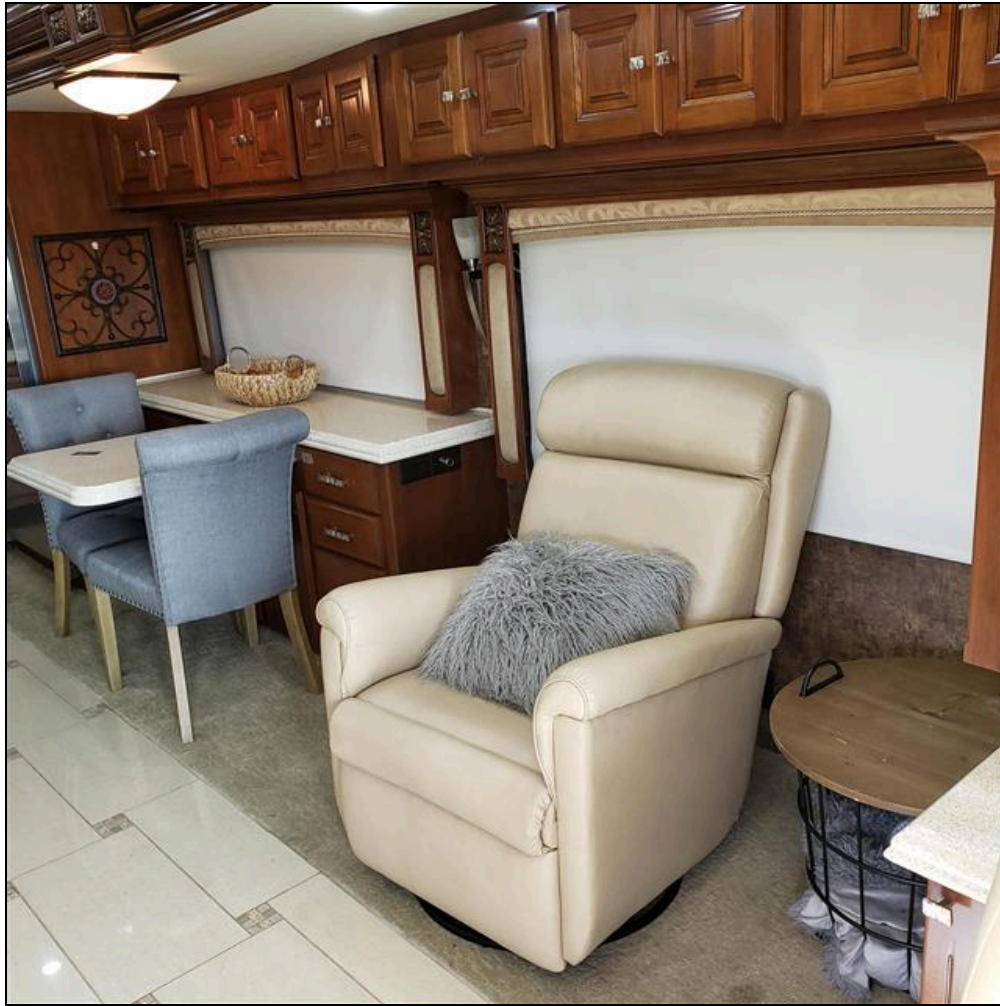
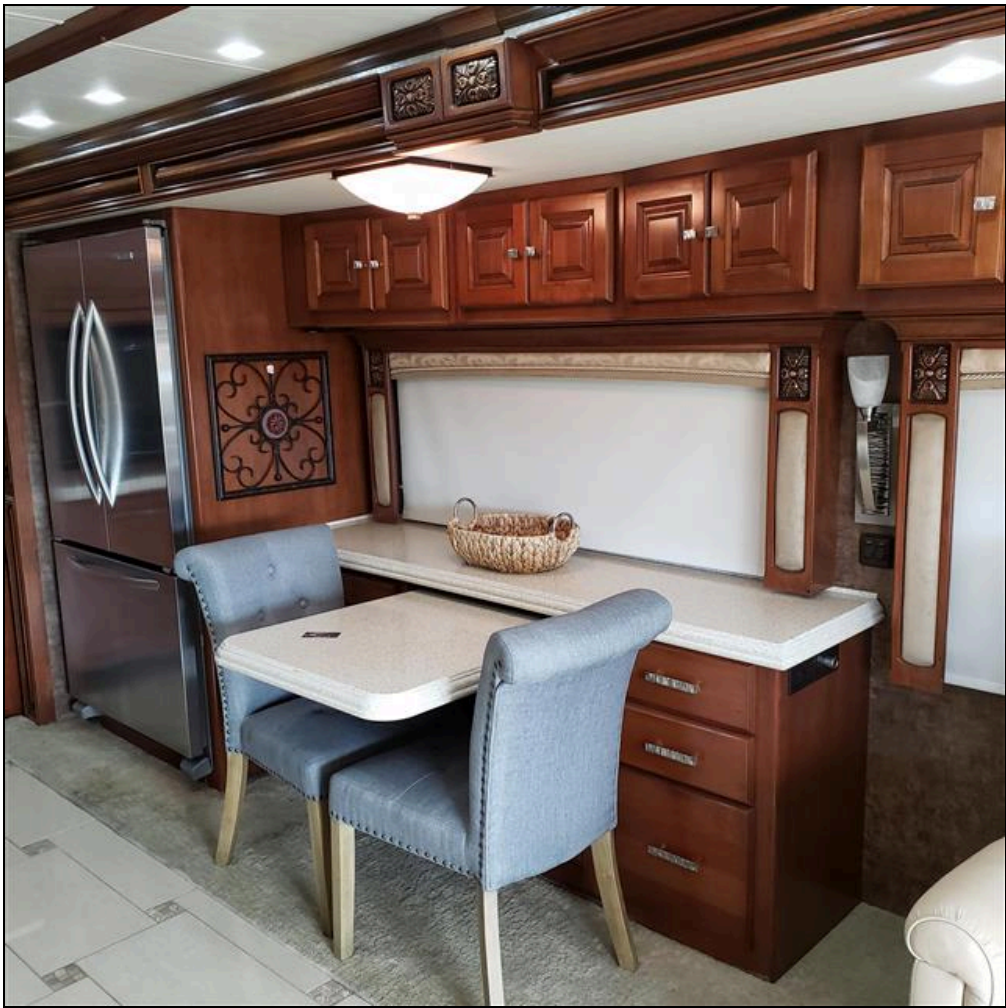
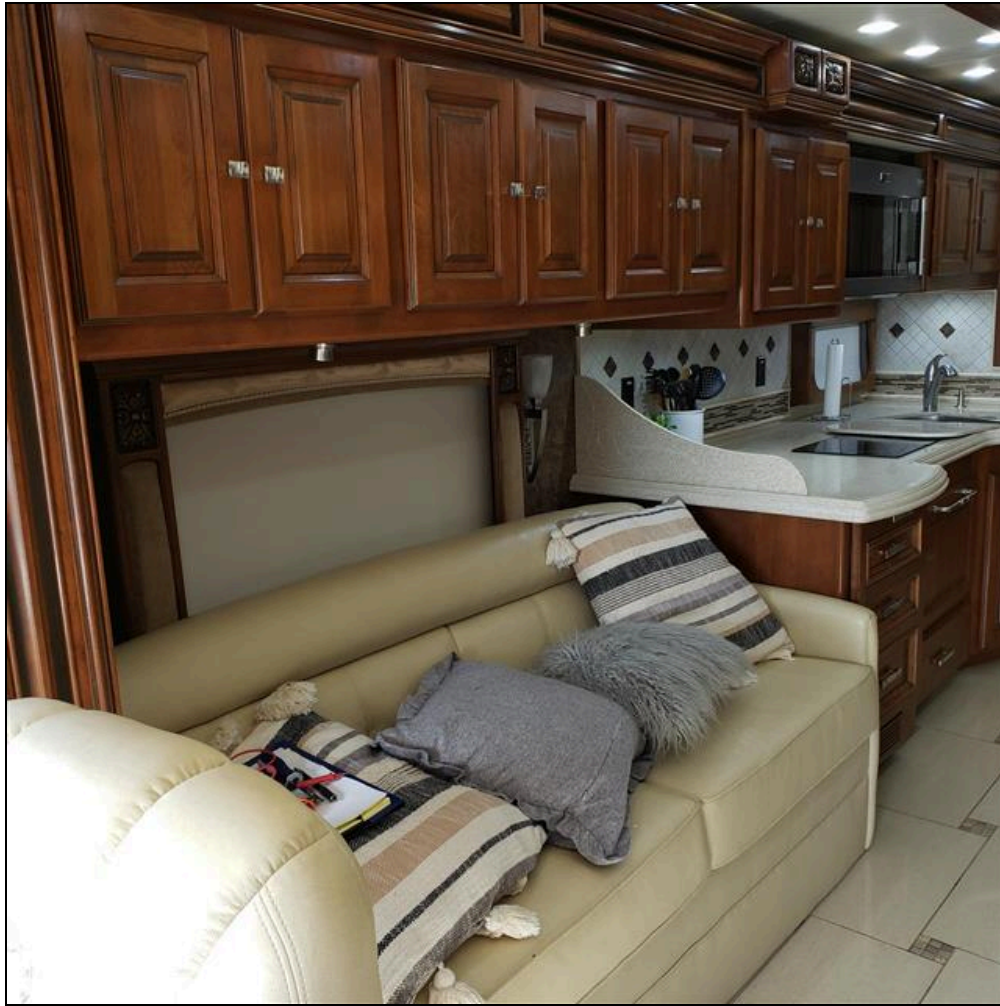
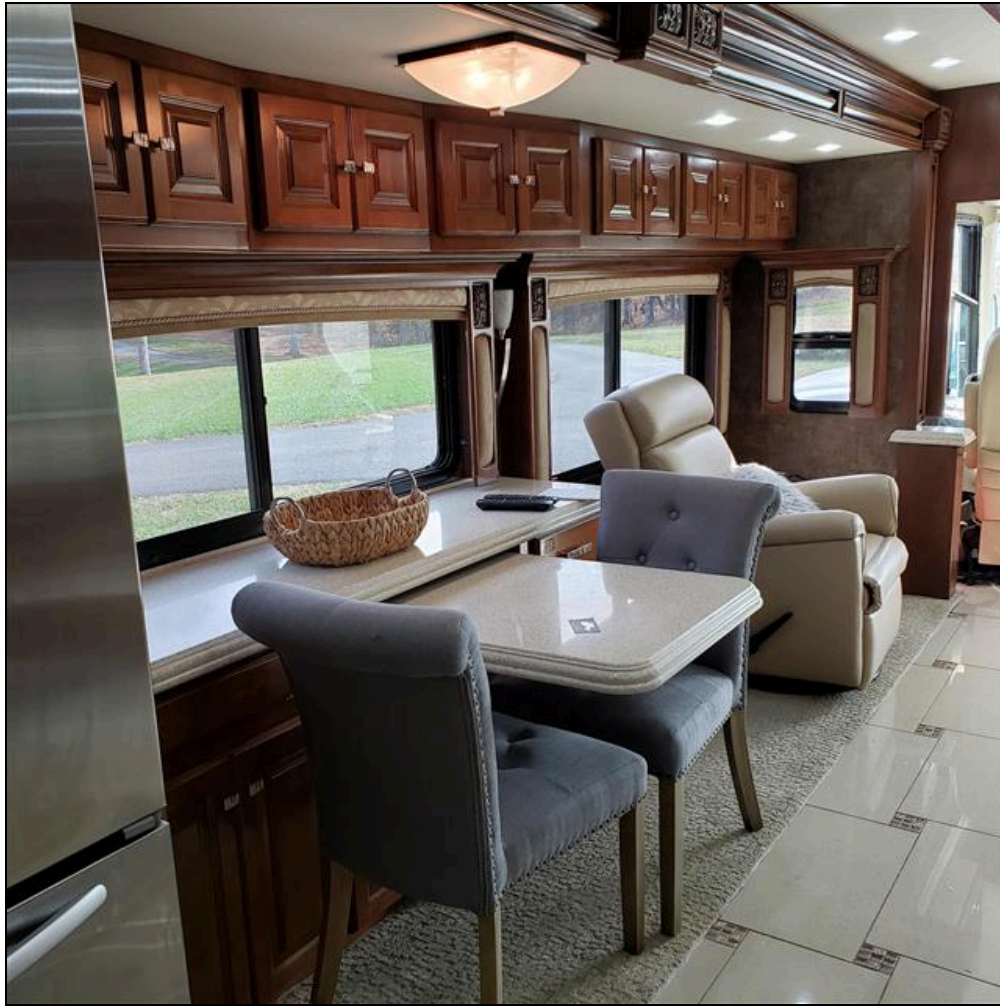
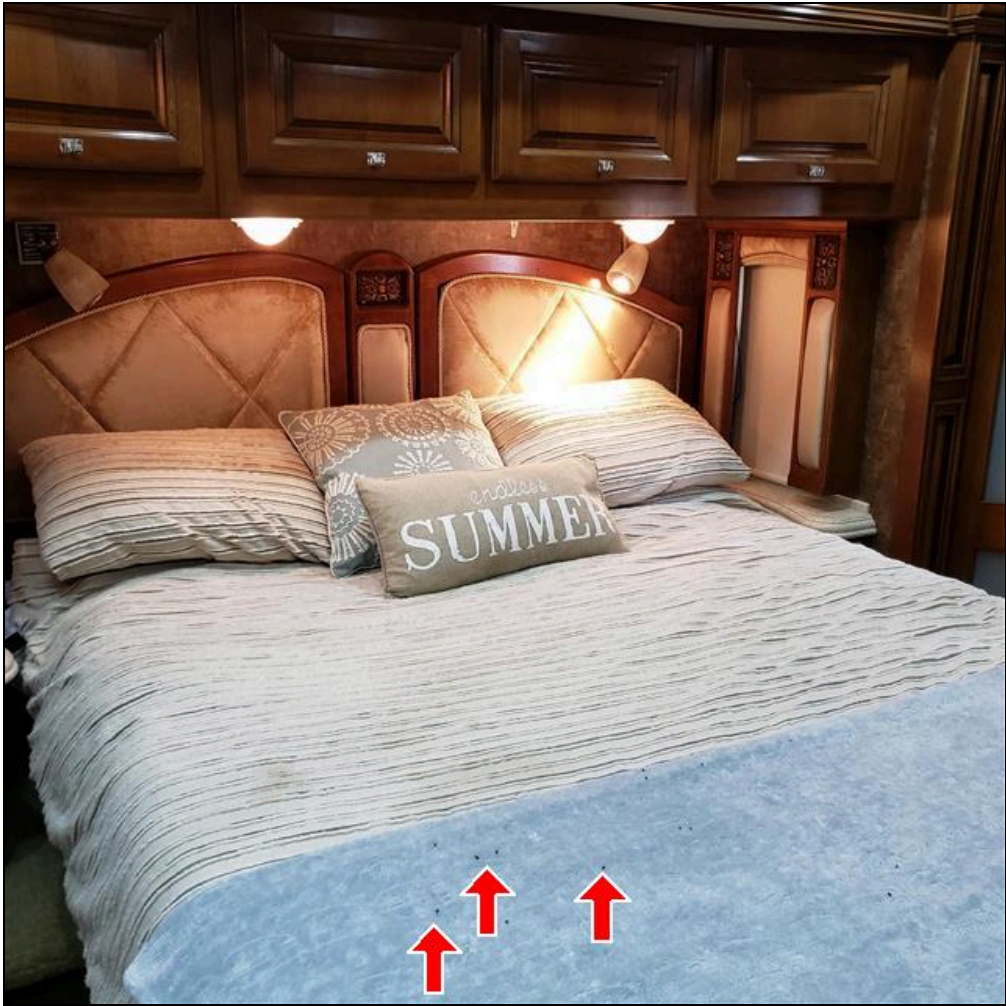
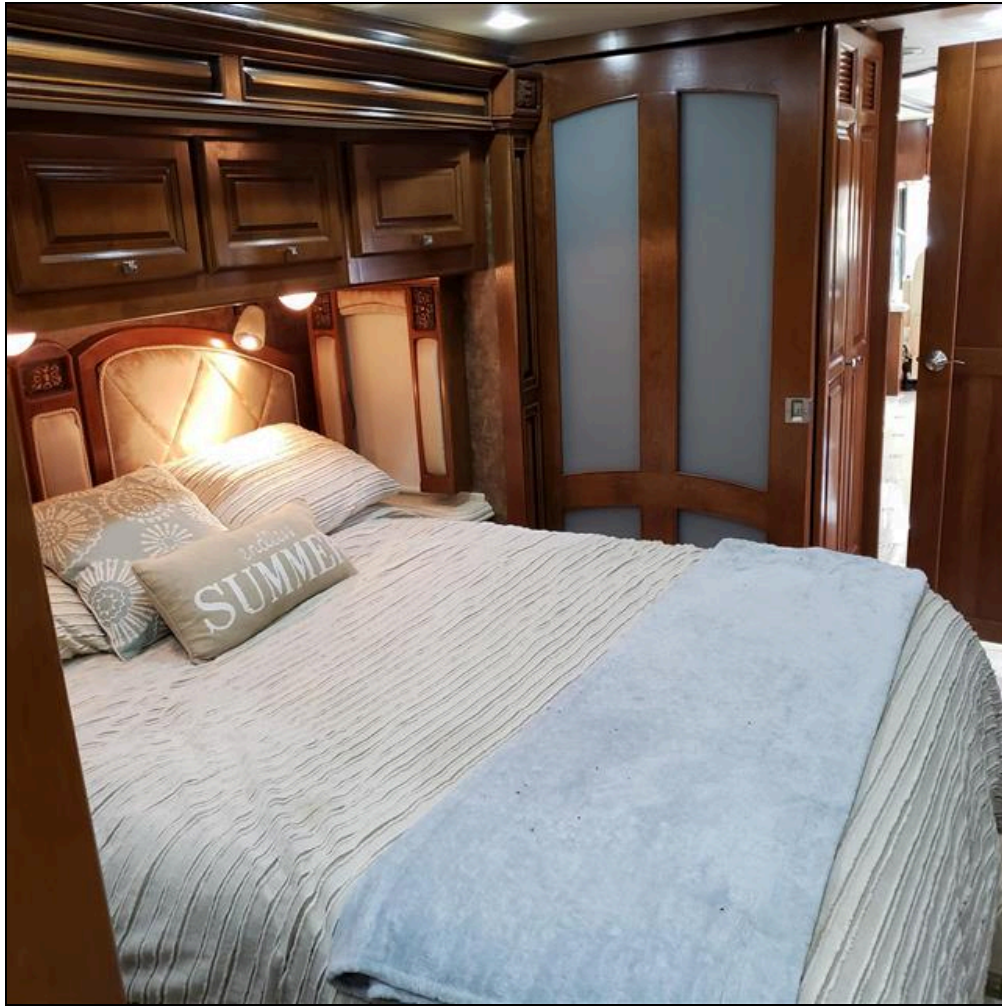
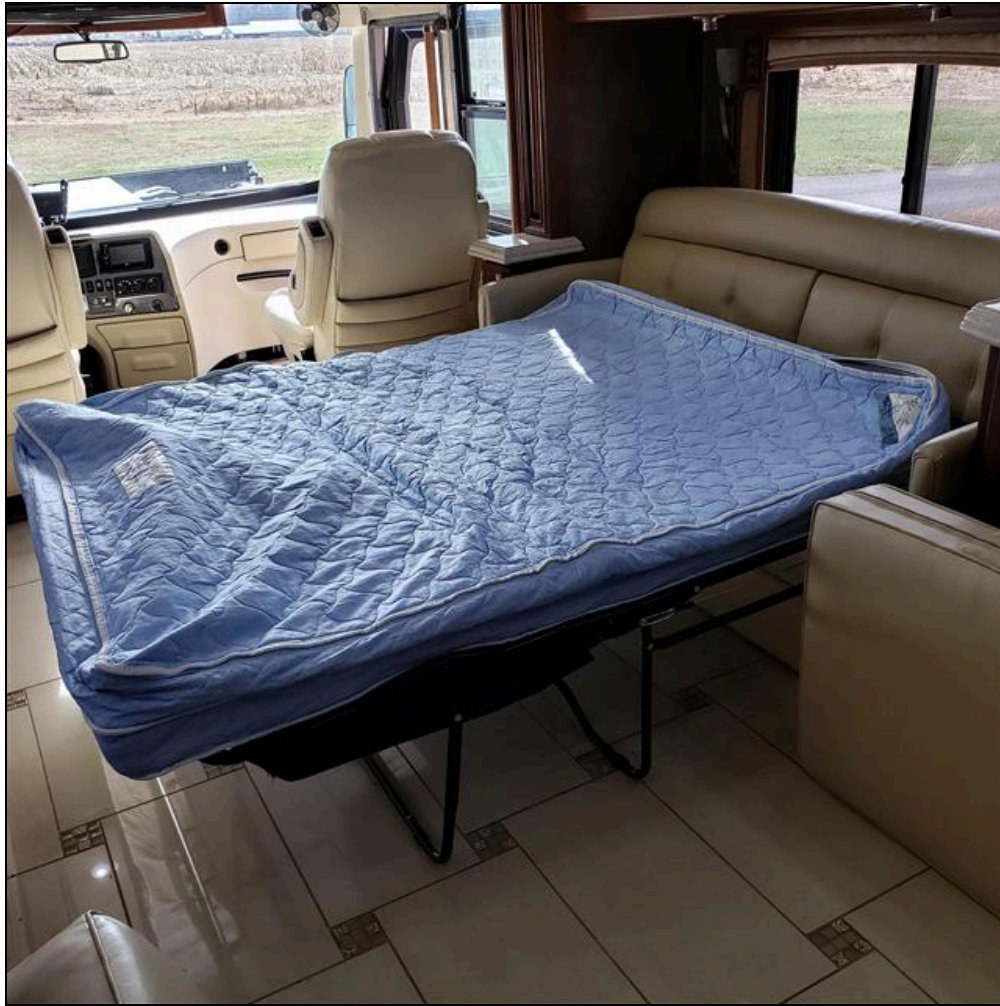
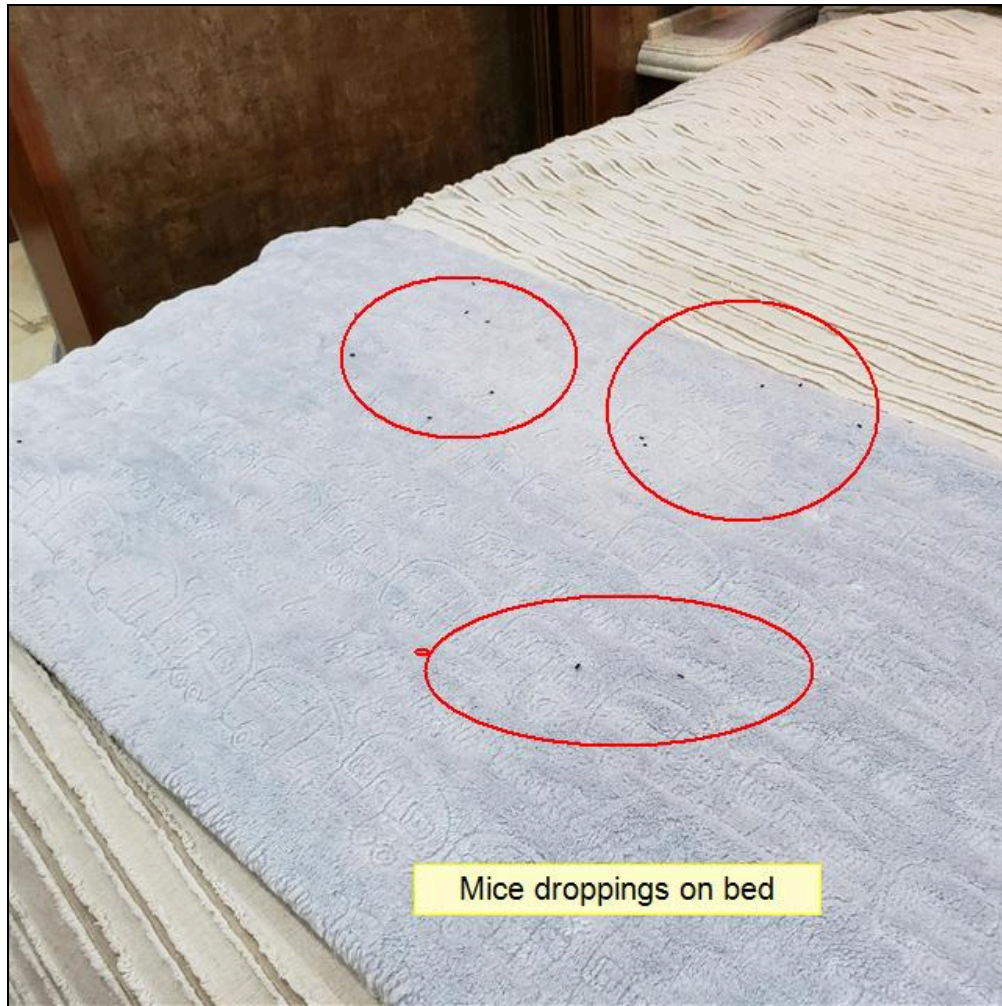
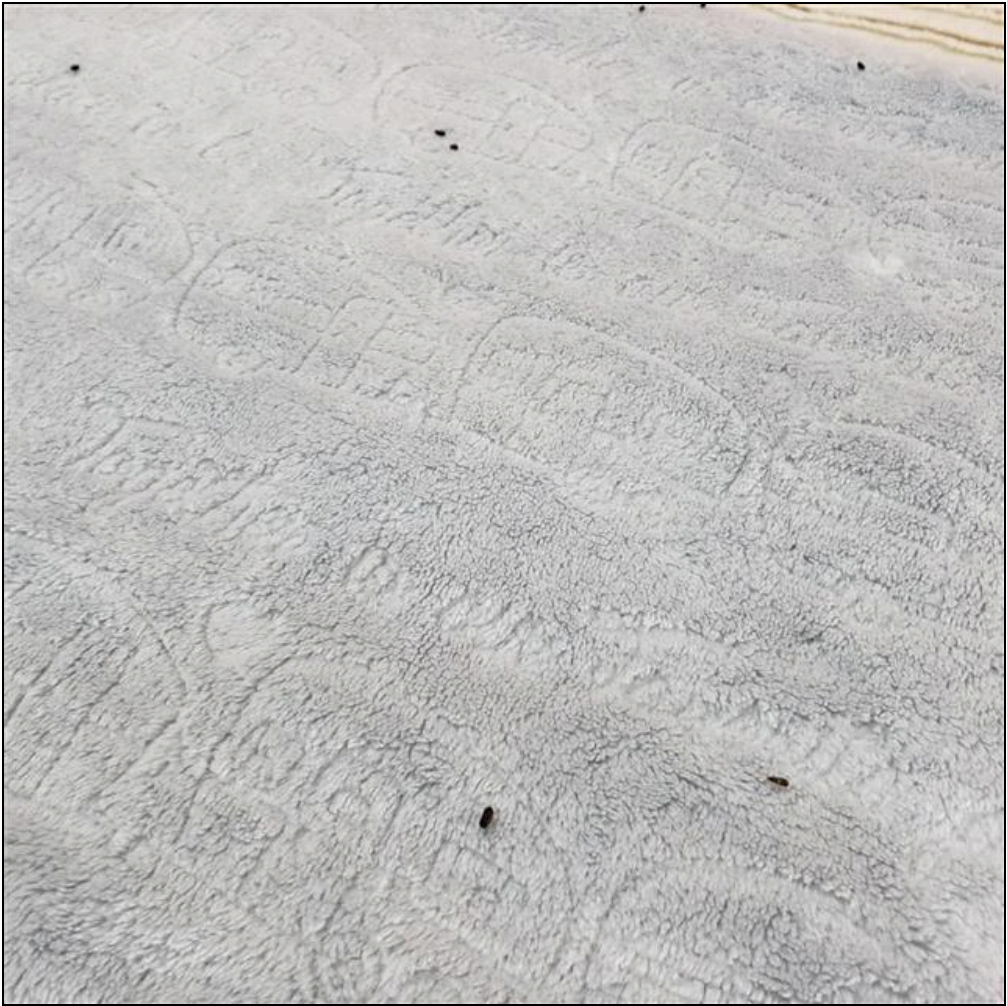
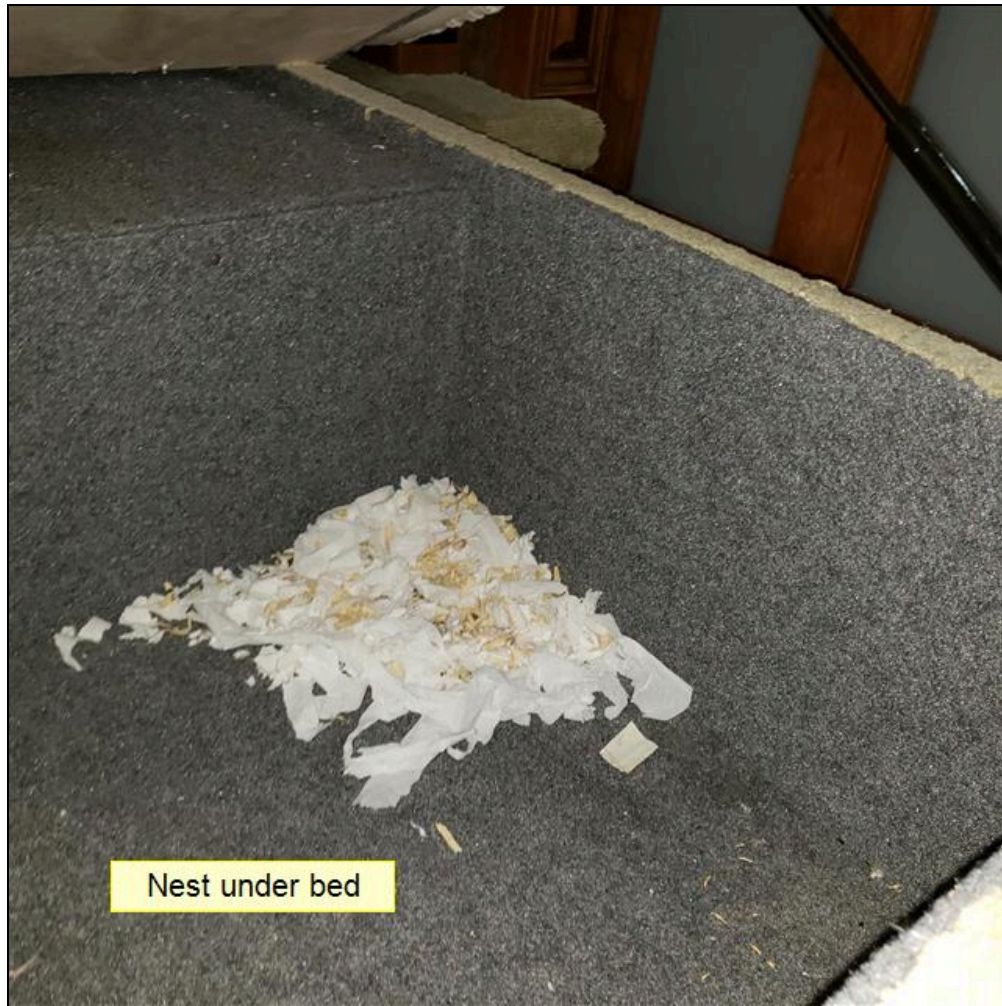
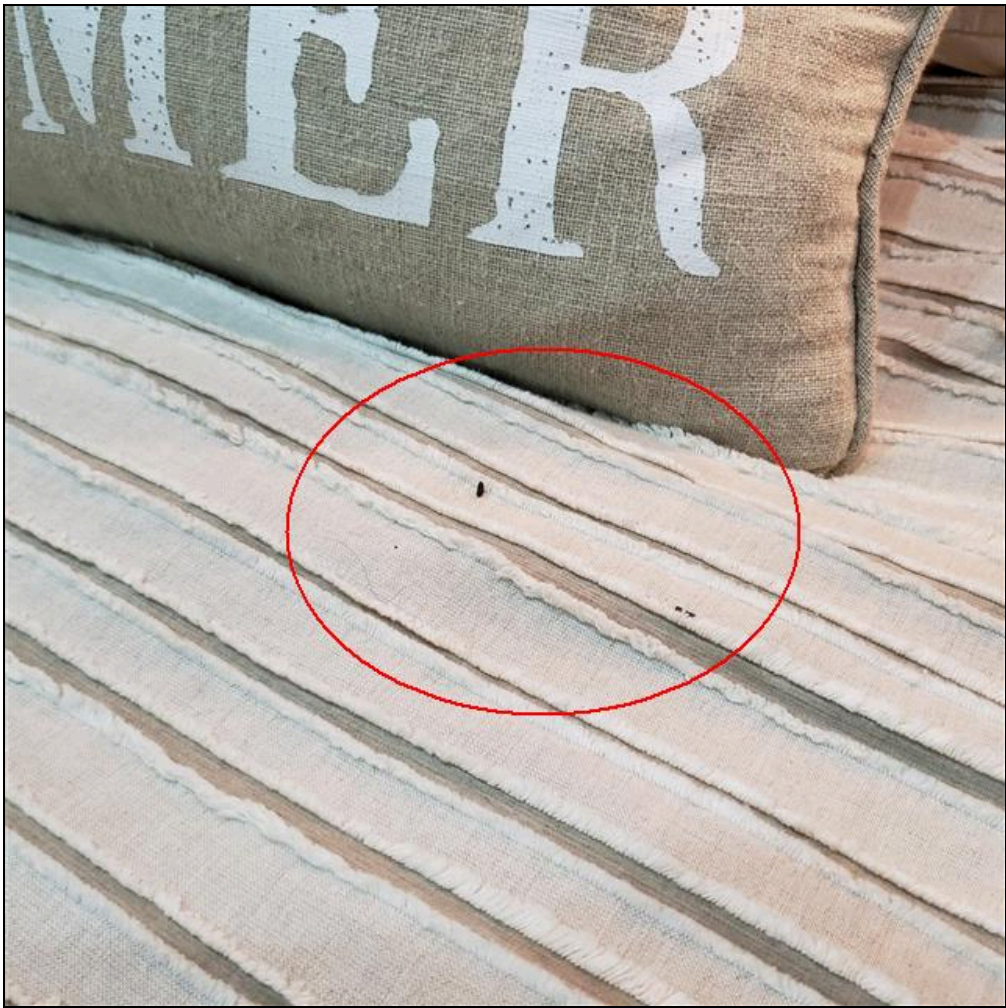
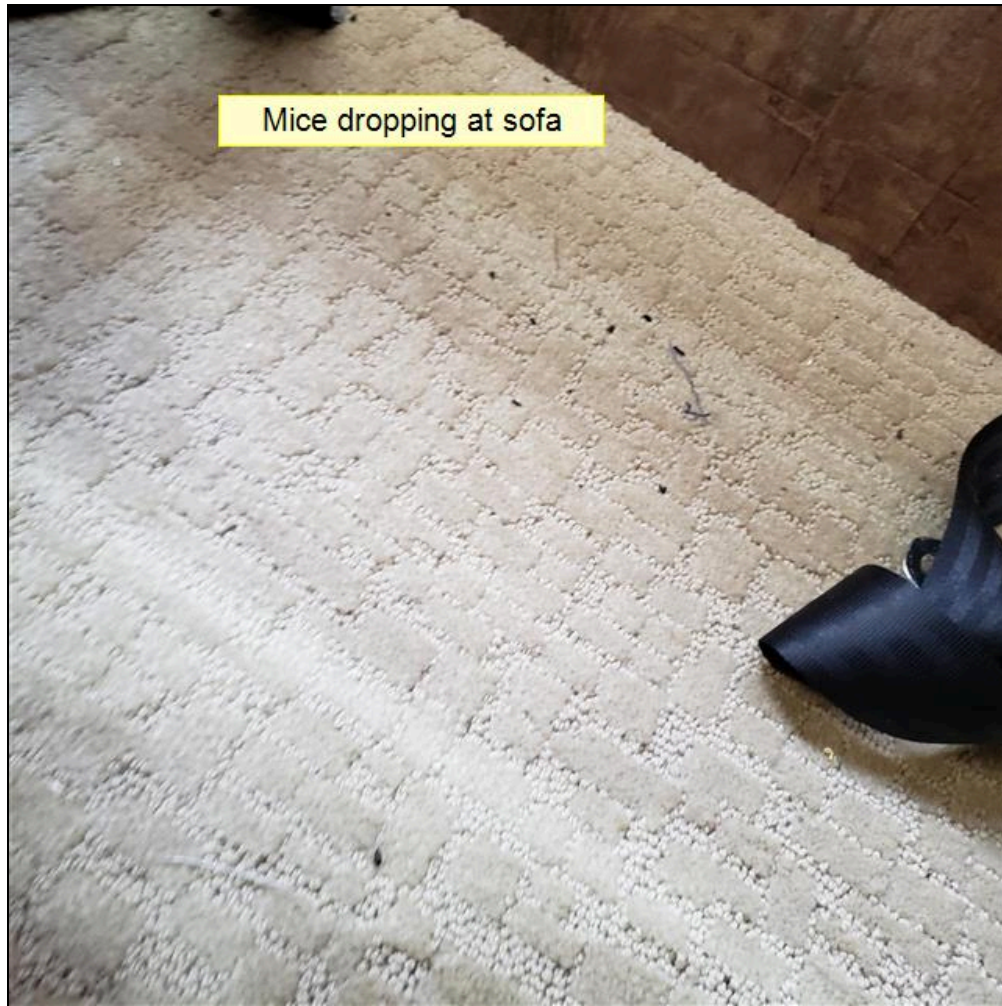
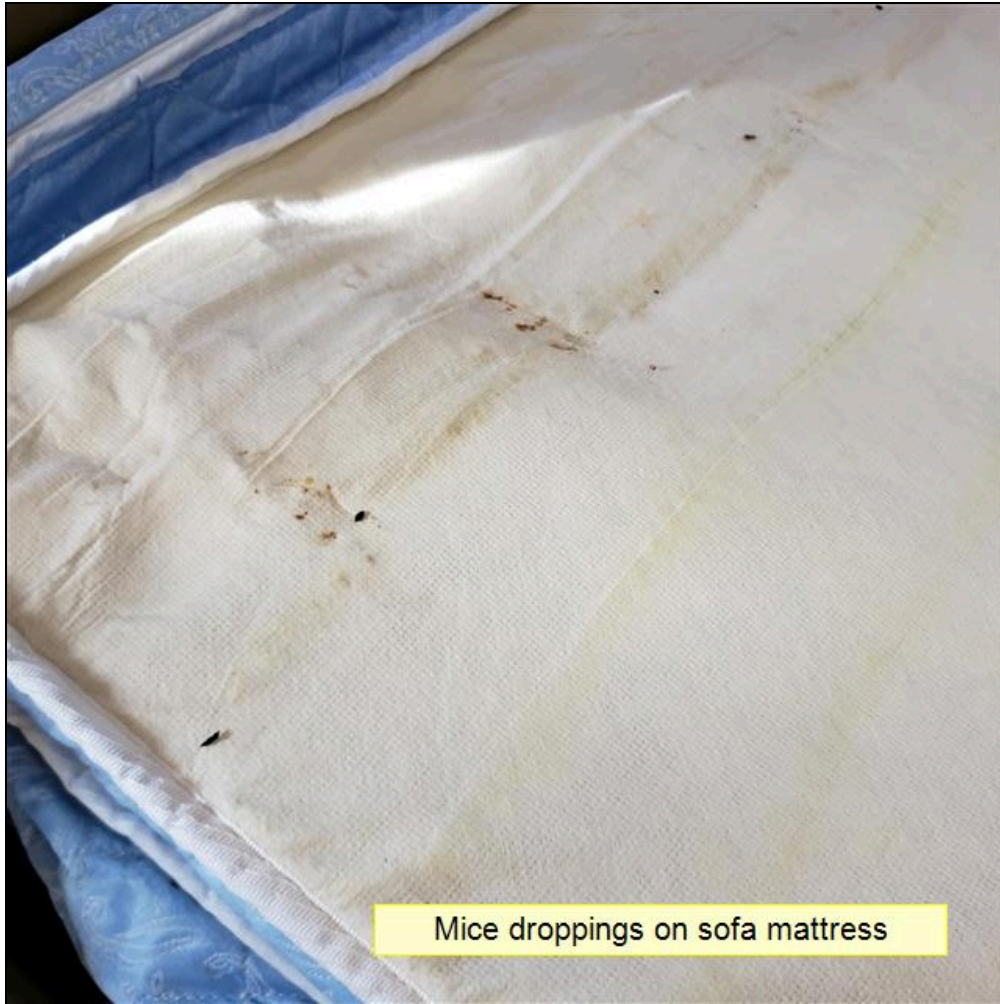
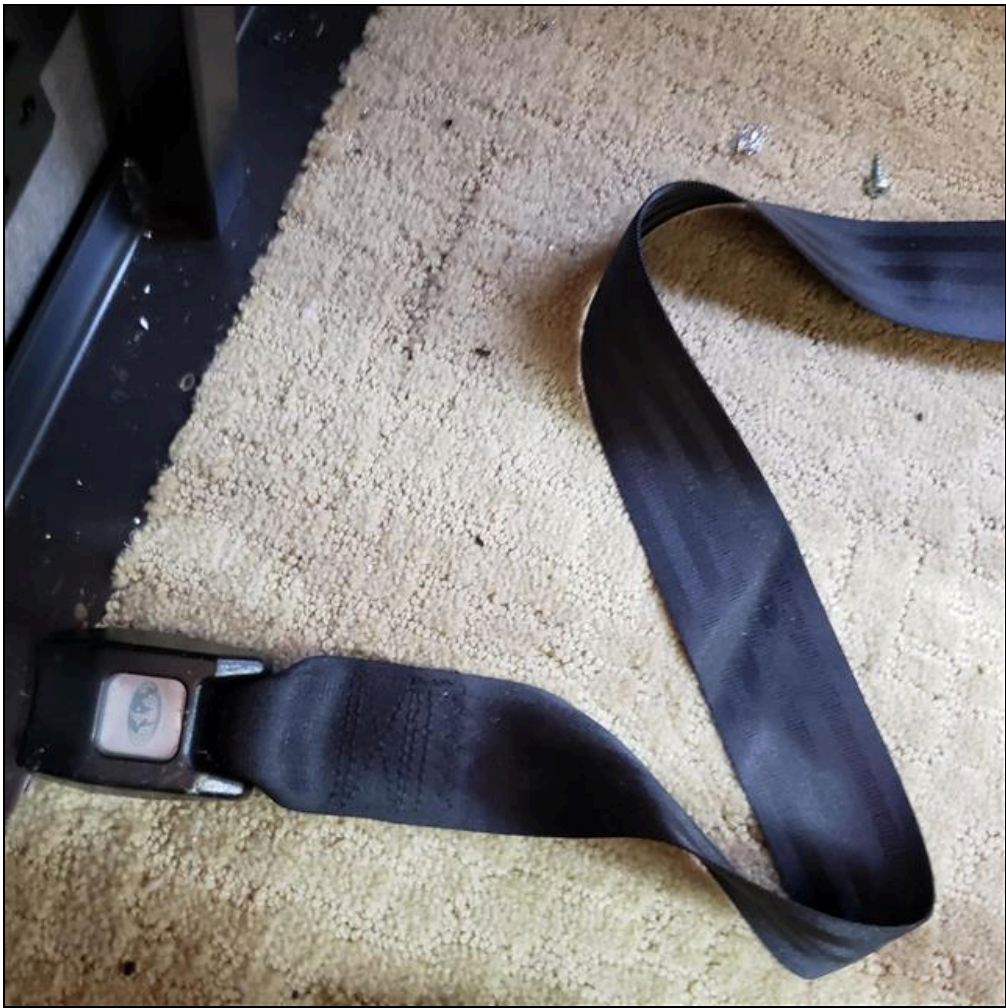
All furnishings are in good condition showing only minor wear consistent with age. Mice "droppings" were found in the sofa/sleeper area and in the bed area. A nest was found under the bed.

The sleeper sofa has an air top mattress. Mattress was not inflated to verify condition.
