S-TEC Corporation

Use of Supplemental Type Certificate Written Permission Statement

FAA/DAS APPROVED
SUPPLEMENTAL FLIGHT MANUAL
FOR
CESSNA MODELS 177, 177A,
AND 177B S/N 17702313 AND BELOW

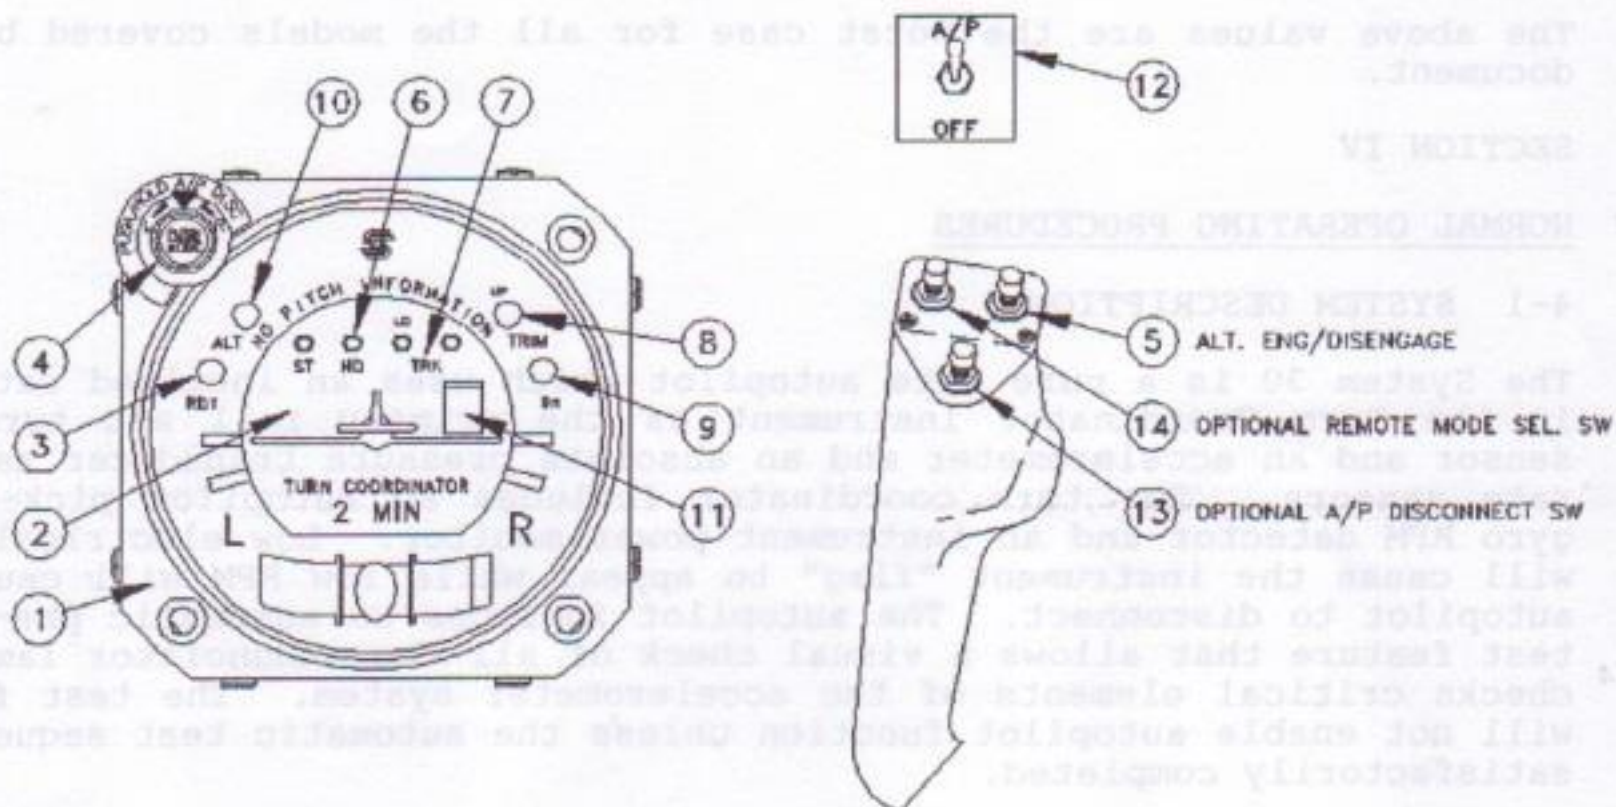
1. Turn Coordinator, Mode Programmer and Annunciator Unit - Provides basic flight information, autopilot mode switching and annunciation.
2. Mode Annunciation Window - Displays mode in use.

3. Green Ready (RDY) Light - Illuminates when autopilot is ready for engagement. When autopilot is disconnected "RDY" will flash for five seconds accompanied by beeping audio tone.
