*Cessna's aircraft of the future can be a bargain today.*

BY THOMAS A. HORNE

## THE CARDINALS

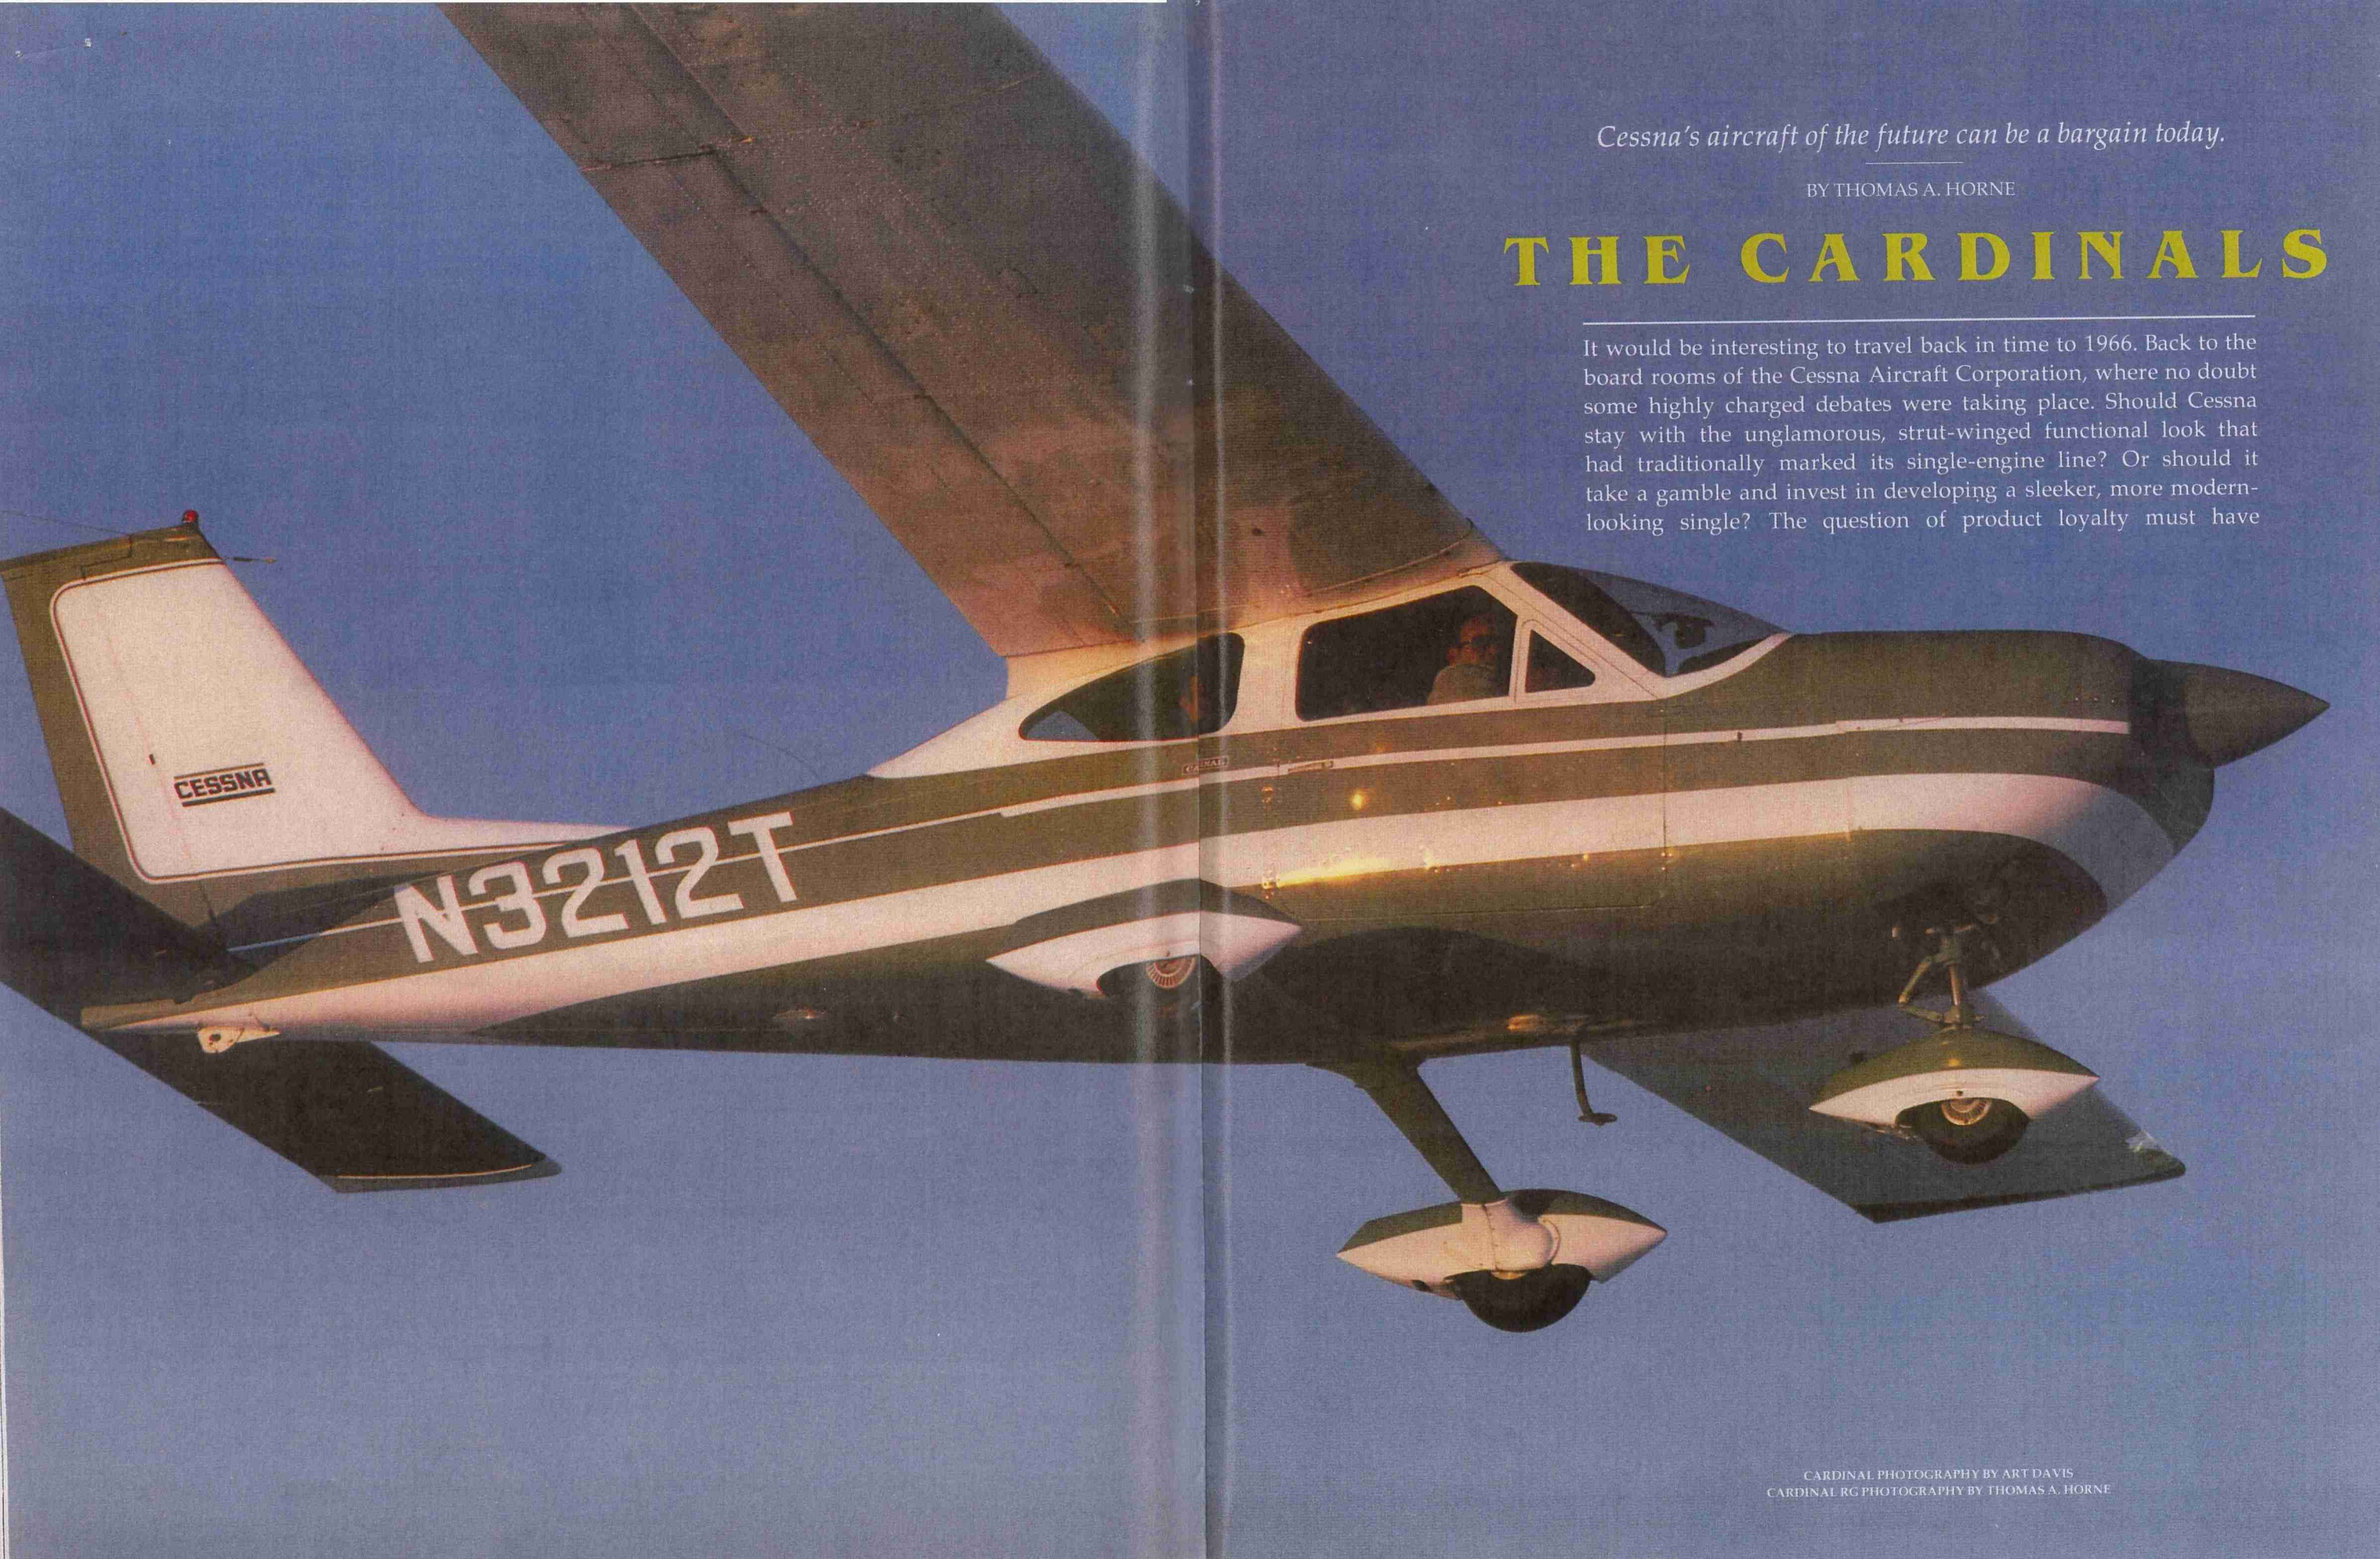
A Cessna Cardinal aircraft is shown in flight against a clear blue sky. The aircraft is a high-wing, single-engine plane with a white base paint and dark horizontal stripes. The registration "N3212T" is prominently displayed on the side of the fuselage. The tail features the "CESSNA" logo. The aircraft is captured from a low angle, emphasizing its sleek design and the large wing structure.
